## BOYER CHUTE BEFORE RESTORATION

## BOYER CHUTE RESTORATION - SECTION 1135 PROJECT

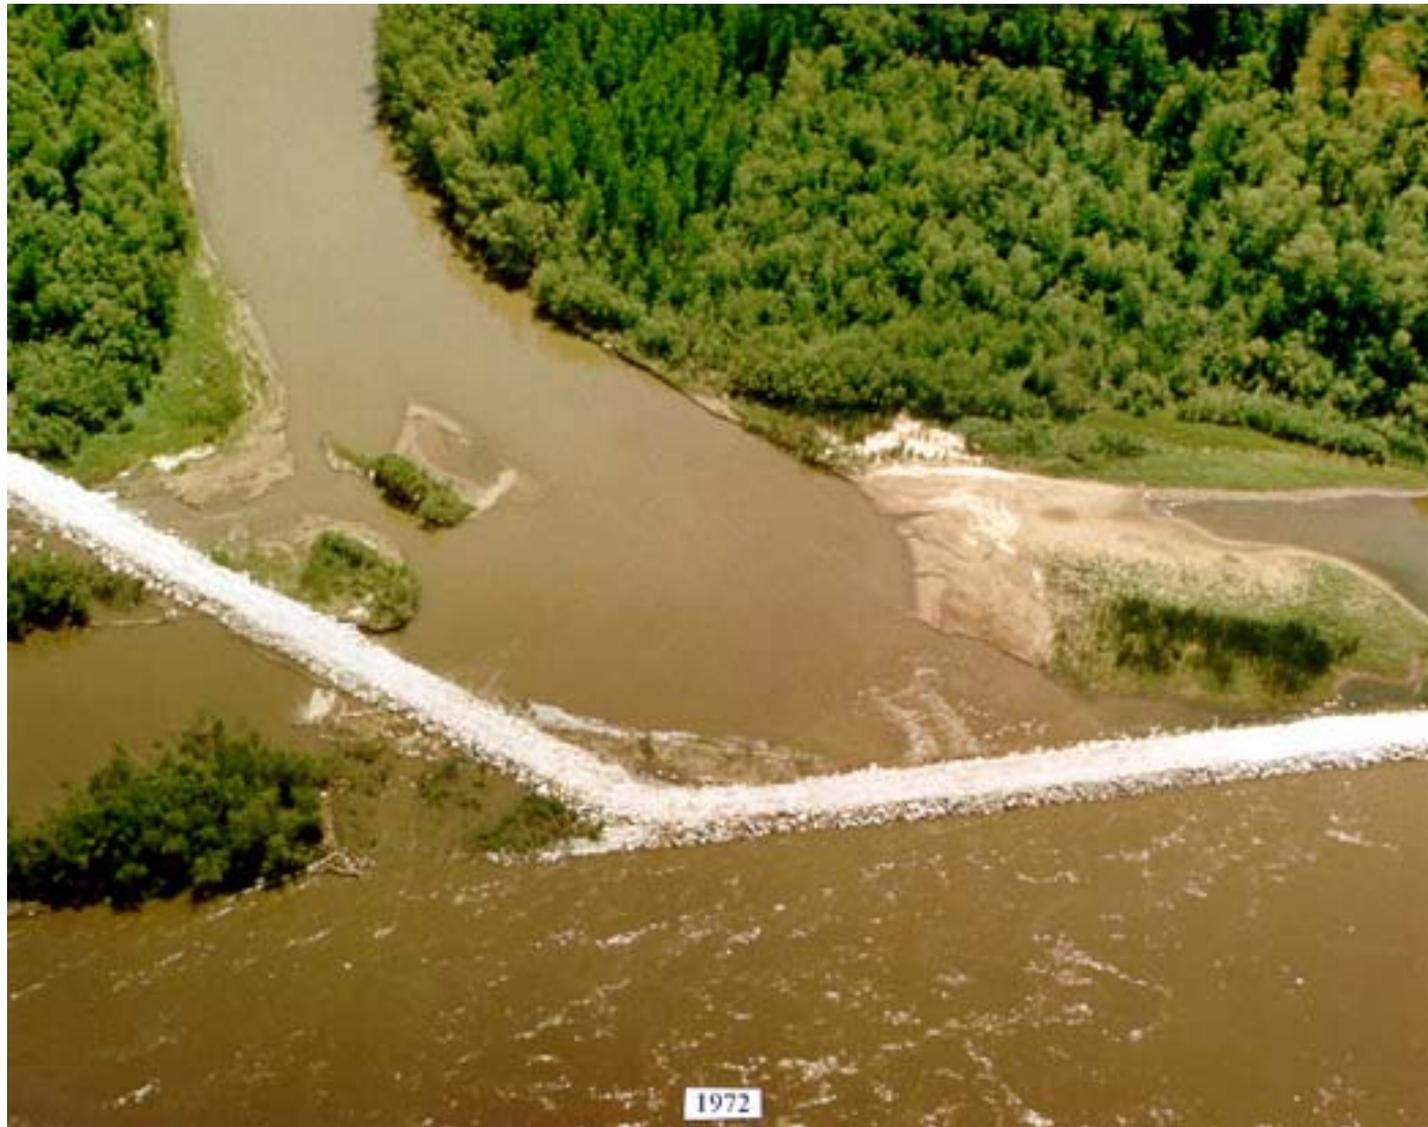
INLET 1972

INLET CUTOFF DIKE AND CHUTE BEFORE CHUTE BECAME FILLED WITH SEDIMENT

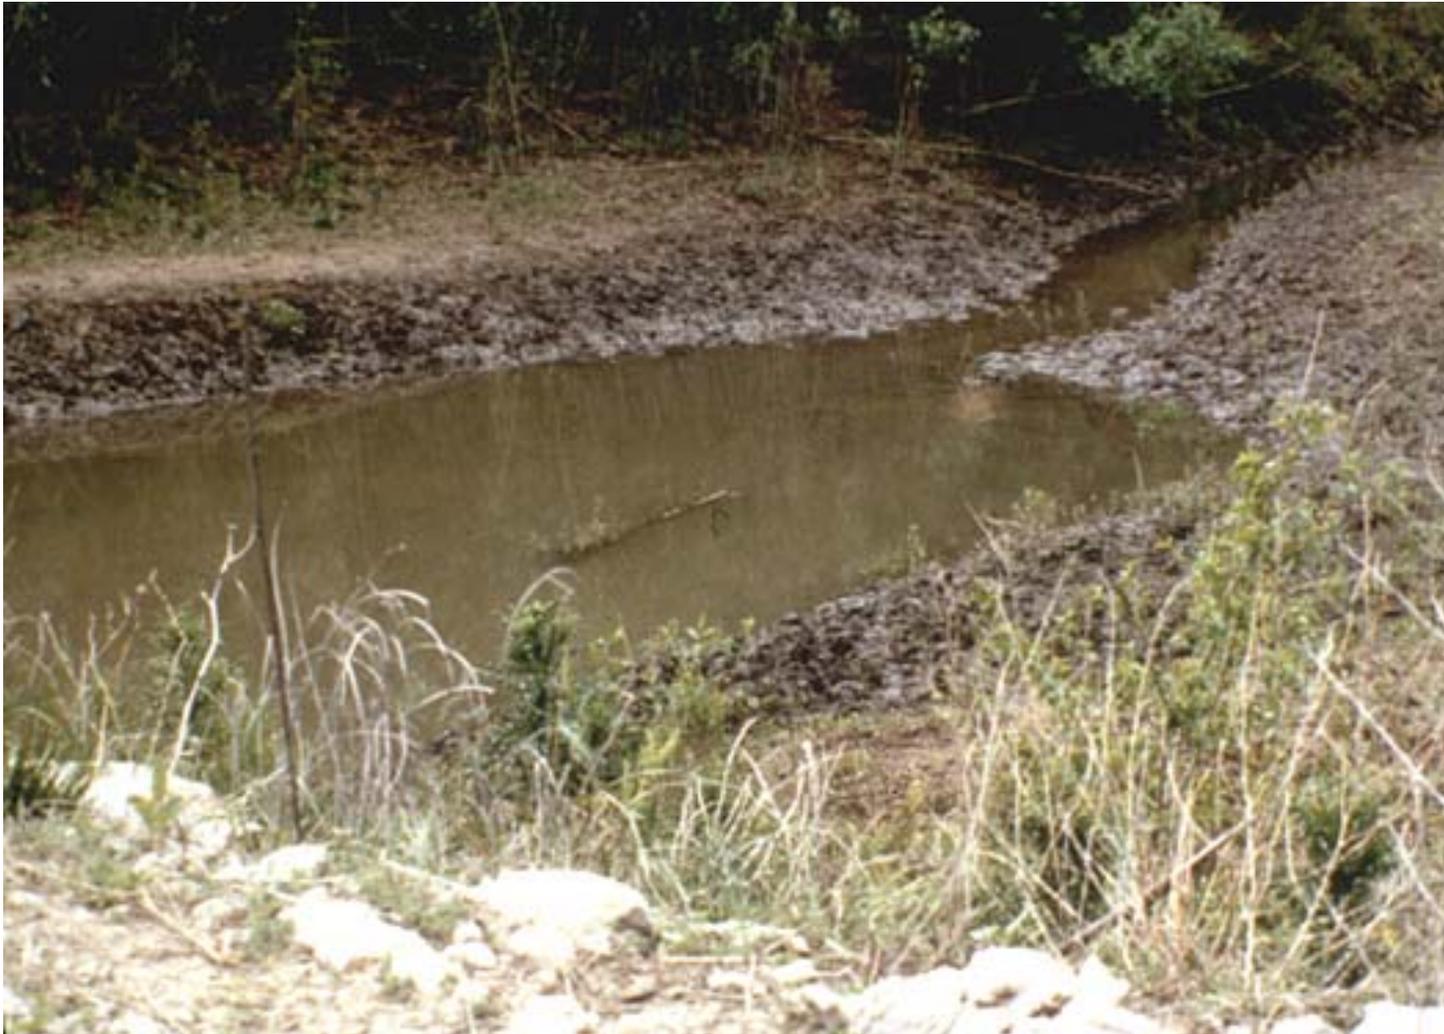
INLET 1989

INLET VIEWED FROM CUTOFF DIKE AFTER CHUTE FILLED WITH SEDIMENT, 1989

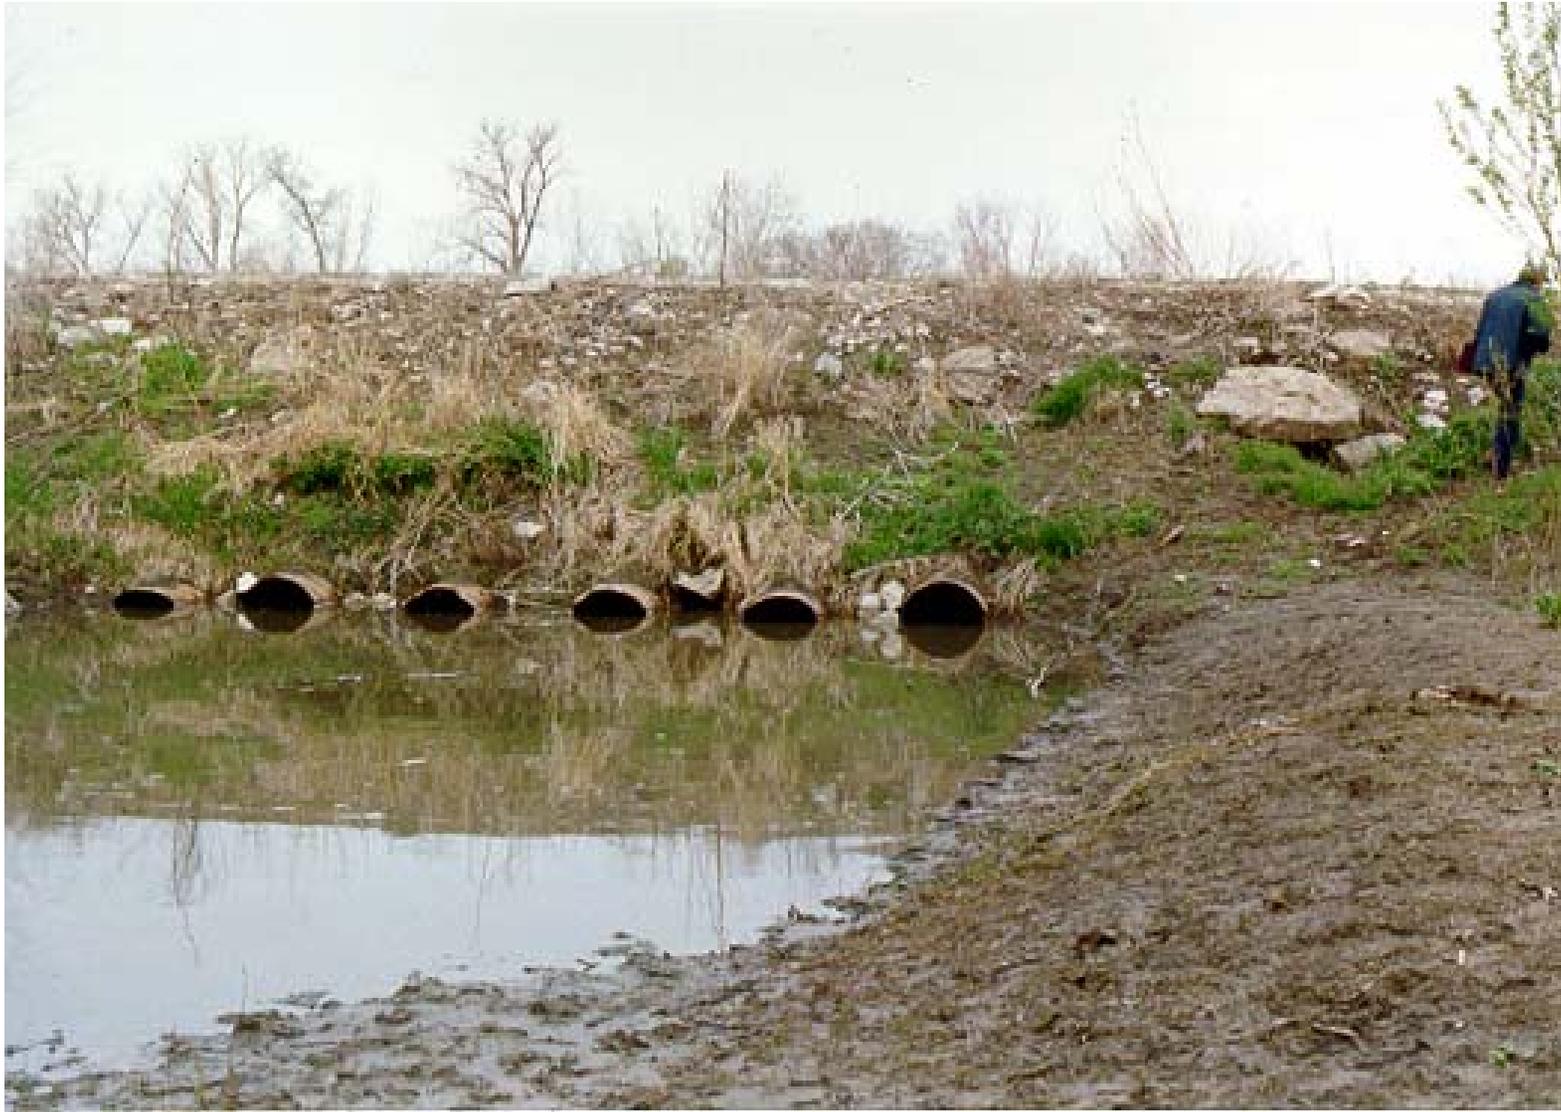
INLET CULVERTS - 1989

INLET BEFORE RESTORATION, 1989, VIEWED FROM CHUTE SIDE, FILLED WITH SEDIMENT

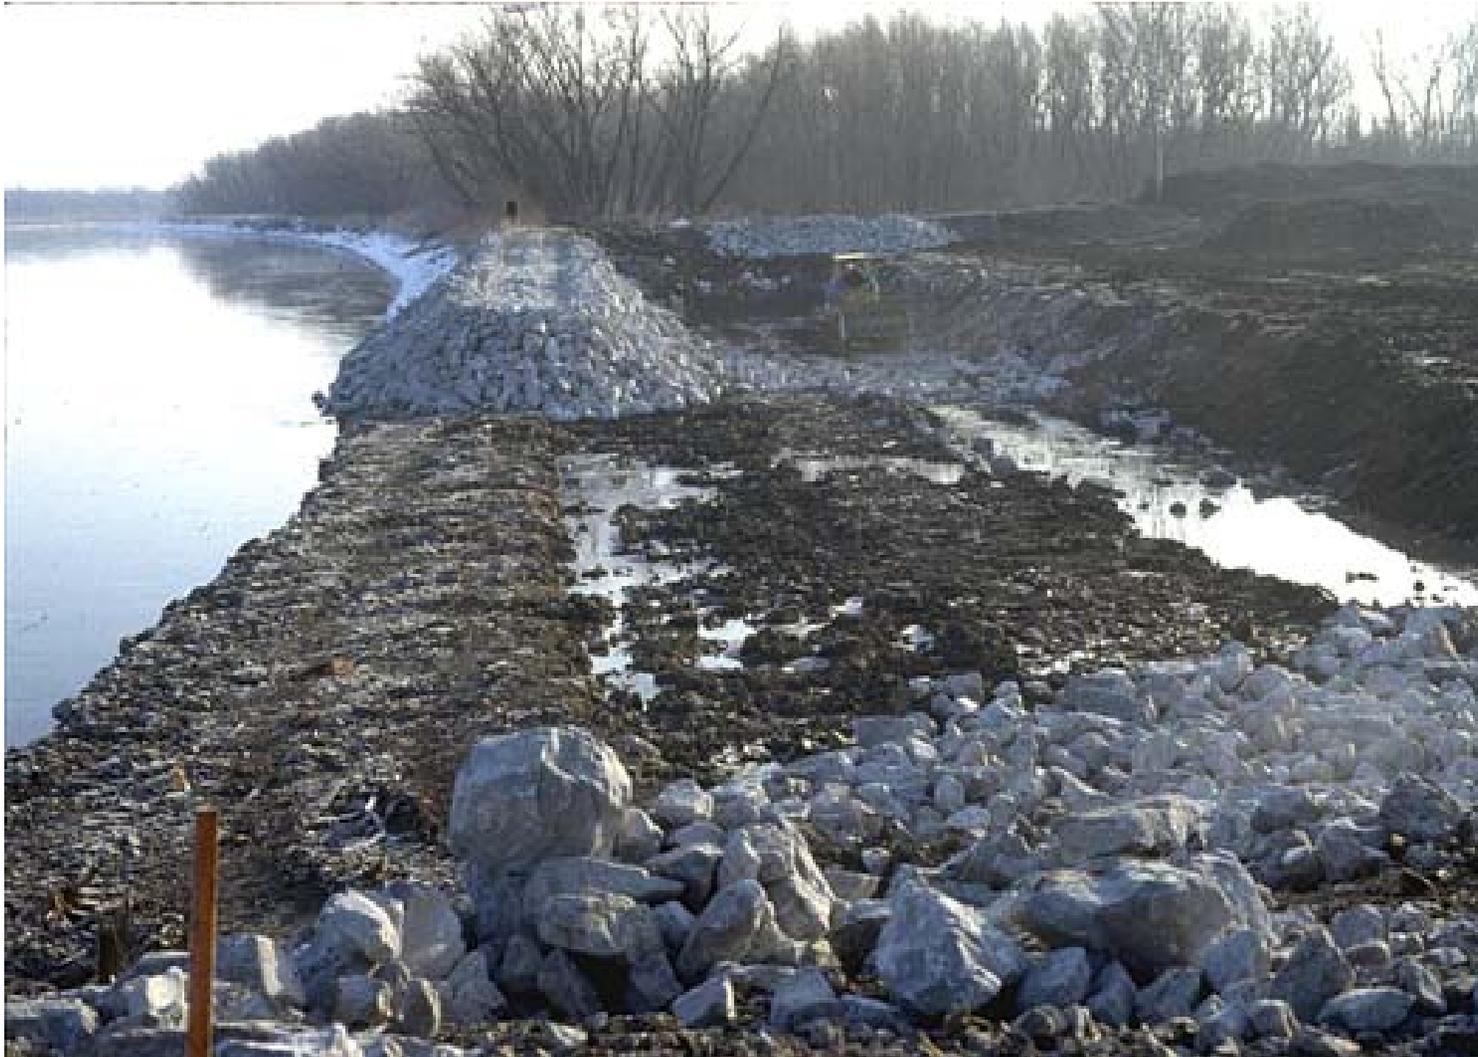
### INLET NOTCH

CONSTRUCTION OF NEW INLET NOTCH THROUGH CUTOFF DIKE, 1993.  
RIVER AT LOW WINTER LEVELS.

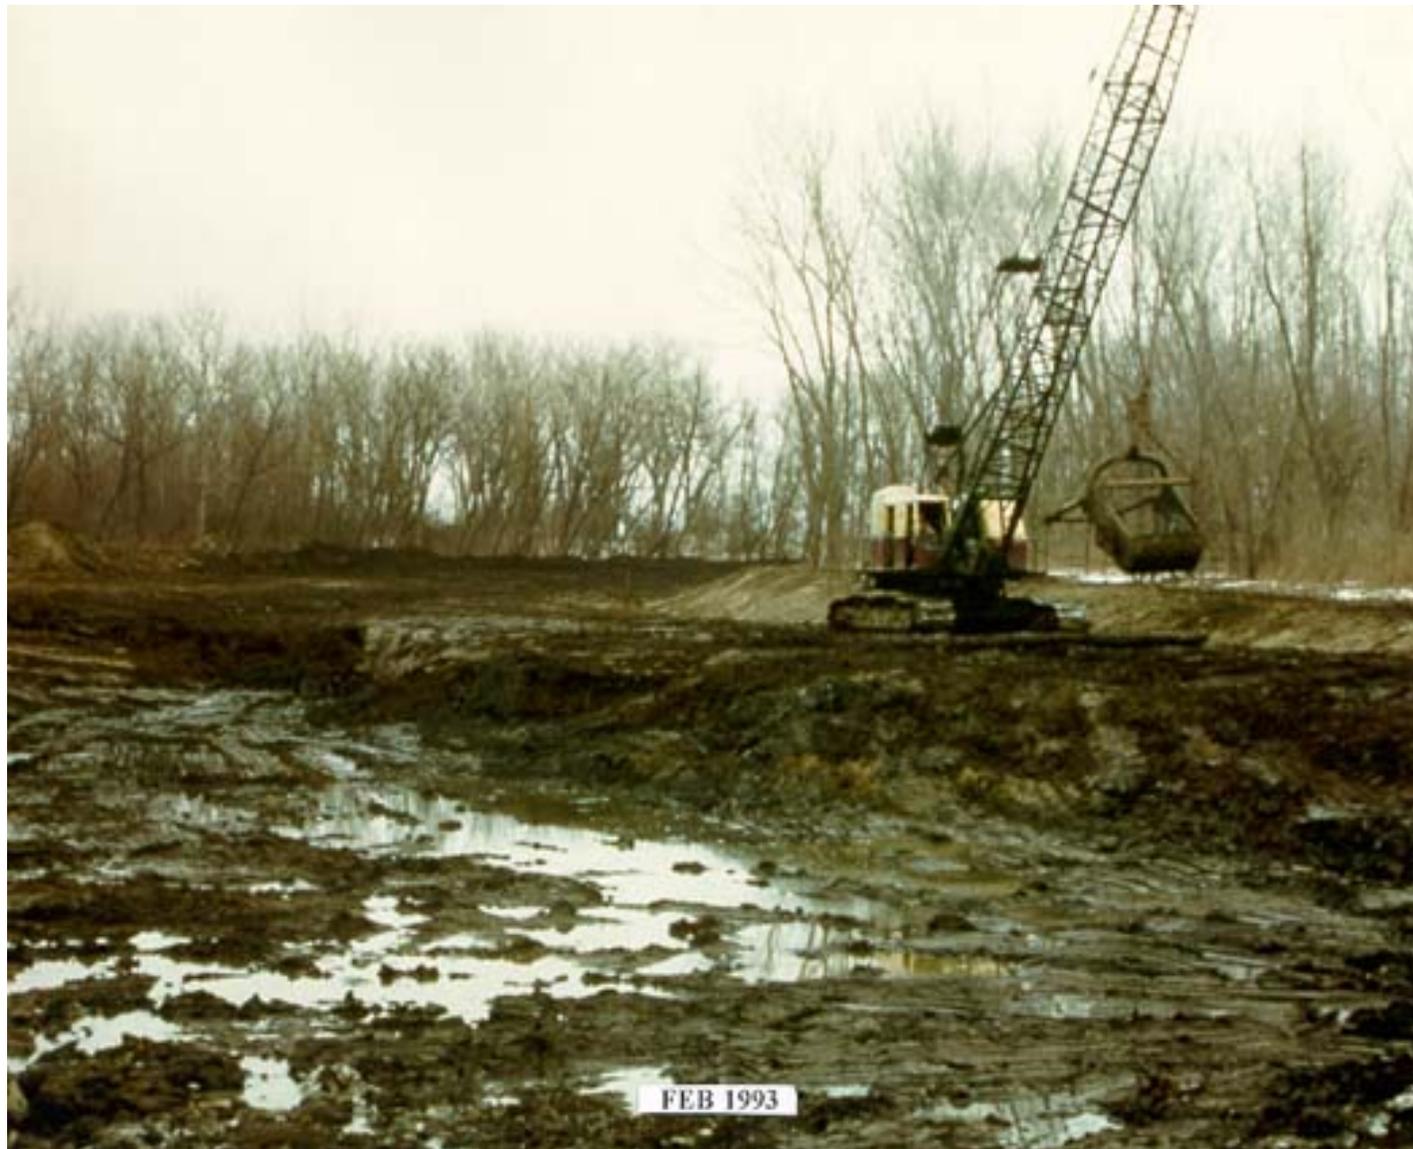
INLET EXCAVATION  
PILOT CHANNEL EXCAVATION DOWNSTREAM FROM INLET.

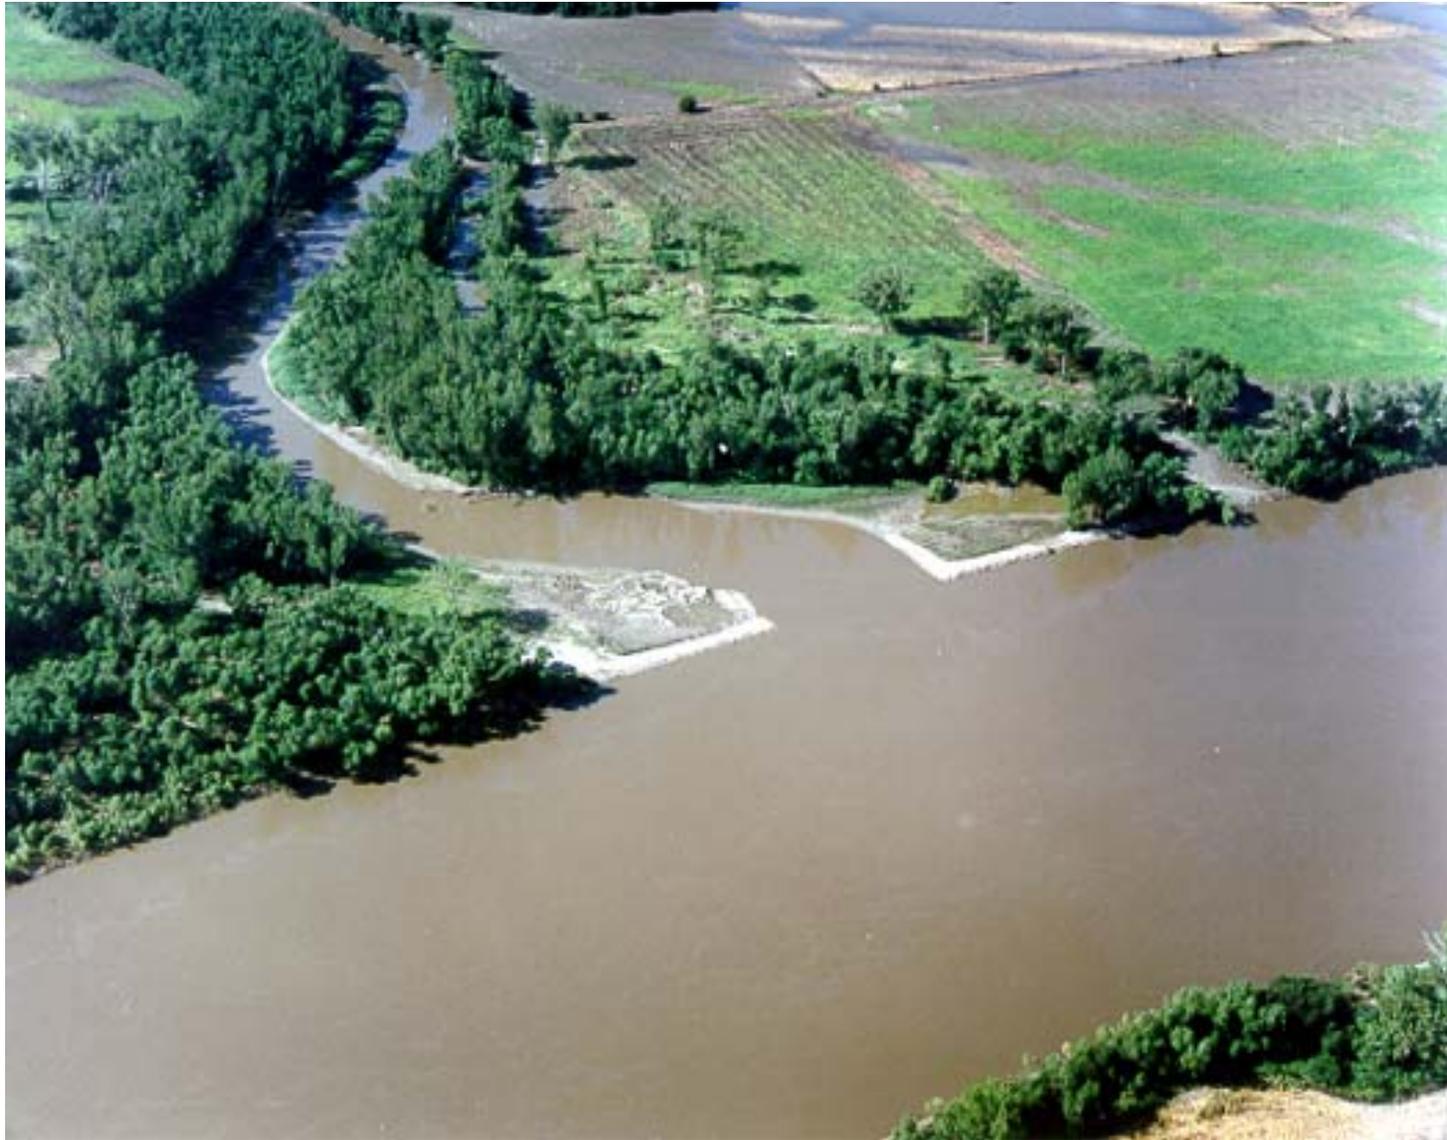
INLET 93

THE RESTORED CHUTE FLOWING THROUGH ITS INLET AND RE-OPENED CHANNEL. 1993

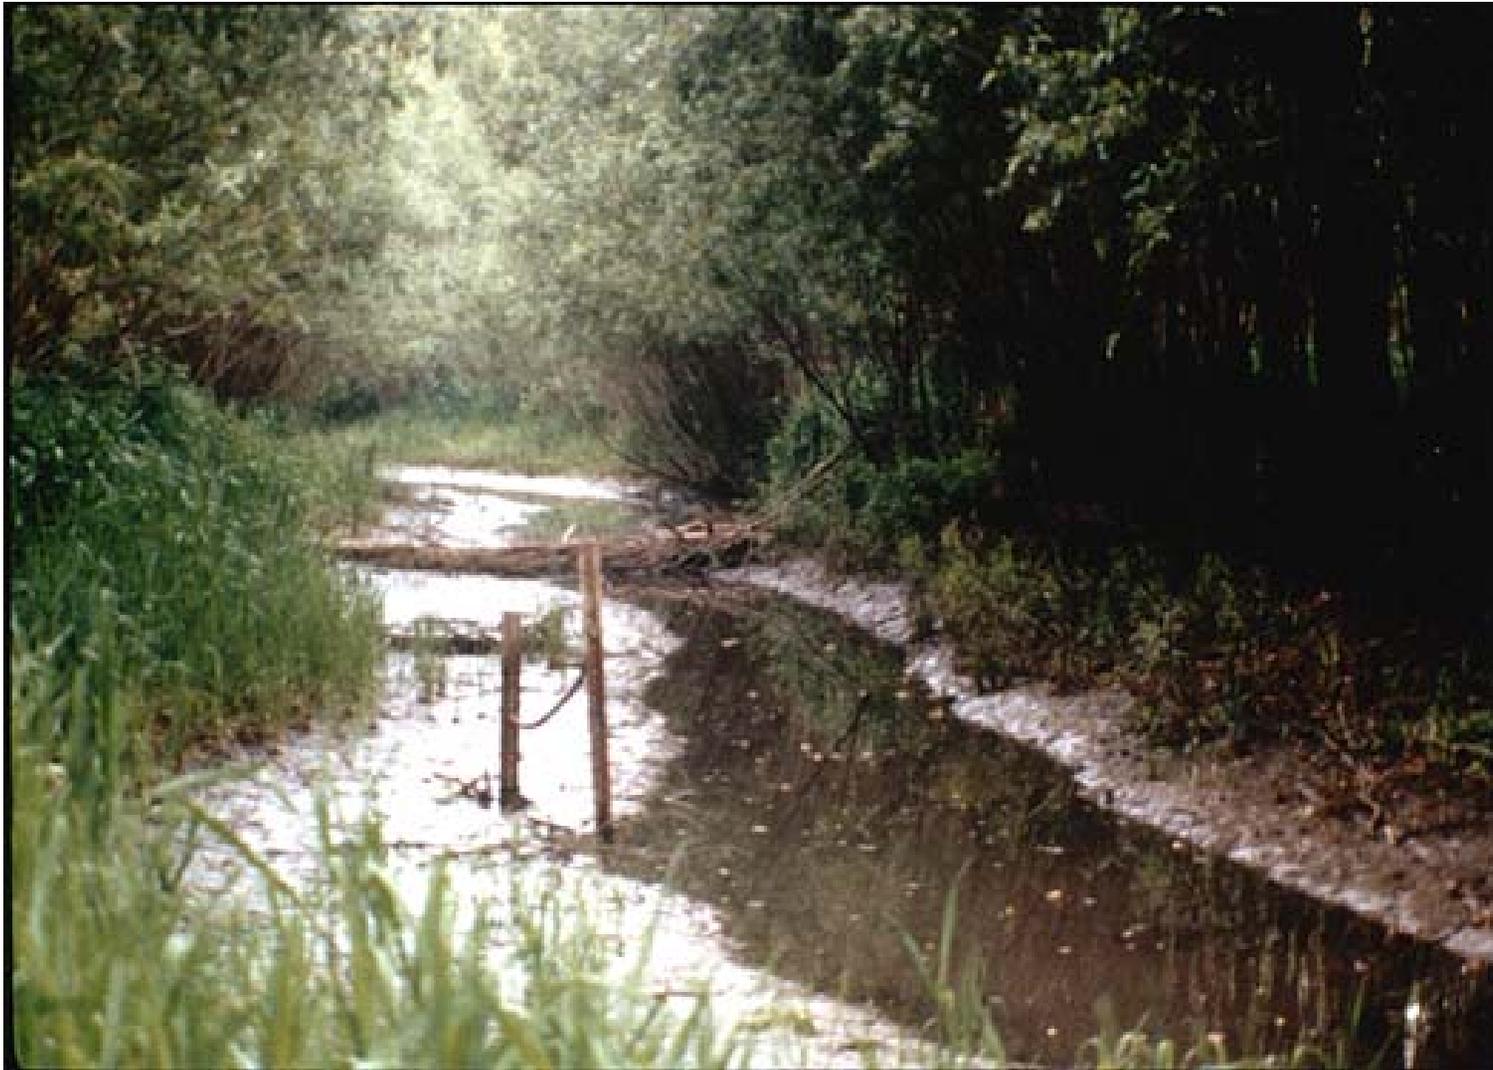
UPSTREAM CHANNEL 89

UPSTREAM CHUTE FILLED WITH SEDIMENT, 1989  
NOTE BURIED FENCE POSTS, SAPLING TREES

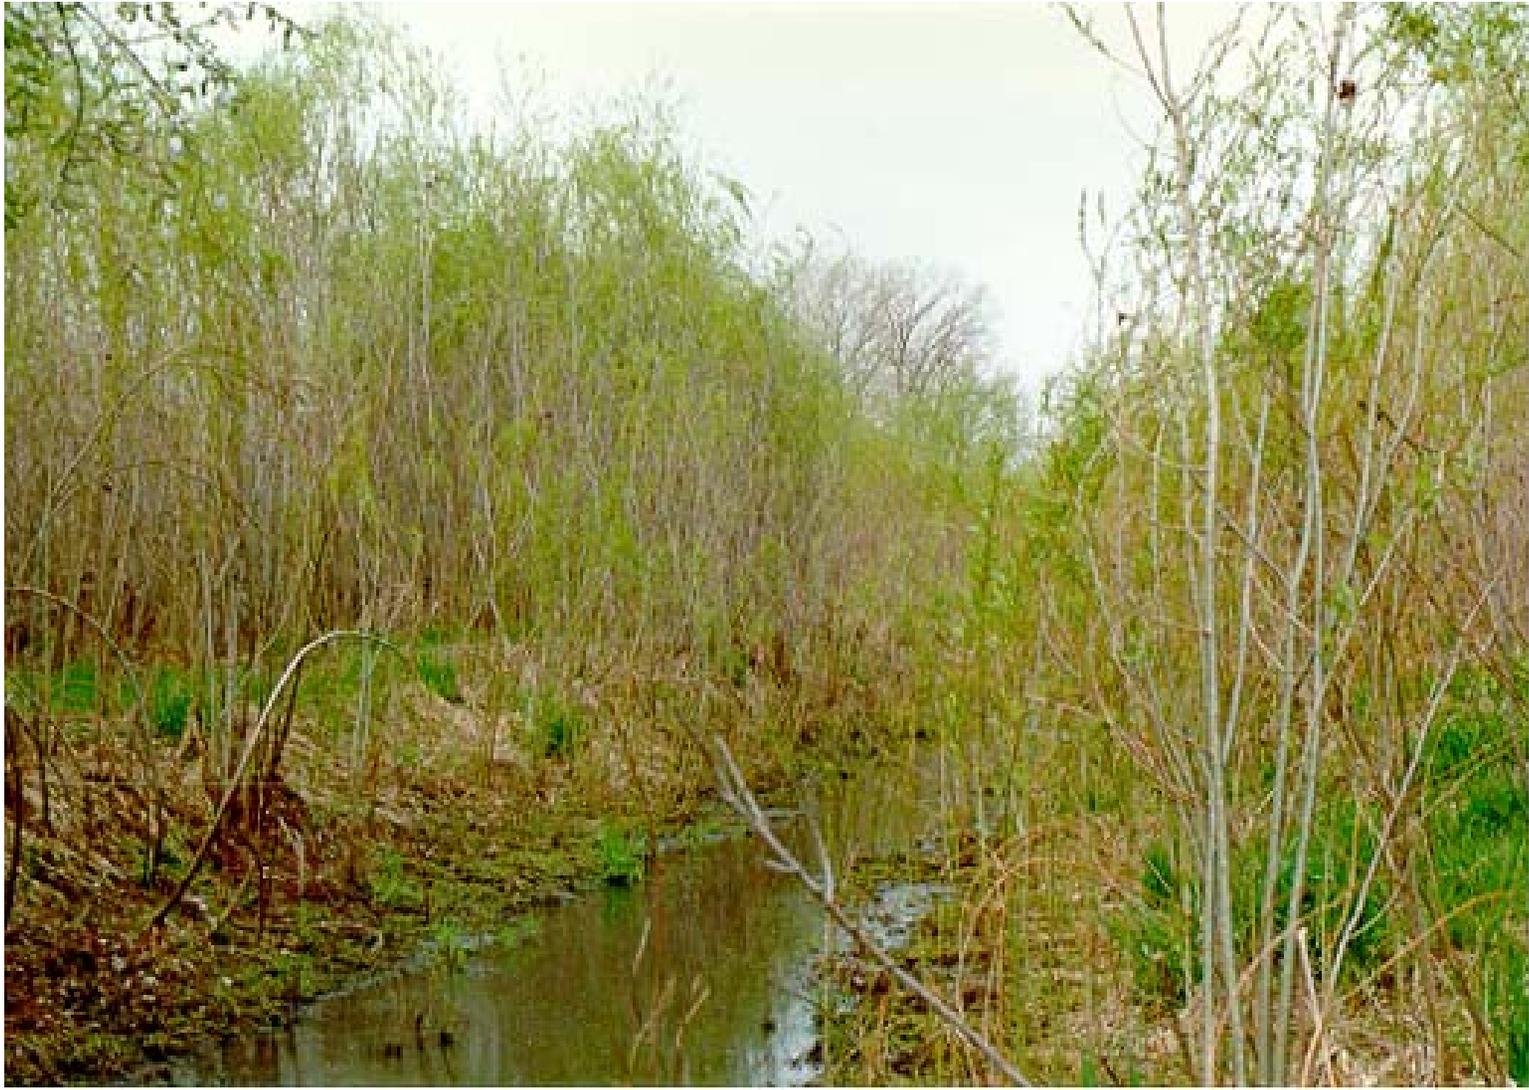
UPSTREAM CHANNEL 89

UPSTREAM CHUTE FILLED WITH SEDIMENT, 1989. NOTE WILLOWS AND SAPLING TREES.

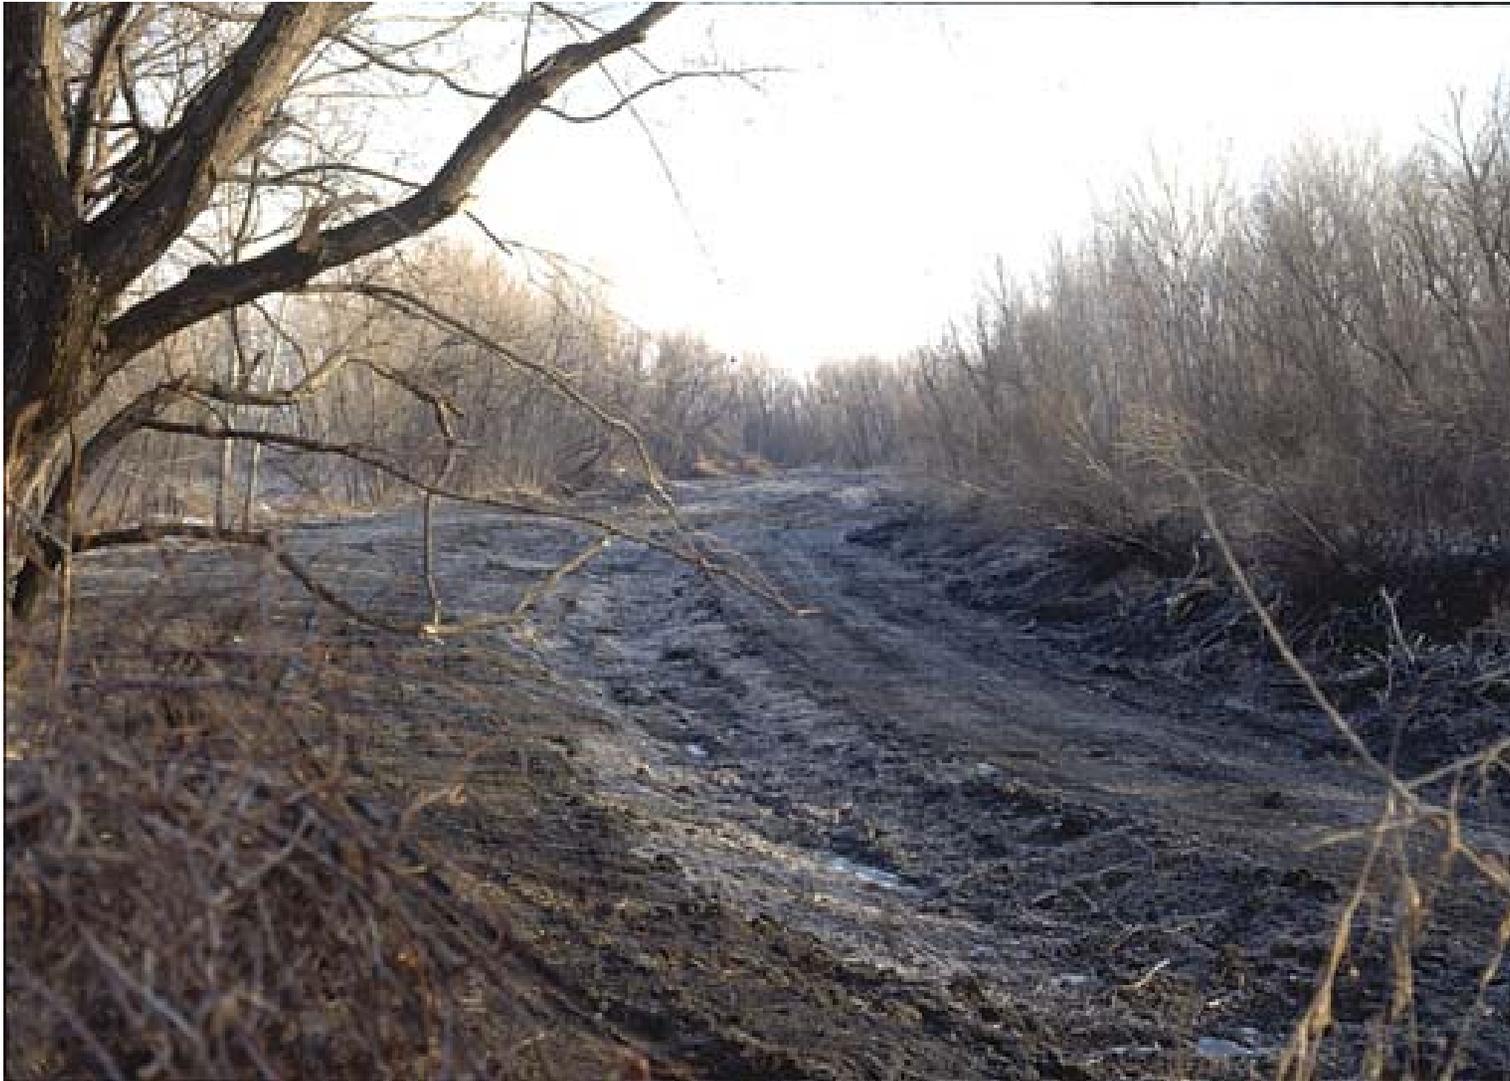
CHANNEL EXCAVATION

UPSTREAM CHUTE EXCAVATION TO A PILOT CHANNEL. 1993

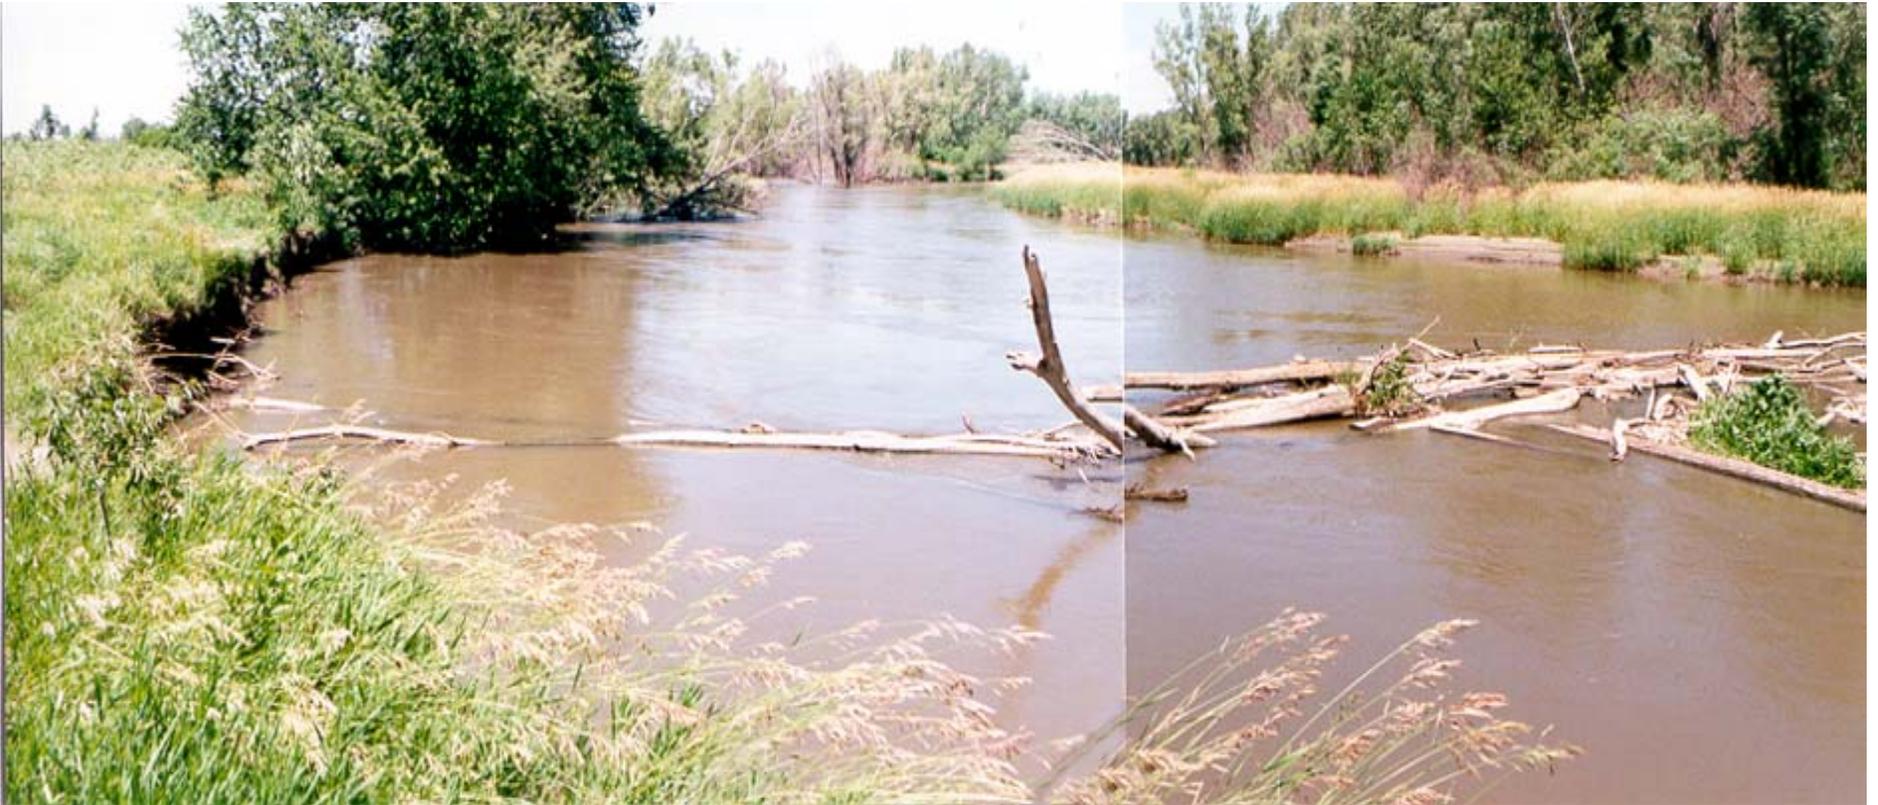
UPSTREAM CHUTE AFTER RESTORATION, AT HIGH FLOWS. NOTE SNAG HABITAT DEVELOPING. 1997

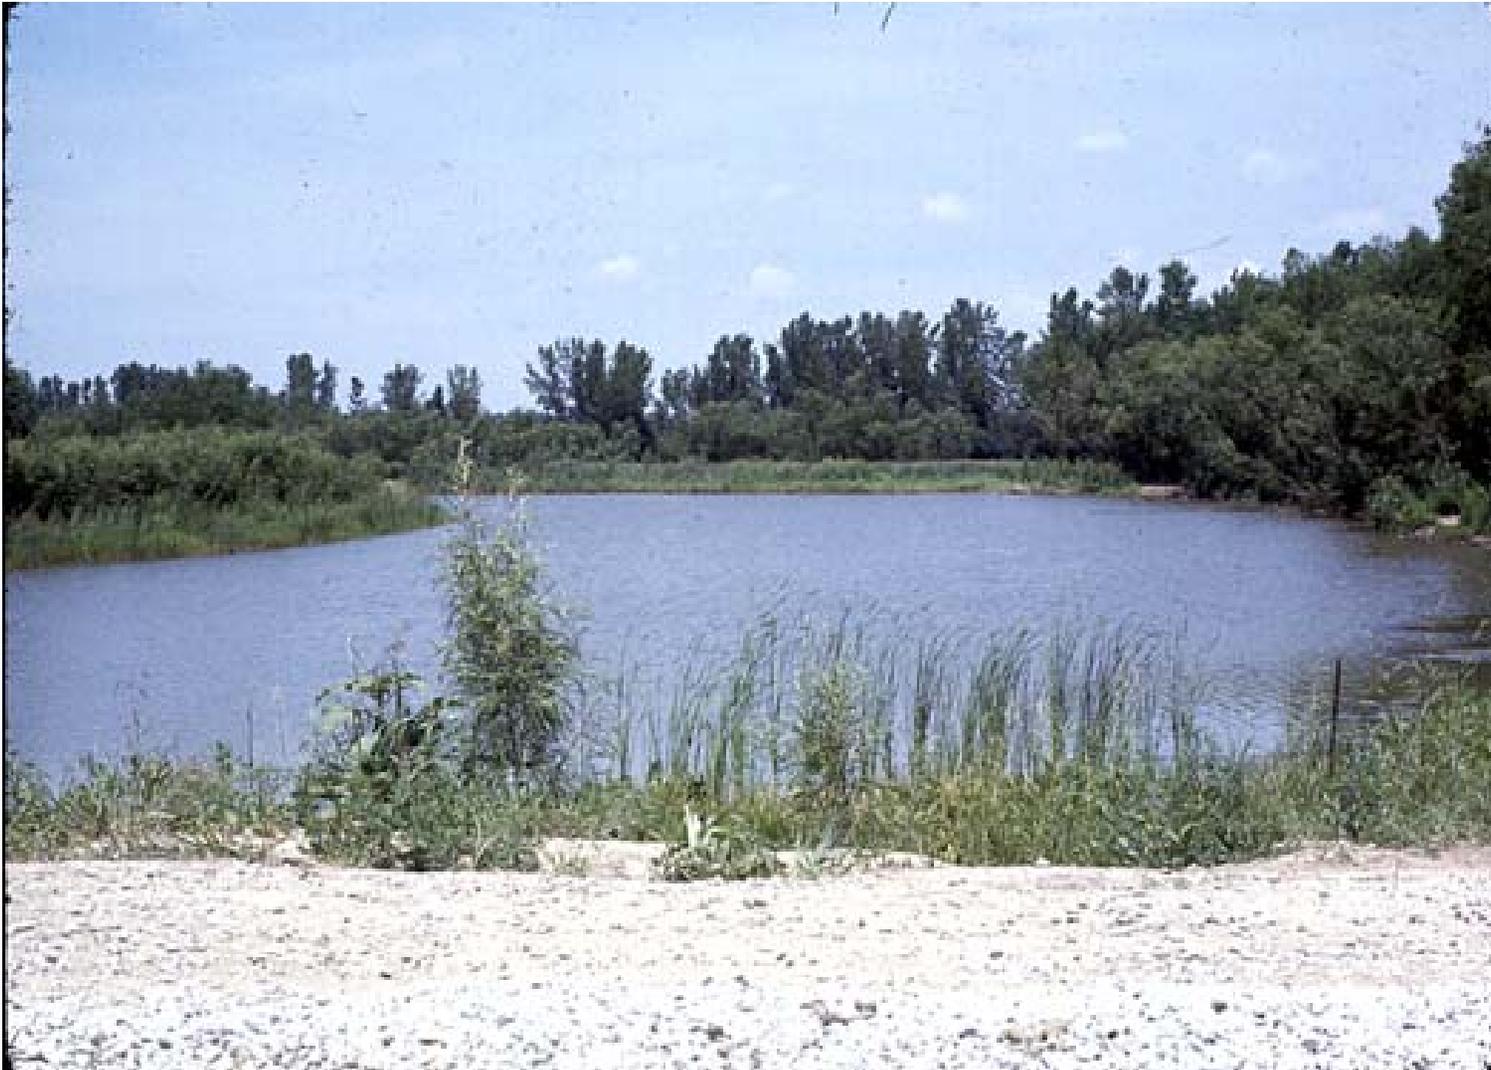
BRIDGE UPSTREAM 74  
CHUTE VIEWED UPSTREAM FROM ROAD CROSSING BEFORE IT BECAME  
FILLED WITH SEDIMENT, 1976

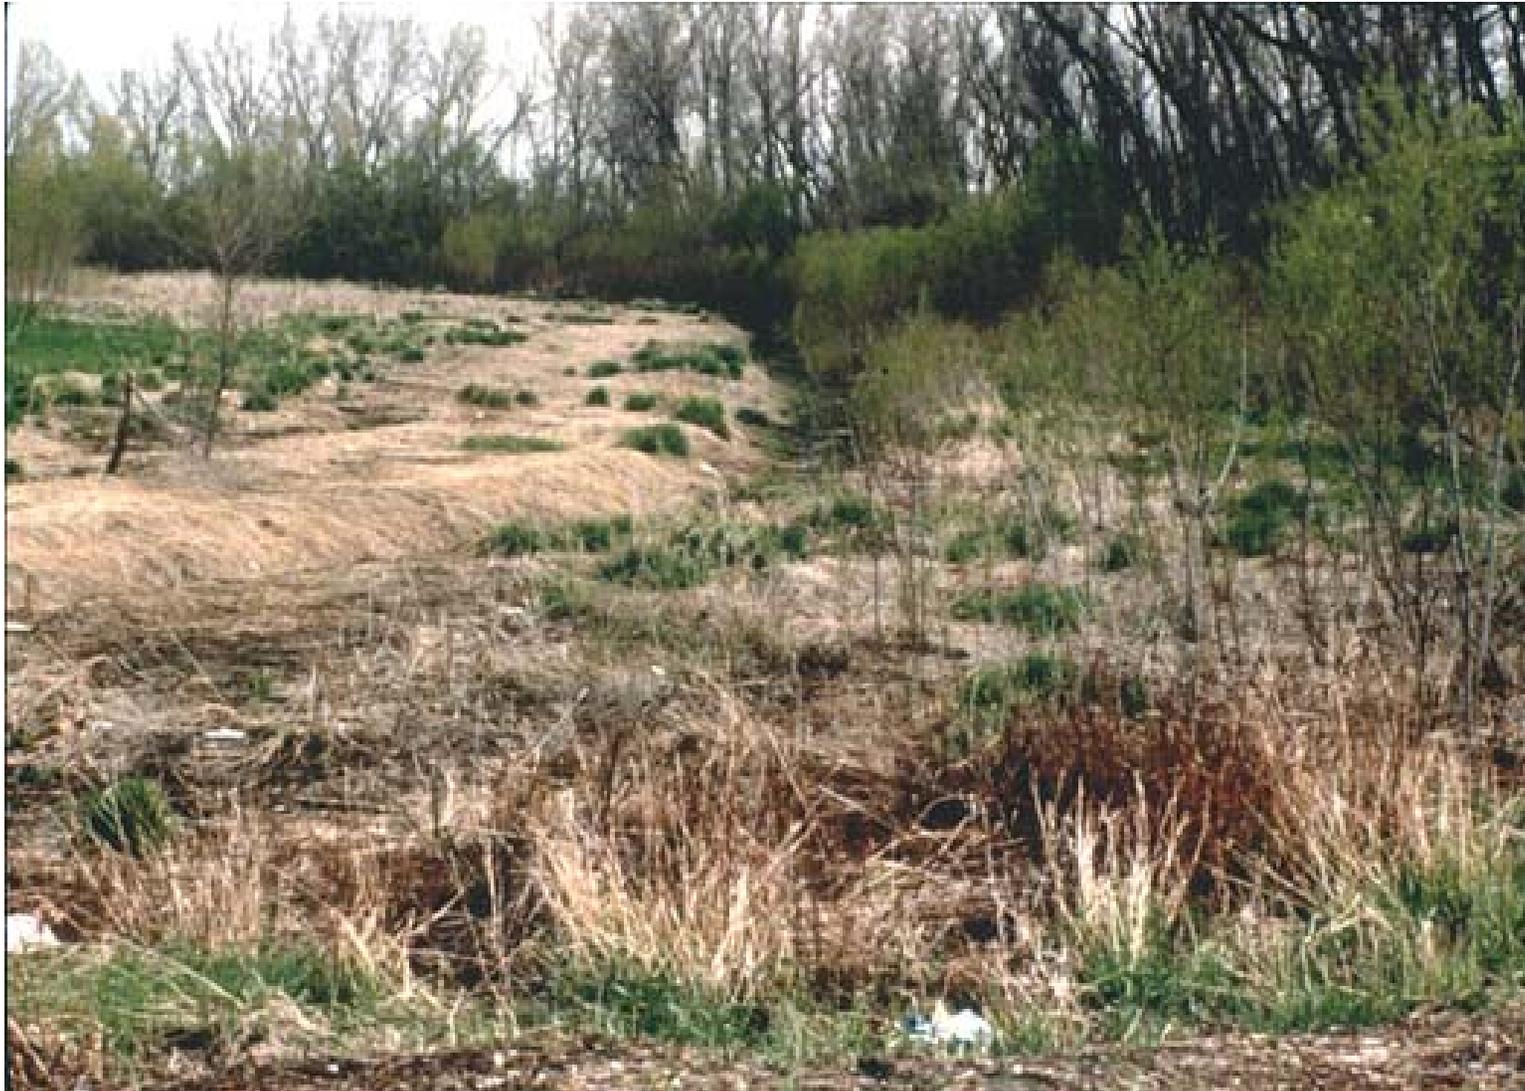
BRIDGE UPSTREAM 89  
CHUTE VIEWED UPSTREAM FROM ROAD CROSSING AFTER EXTENSIVE  
SEDIMENT FILLING, 1989

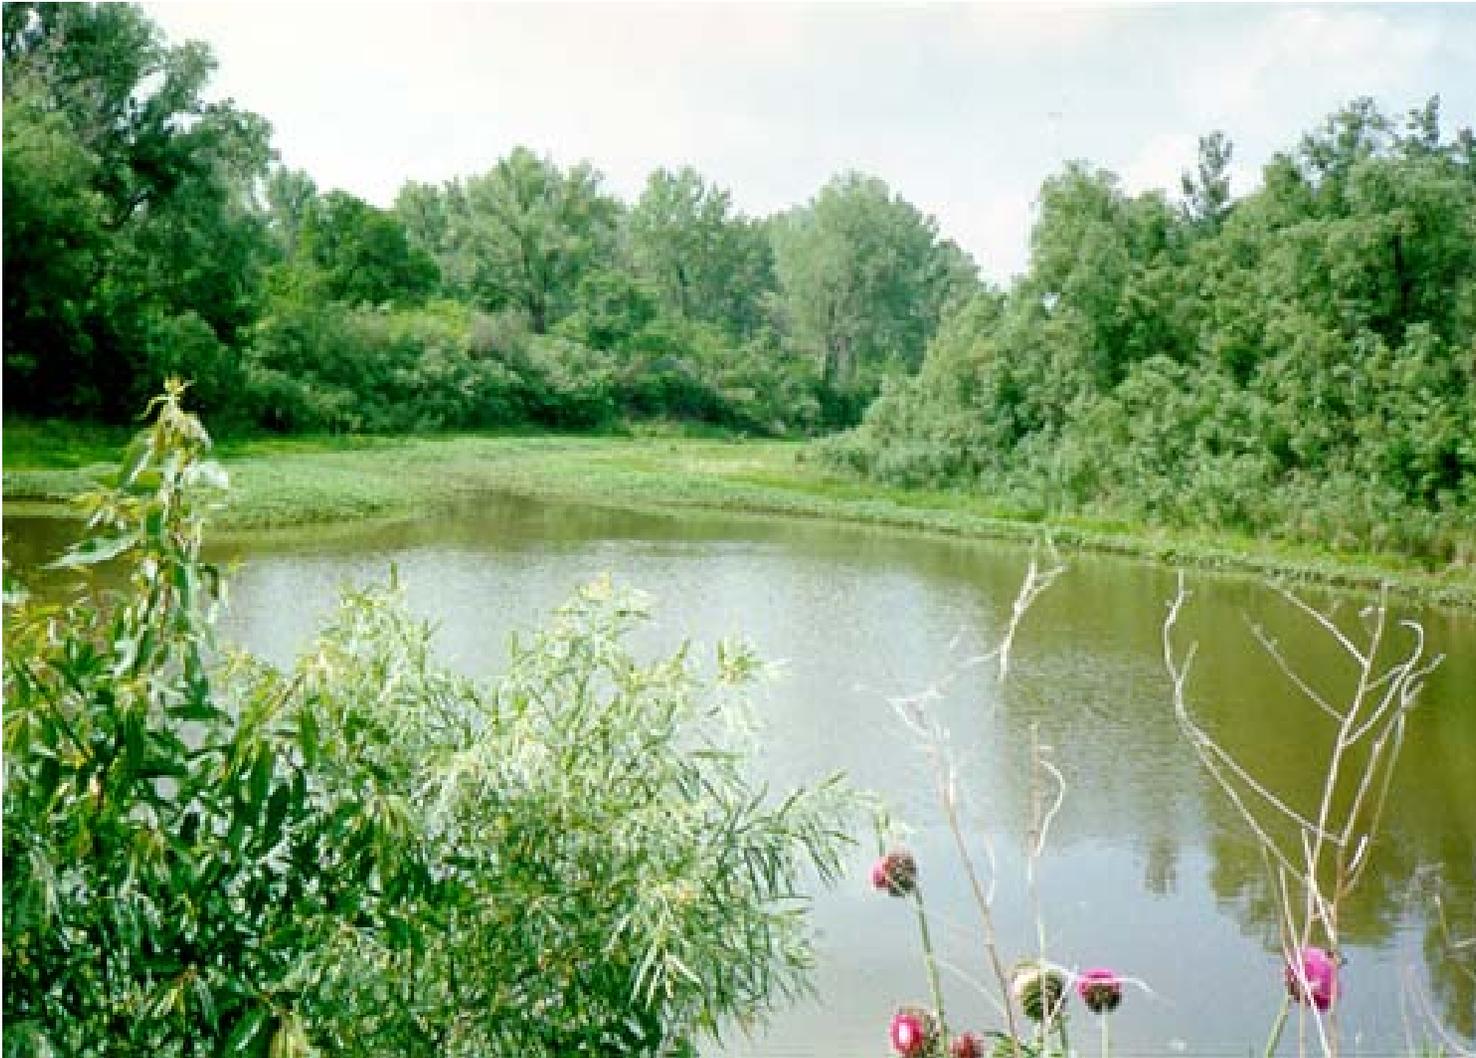
BRIDGE DOWNSTREAM 1989

AN ISOLATED POOL, VIEW DOWNSTREAM FROM THE ROAD CROSSING

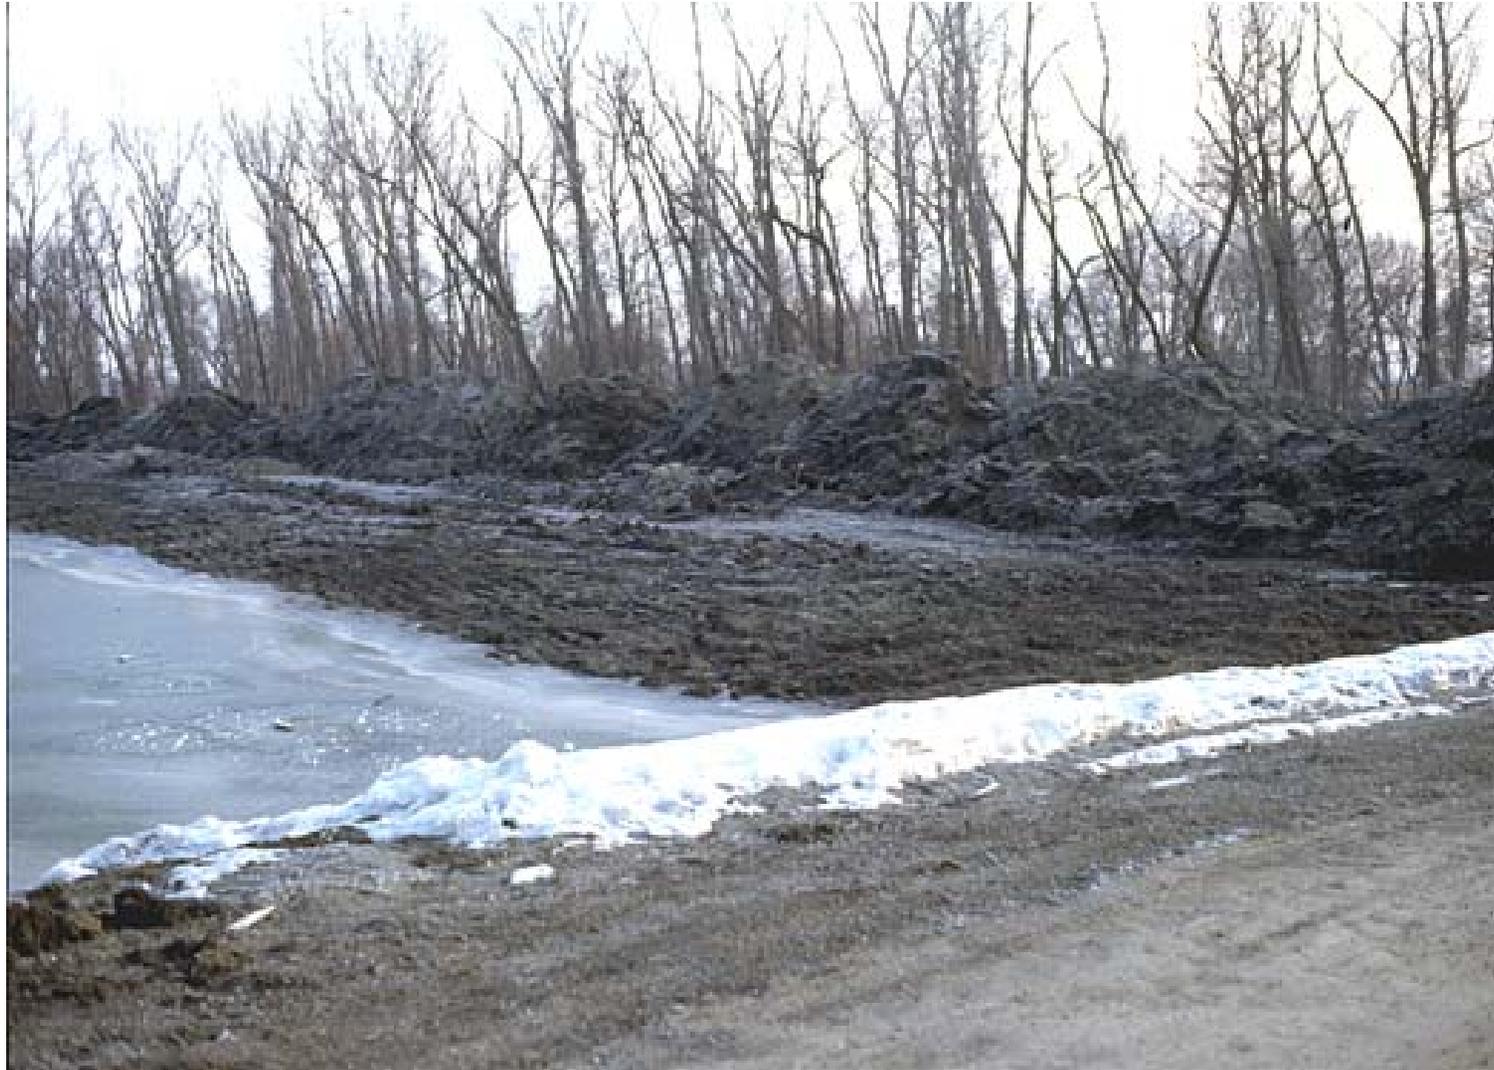
SPOIL PILES 93

EXCAVATION SPOIL PILES NEXT TO PILOT CHANNEL SLOWED CHUTE WIDENING,  
BUT WASHED AWAY GRADUALLY.
