## BOYER CHUTE BEFORE RESTORATION

## BOYER CHUTE RESTORATION - SECTION 1135 PROJECT

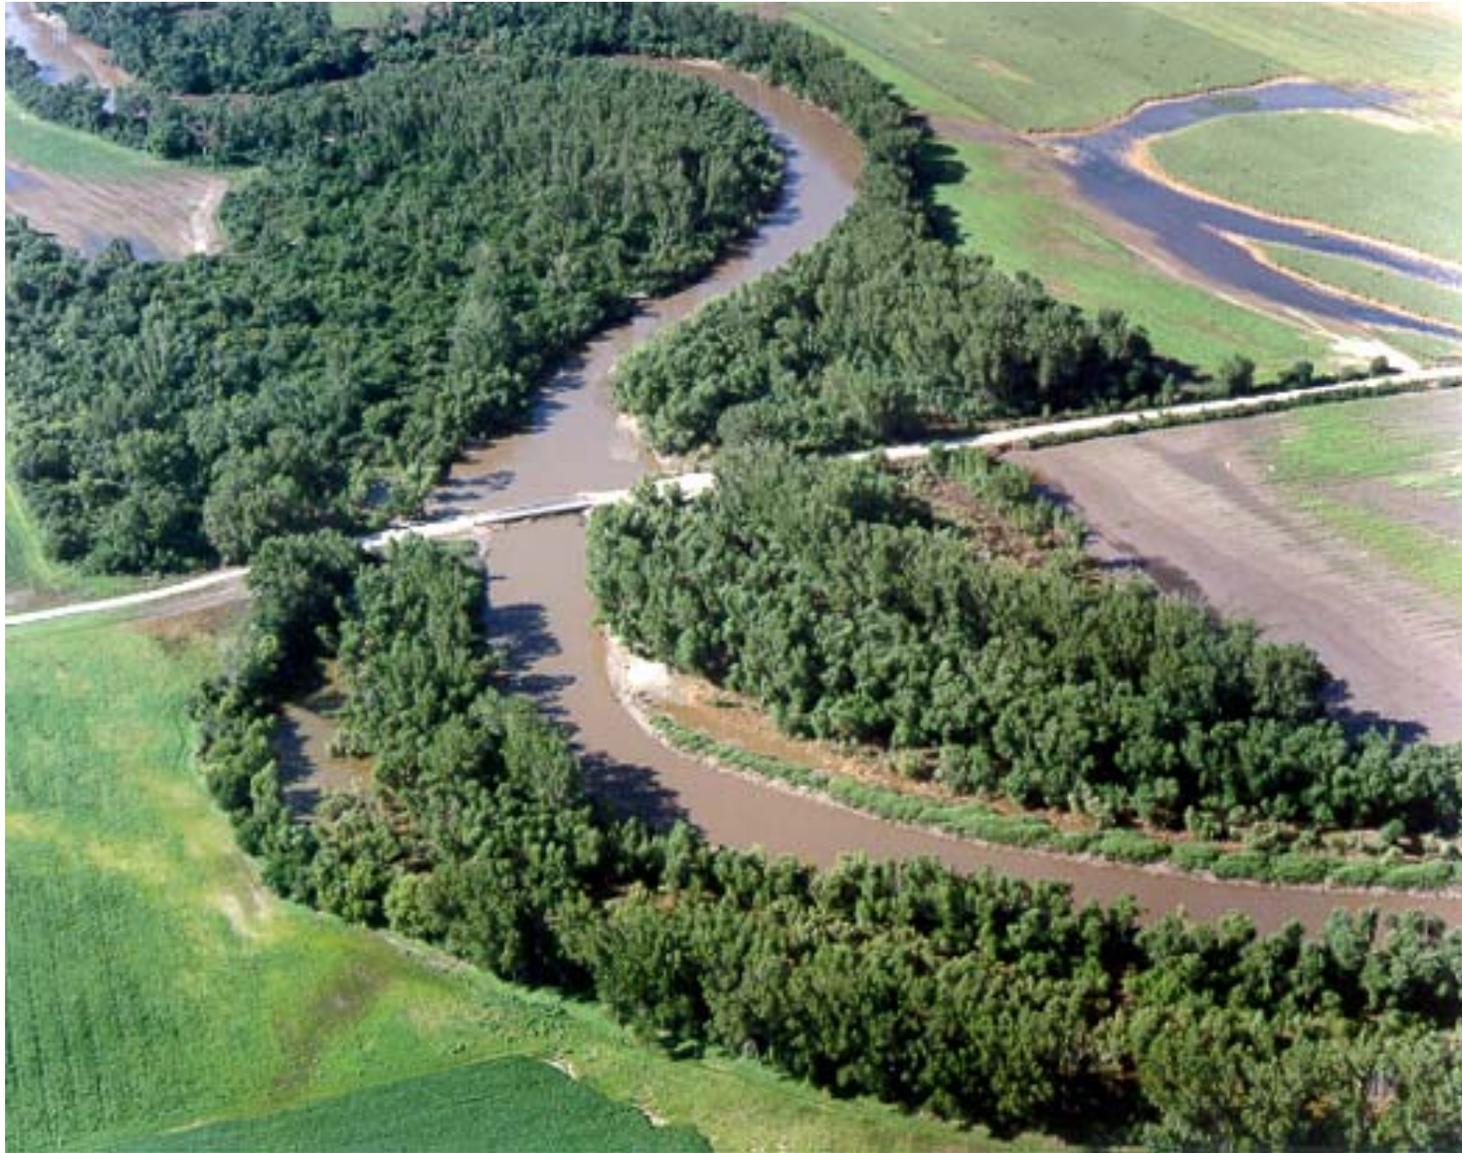
BRIDGE 96

THE RESTORED CHUTE FLOWING UNDER THE NEW BRIDGE. 1996

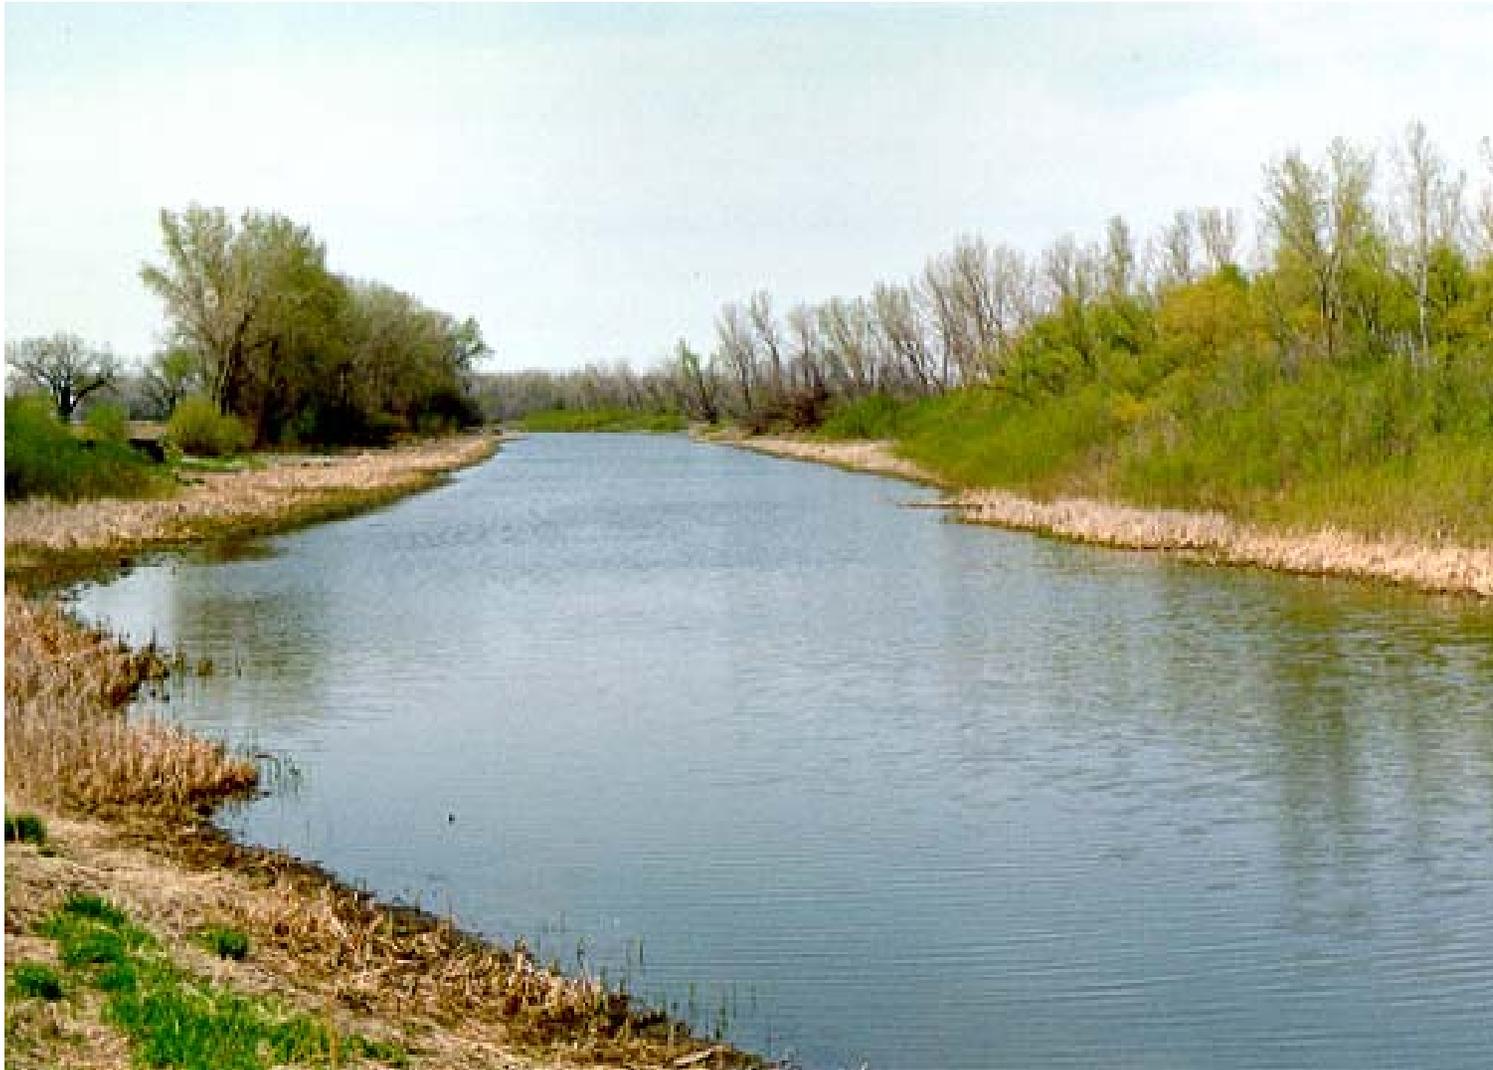
### DOWNSTREAM BACKWATER 89

PRE-RESTORATION DOWNSTREAM PORTION OF CHUTE WAS A NICE POOL OCCASIONALLY CONNECTED TO THE RIVER. BUT PONDS AND THEIR FISH ARE NOT AS RARE AS ARE CHUTES AND THEIR SPECIES. 1989

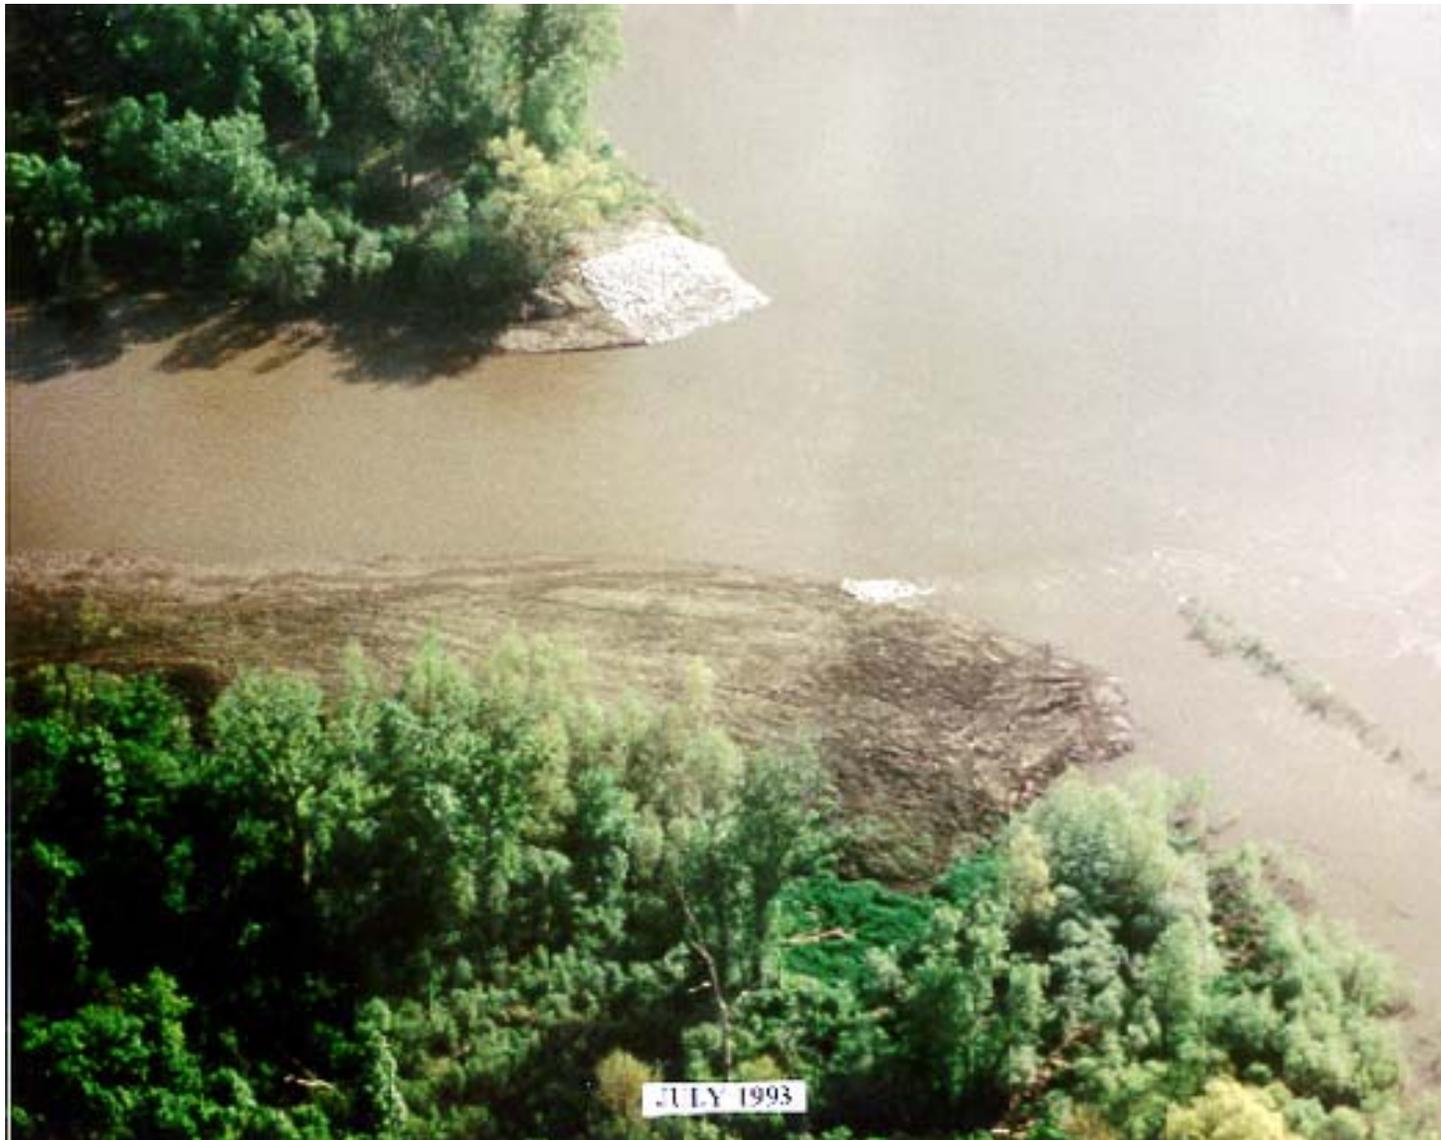
OUTLET 1993

THE RESTORED OUTLET OF THE CHUTE MERGING INTO THE MISSOURI RIVER.

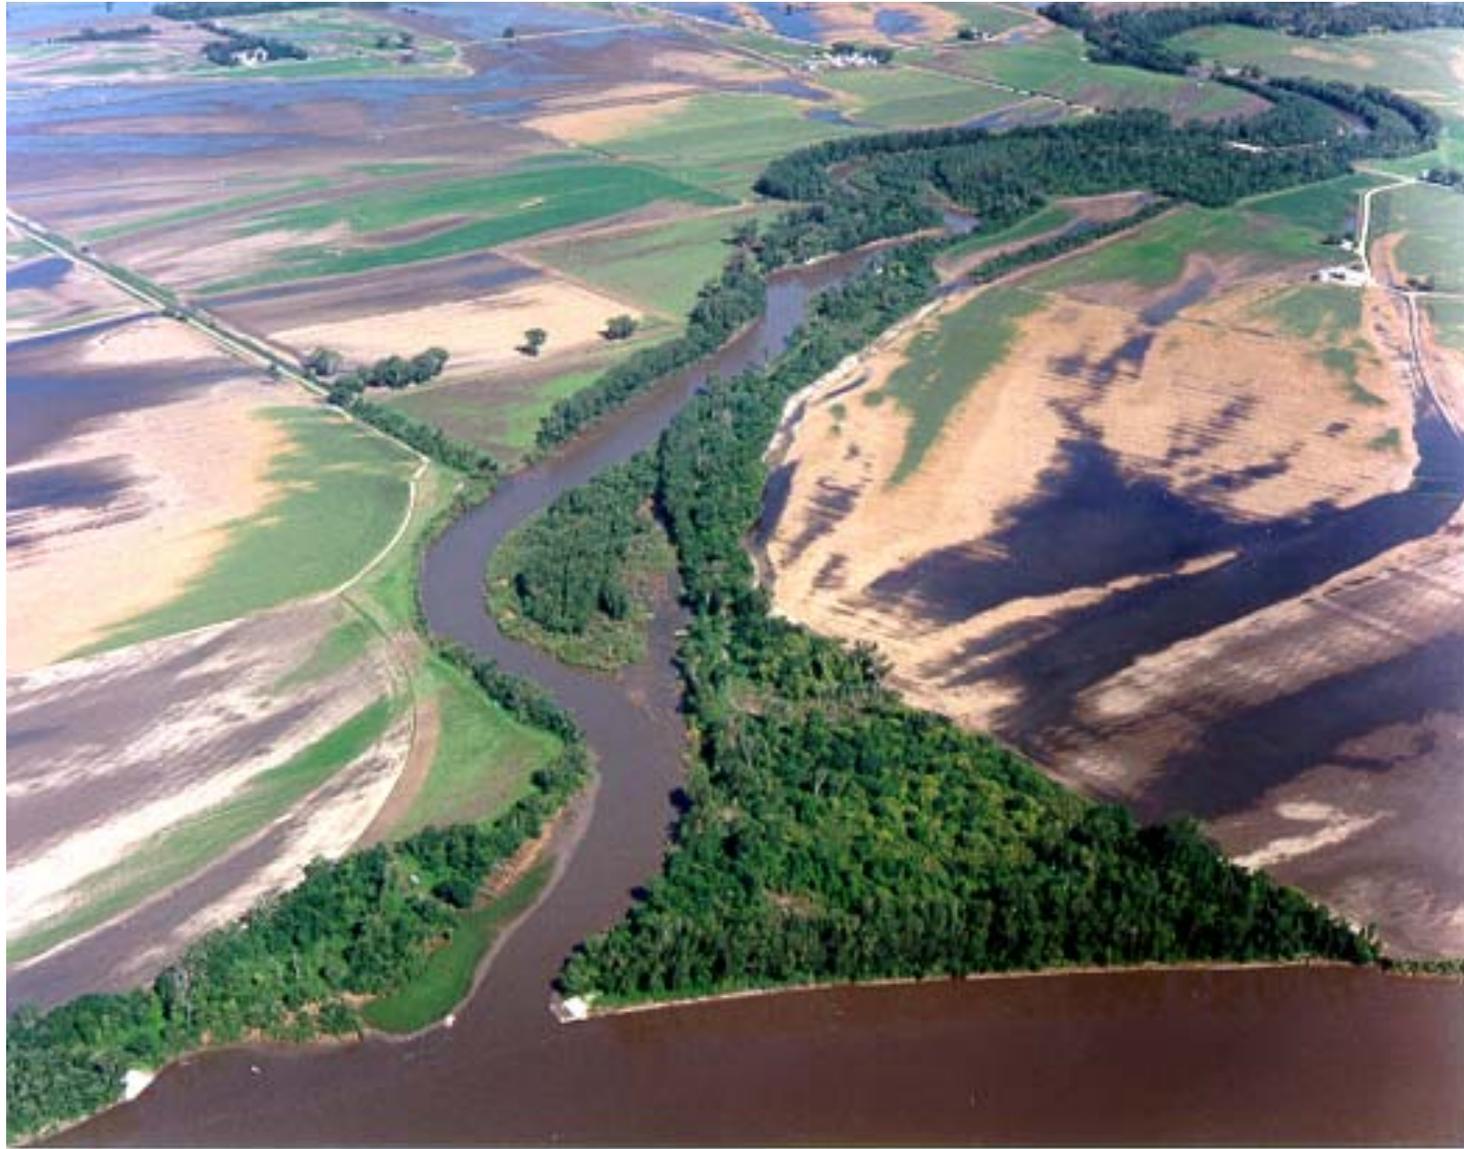
OUTLET AERIAL 1996

THE RESTORED CHUTE'S DOWNSTREAM HALF AFTER THE 1996 FLOOD PEAK.

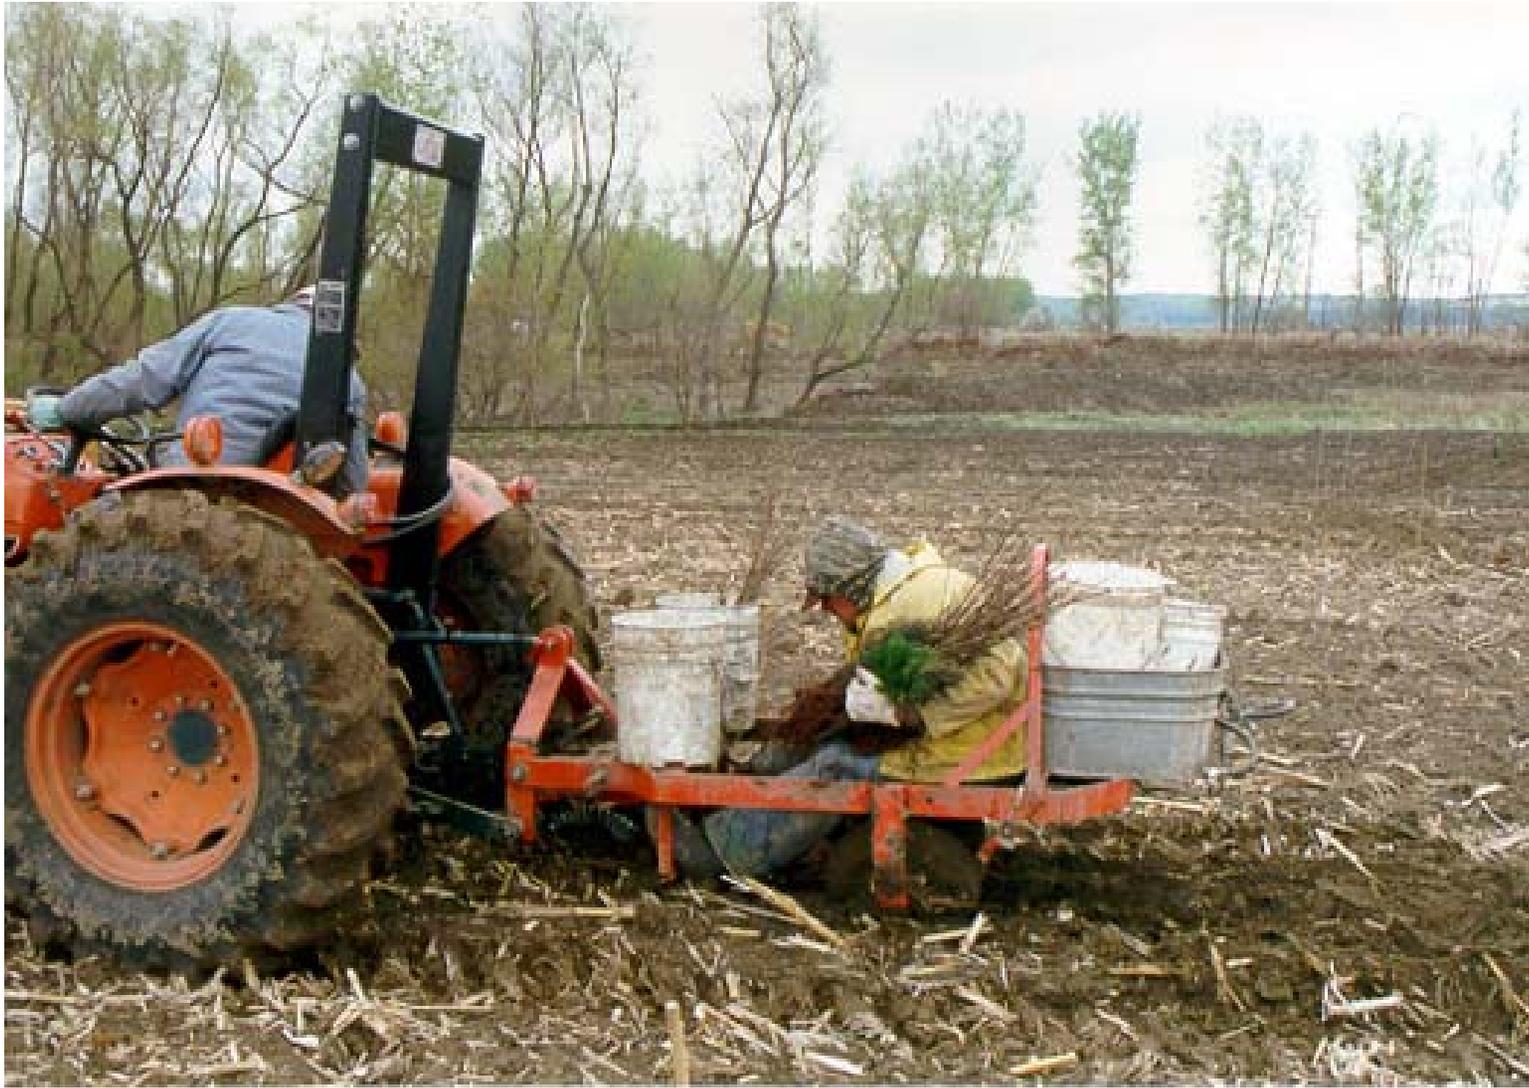
TREE PLANTING

PLANTING OF 7,000 TREES AND SHRUBS, 1994

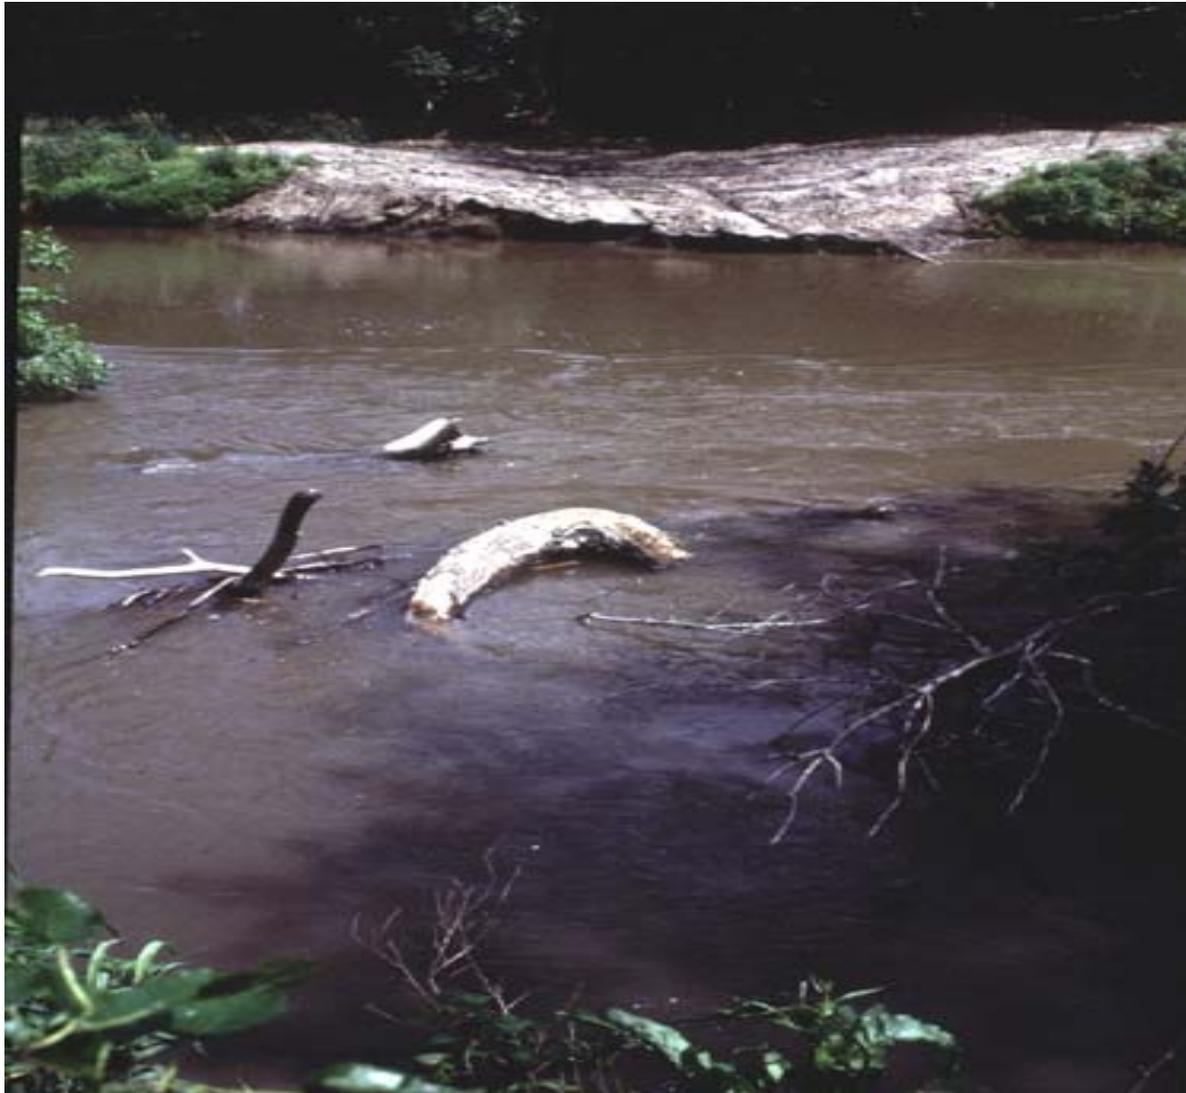
### SNAG AND NOTCH

SPOIL BANKS WERE NOTCHED AND TREE SNAGS WERE PLACED TO FACILITATE HABITAT RESTORATION.  
BOTH WERE OF LIMITED VALUE RELATIVE TO THE NATURAL PROCESSES RESTORED.

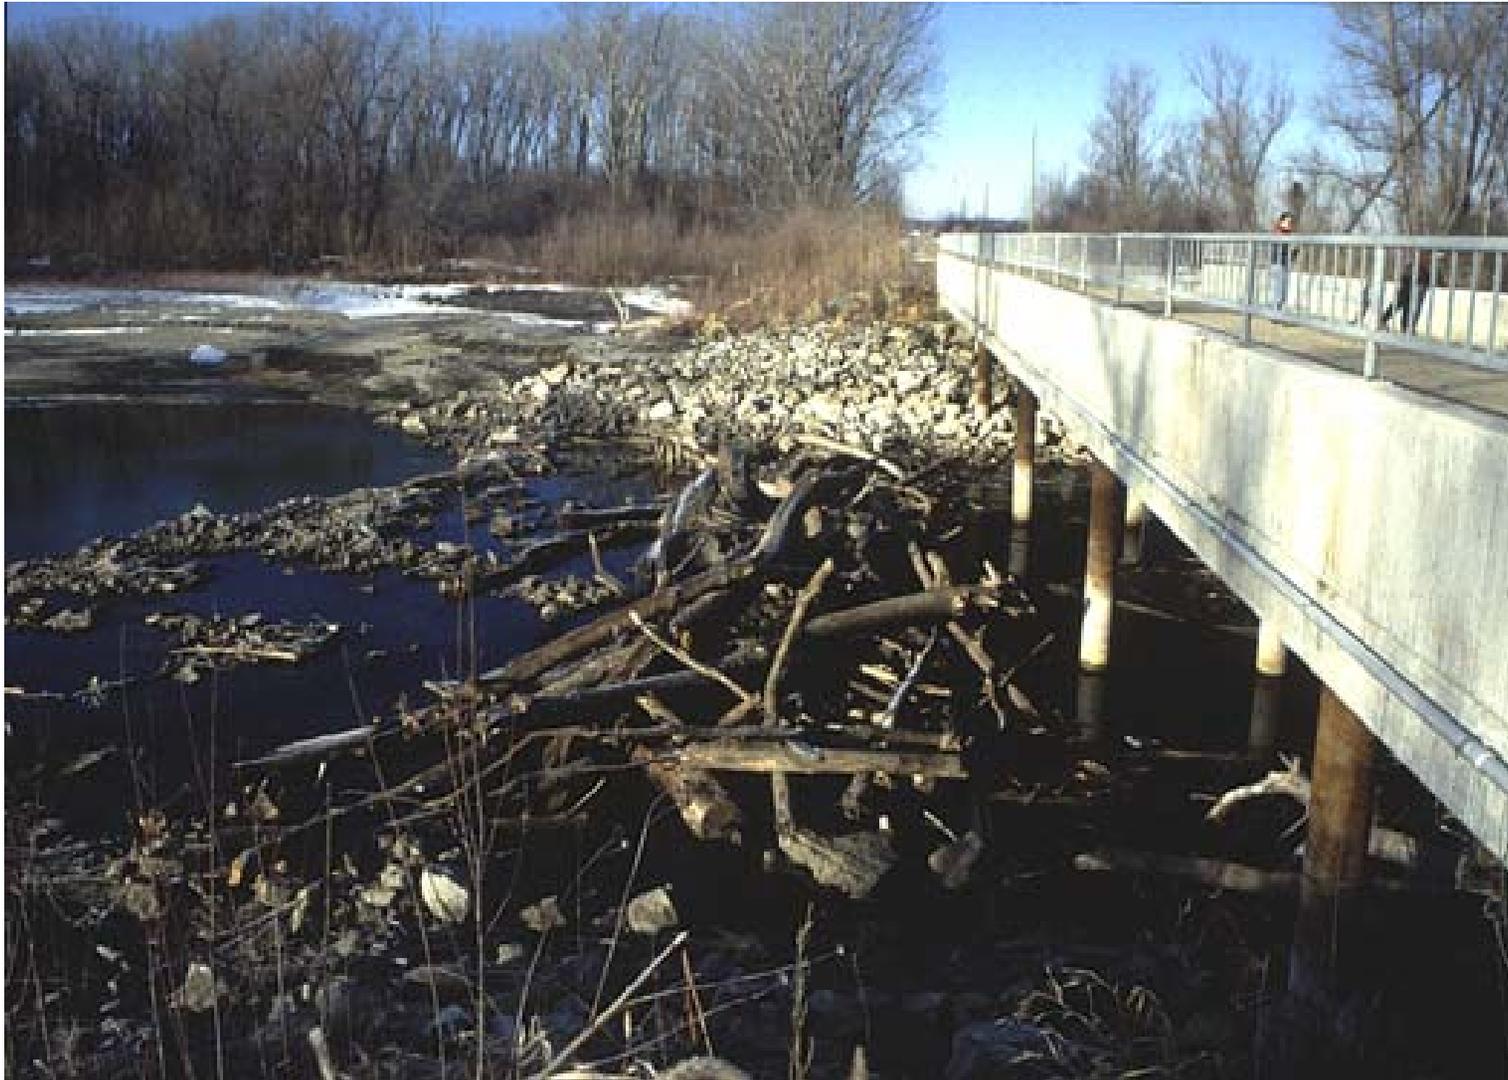
BRIDGE DEBRIS

DEBRIS CAUGHT ON UPSTREAM SIDE OF BRIDGE MIGHT HAVE BEEN LESS WITH FEWER BRIDGE PIERS

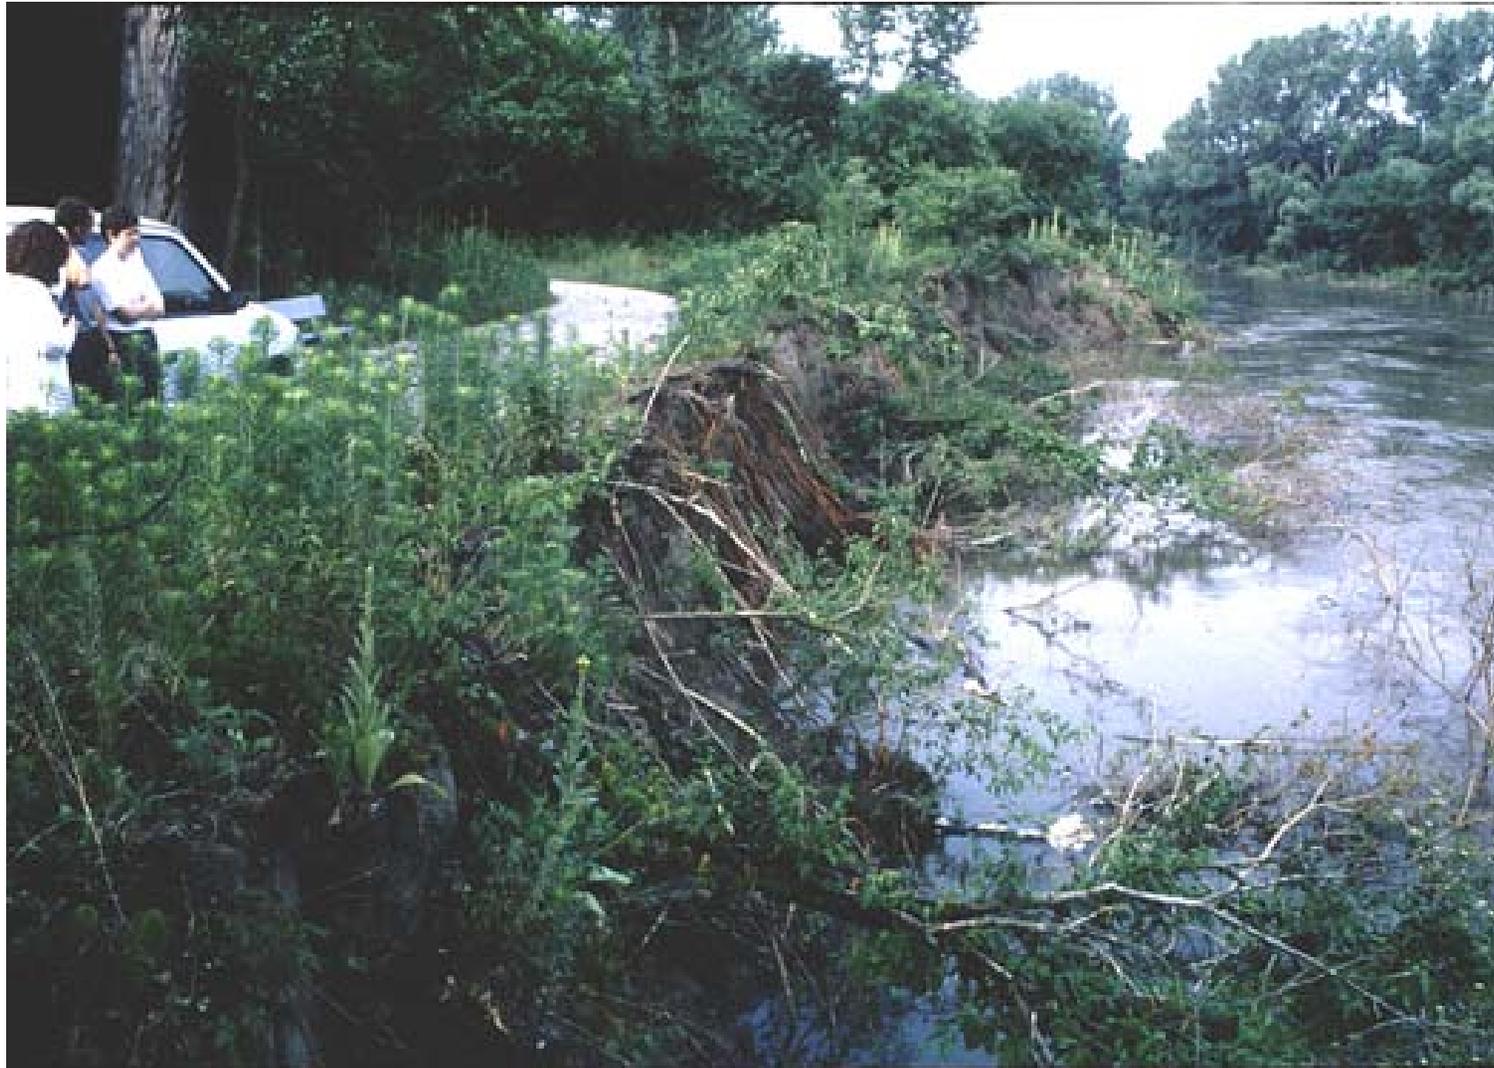
### TRAIL BANK EROSION

DESIRABLE CHUTE WIDENING DOWNSTREAM OF BRIDGE ERASED A NEW TRAIL BUILT BY SPONSOR. 1995. FACILITIES SHOULD BE KEPT FAR FROM DESIRED MEANDER ZONE.

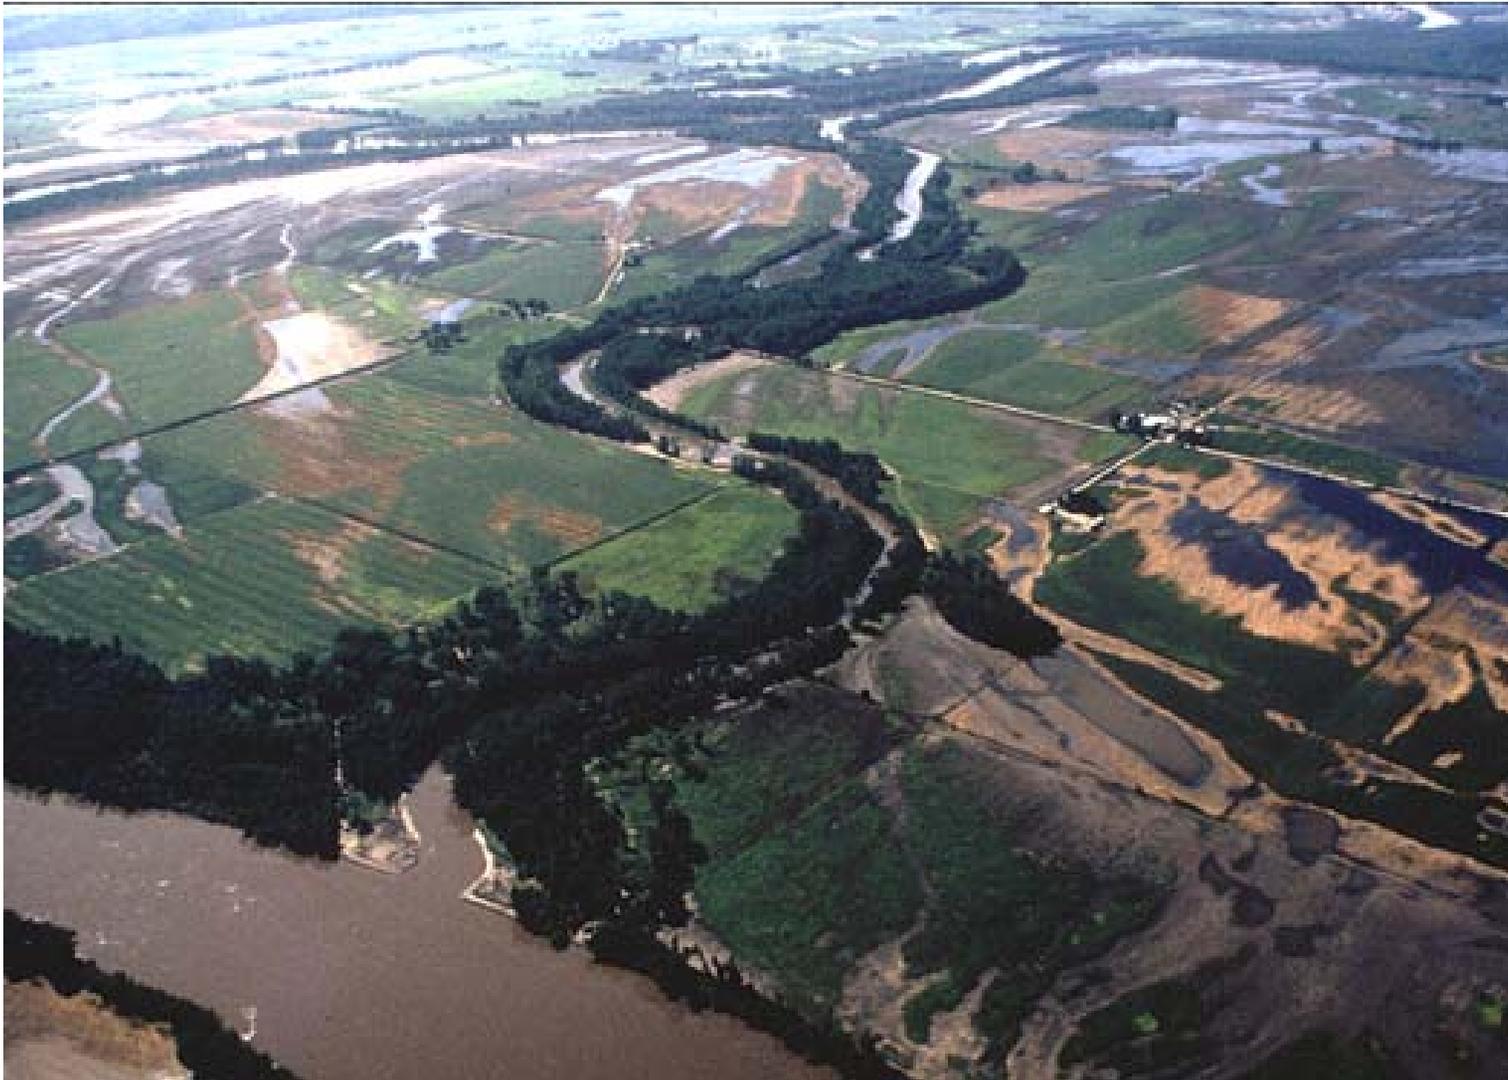
INLET AERIAL 96

THE RESTORED CHUTE AND ITS INLET, SHORTLY AFTER THE 1996 FLOOD PEAK

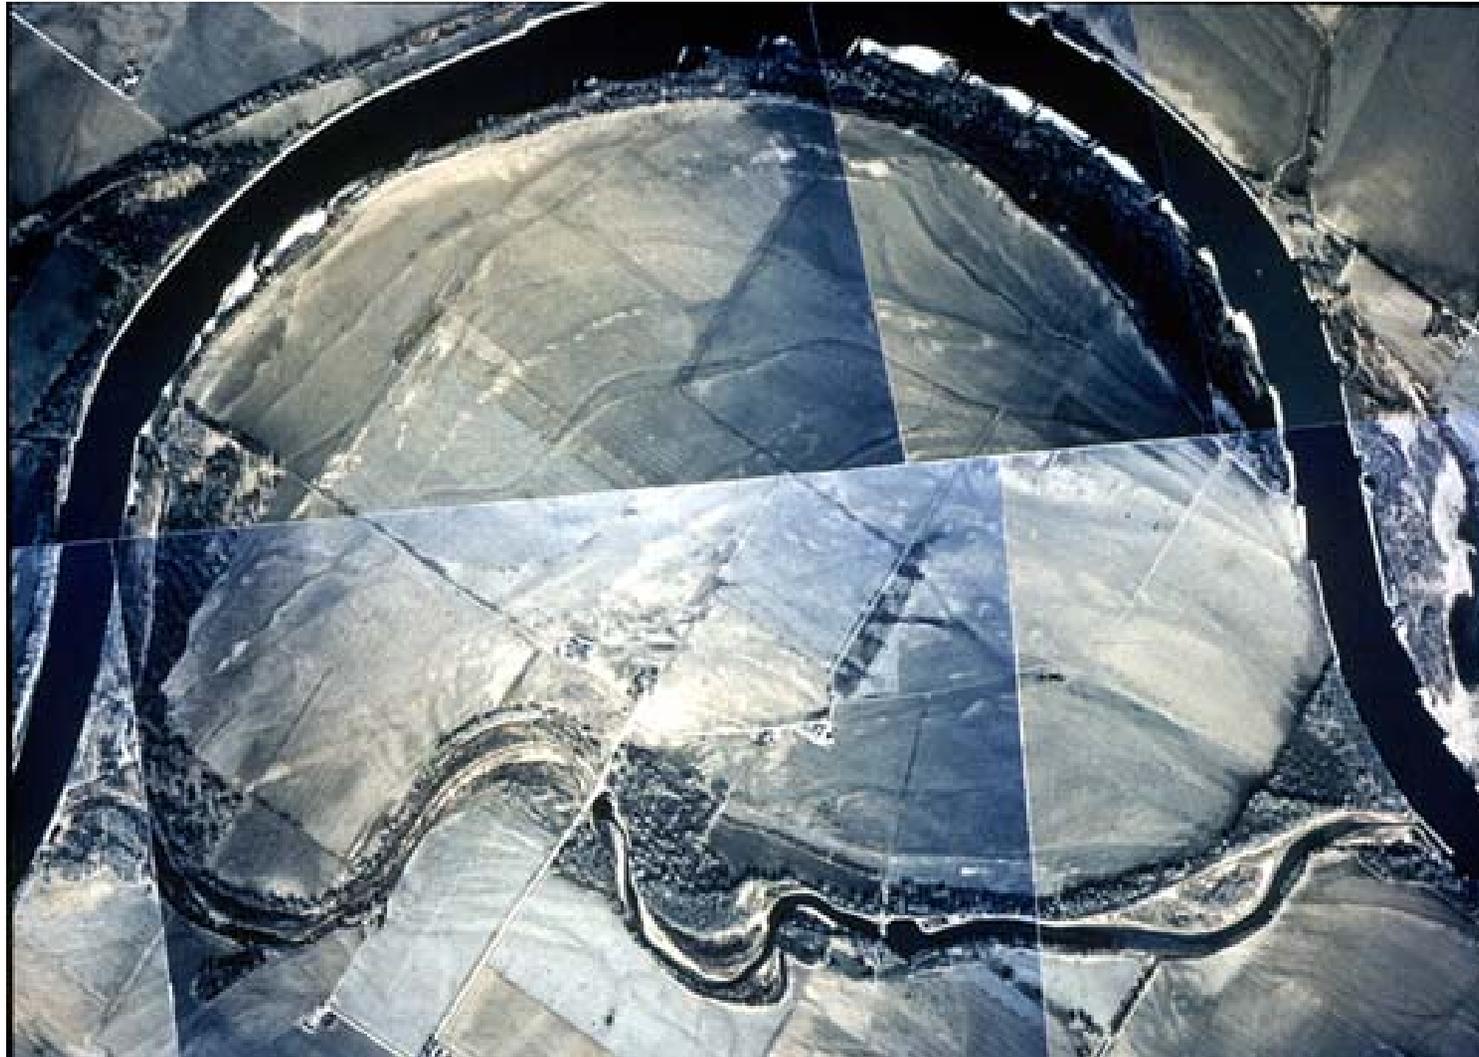
BIG AERIAL 1989

PRE-RESTORATION AERIAL SHOWING CHUTE'S SEDIMENT-FILLED UPPER MILE,  
EARTH FILL ROAD CROSSING, CHUTE CLOSURE DIKE, AND SEDIMENT-CHOKED  
DOWNSTREAM END. 1989
