U.S. Army Corps of Engineers
Omaha District

2015 Report

Water Quality Conditions at Omaha District Tributary Projects in Colorado, North Dakota, and South Dakota

June 2016

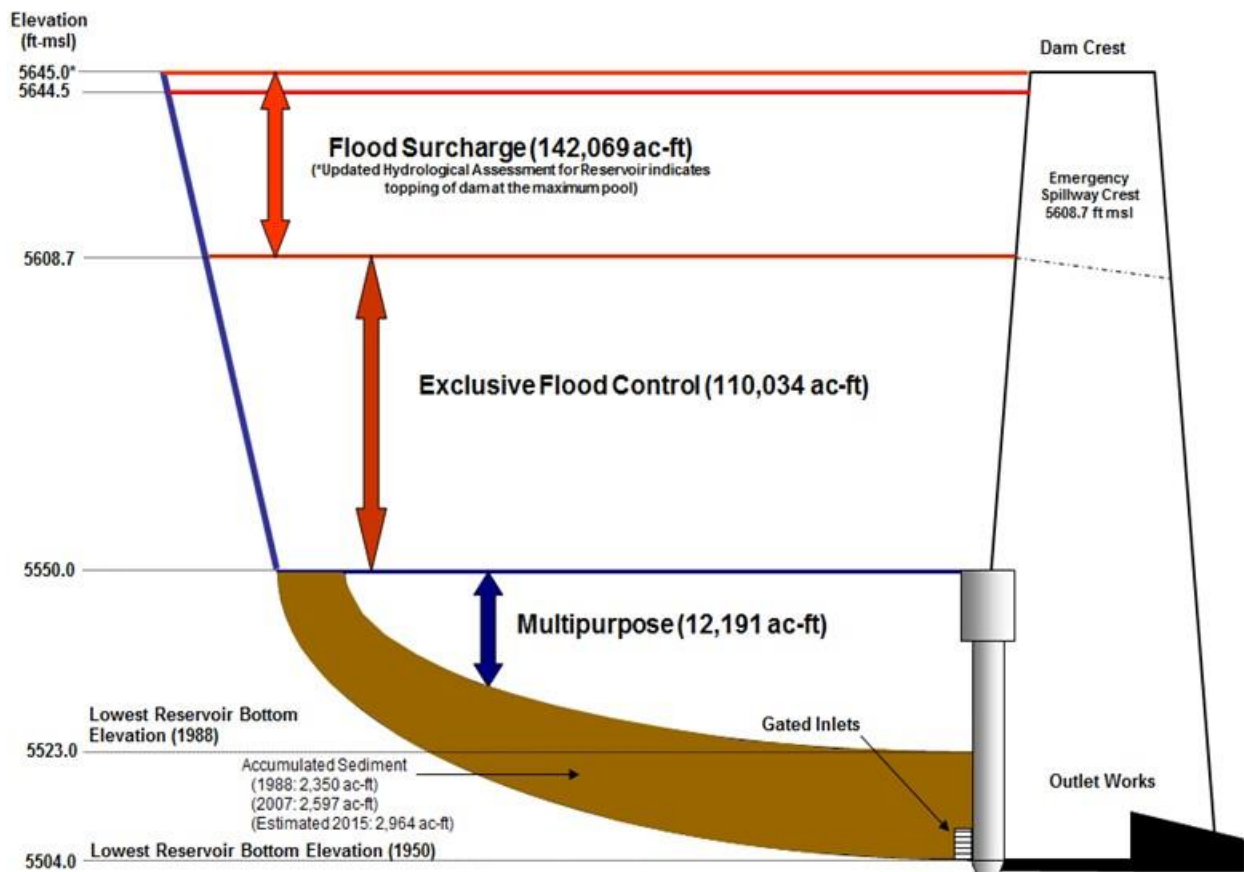
Figure 3.4. Current storage zones of Cherry Creek Reservoir based on the 2007 survey data and estimated sedimentation.

Error! Reference source not found. depicts the current storage zones of Cherry Creek Reservoir based on the 2007 survey data and estimated sedimentation. It is estimated that 19 percent of the Multipurpose Pool has been lost to sedimentation as of 2015.

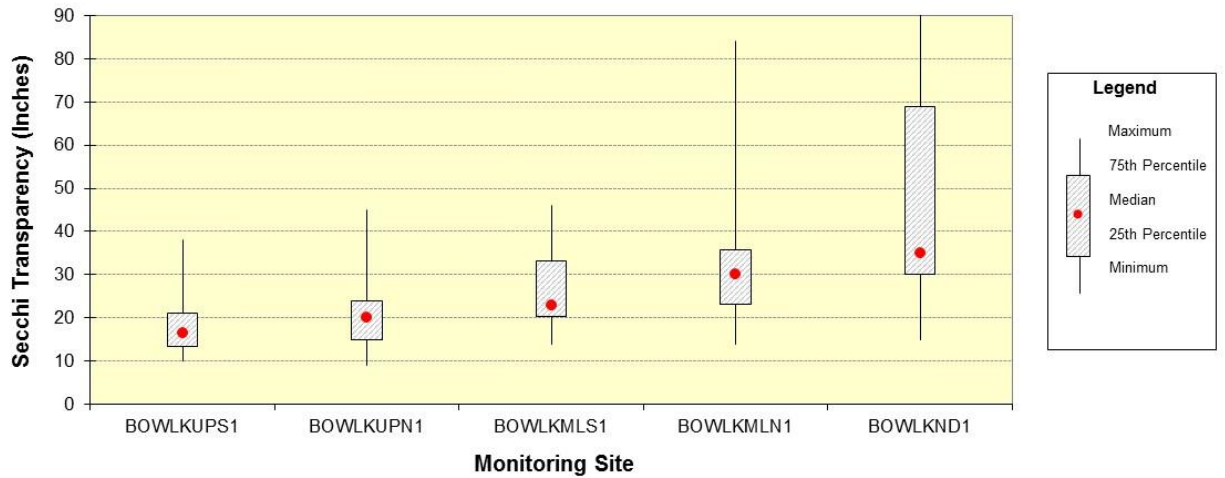
Figure 4.3. Box plot of Secchi depth transparencies measured in Bowman-Haley Reservoir during the period 2010 through 2015.

Figure 4.3 displays a box plot of the Secchi depth transparencies measured at the five in-reservoir monitoring sites during the 2010 through 2015 period (note: the monitoring sites are oriented in an upstream to downstream direction). Water clarity in the reservoir was slightly higher in the north arm than in the south arm with the area near the dam similar to the north arm.

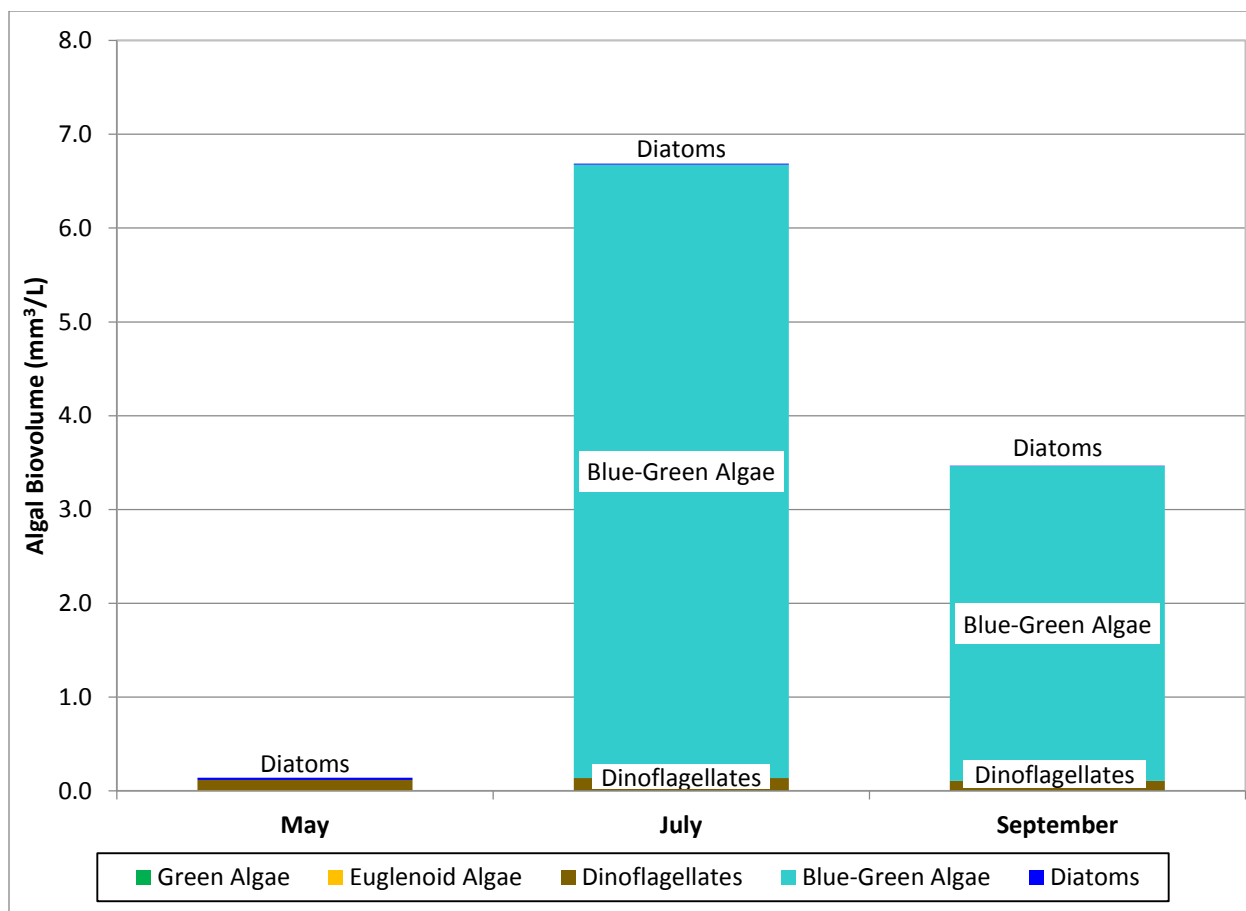
Figure 4.4. Graph showing total and relative phytoplankton biovolume at the near dam station of Bowman-Haley Reservoir in 2015.

Phytoplankton samples were collected at the near dam station (BOWLKND1) in May, July, and September of 2015. Total and relative group biovolume are shown in Figure 5.4. The May sample indicated relatively little algal production within the reservoir. July and September results show dominance by the blue green algae *Aphanizomenon flos-aquae*.

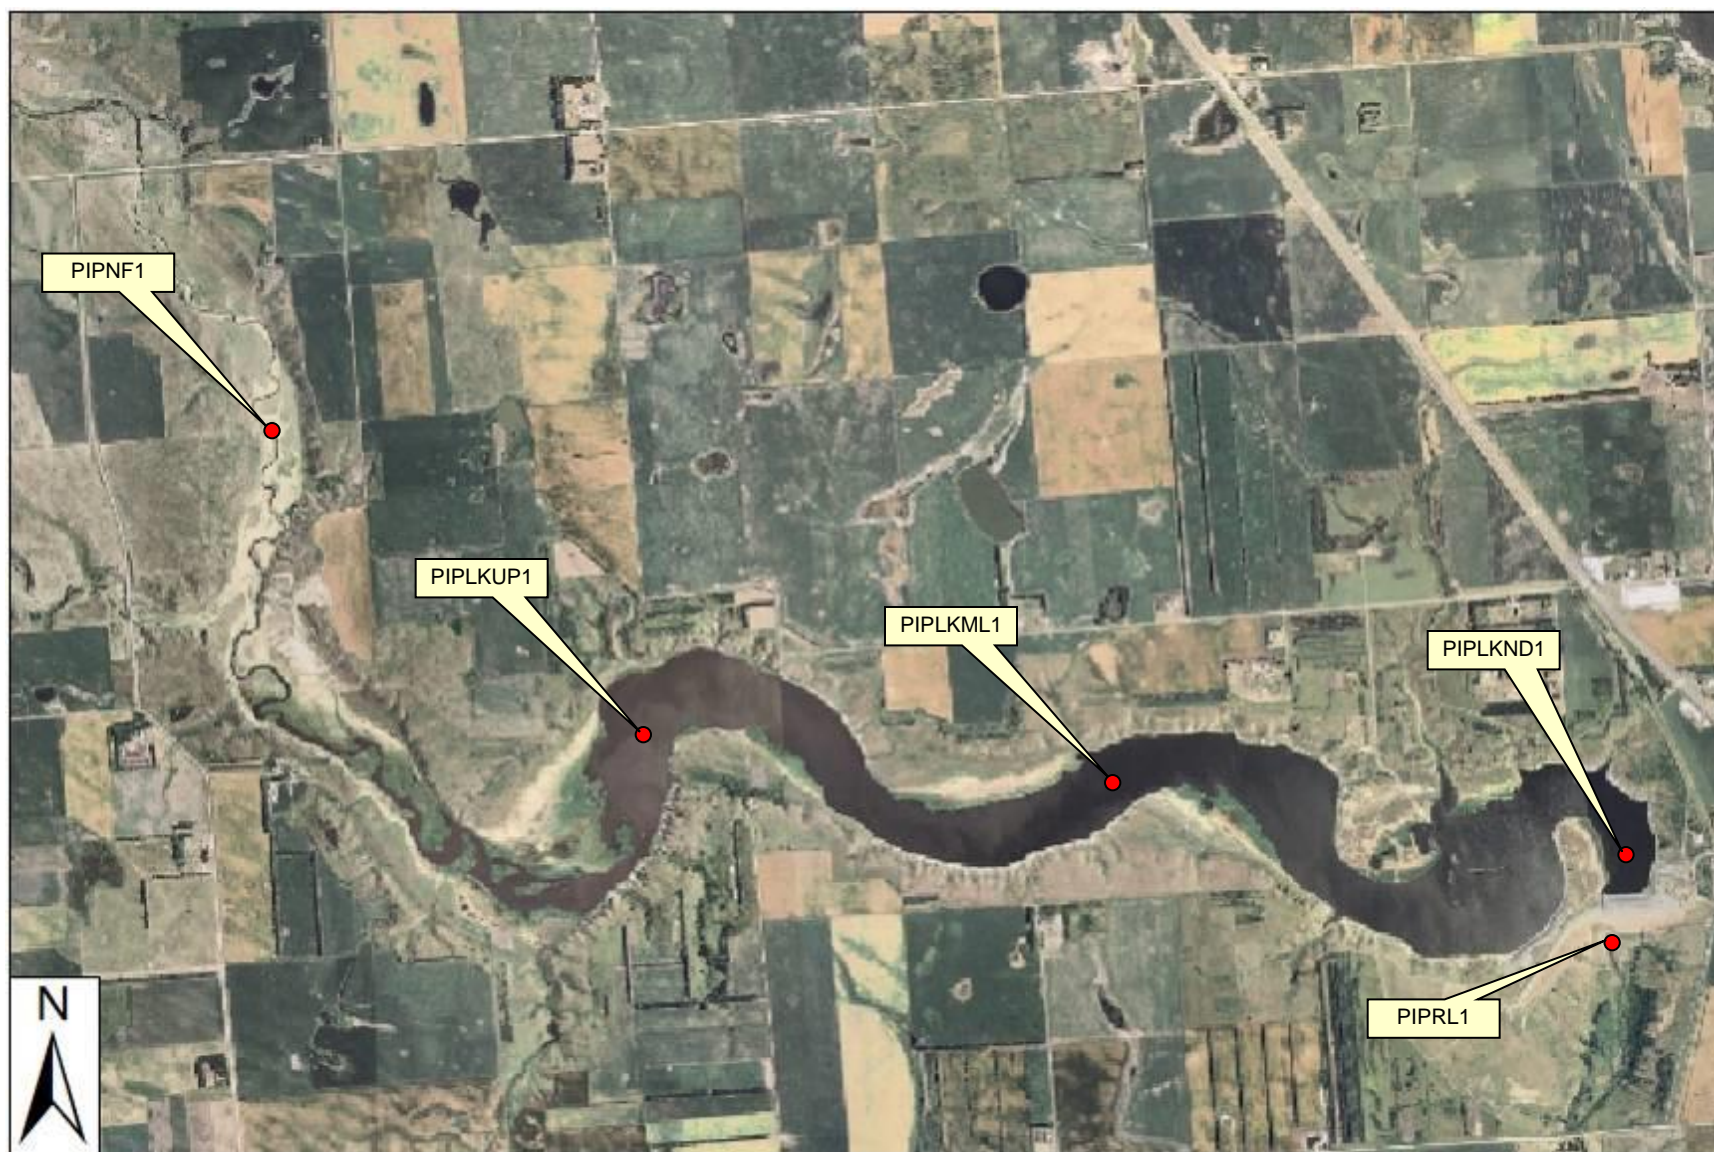
Figure 4.6. Location of sites where water quality monitoring was conducted at Pipestem Reservoir during the period 2010, 2012, and 2015.

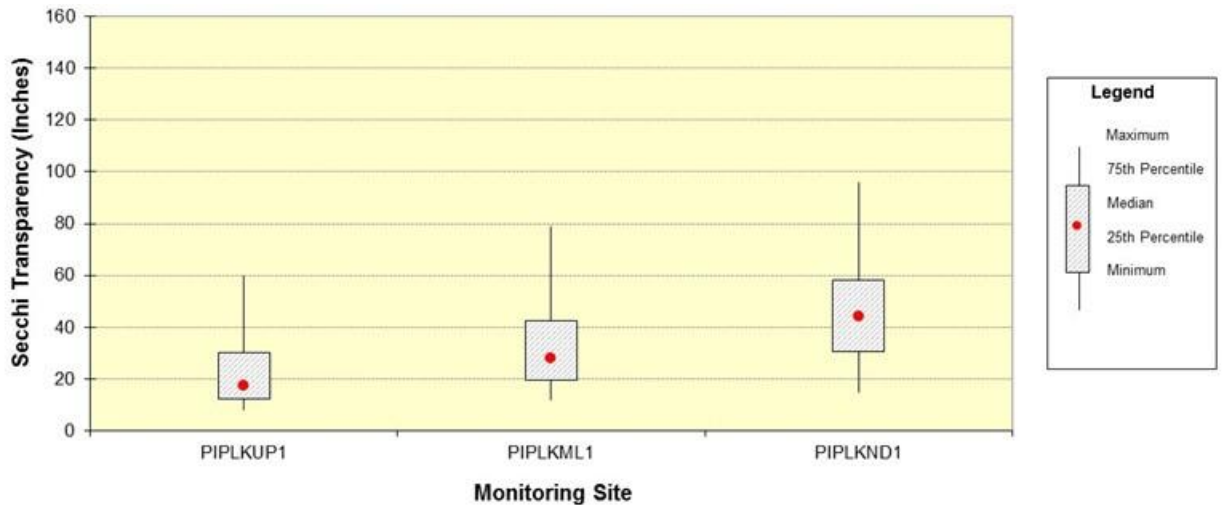
Figure 4.7. Box plot of Secchi depth transparencies measured in Pipestem Reservoir during 2010, 2012, and 2015.

Figure 4.7 displays a box plot of the Secchi depth transparencies measured at the three in-reservoir monitoring sites (i.e., PIPLKUP1, PIPLKML1, and PIPLKND1) during 2010, 2012, and 2015 (note: the monitoring sites are oriented in an upstream to downstream direction). Water clarity in the reservoir was noticeably higher near the dam as compared to sites farther upstream (Figure 4.7)

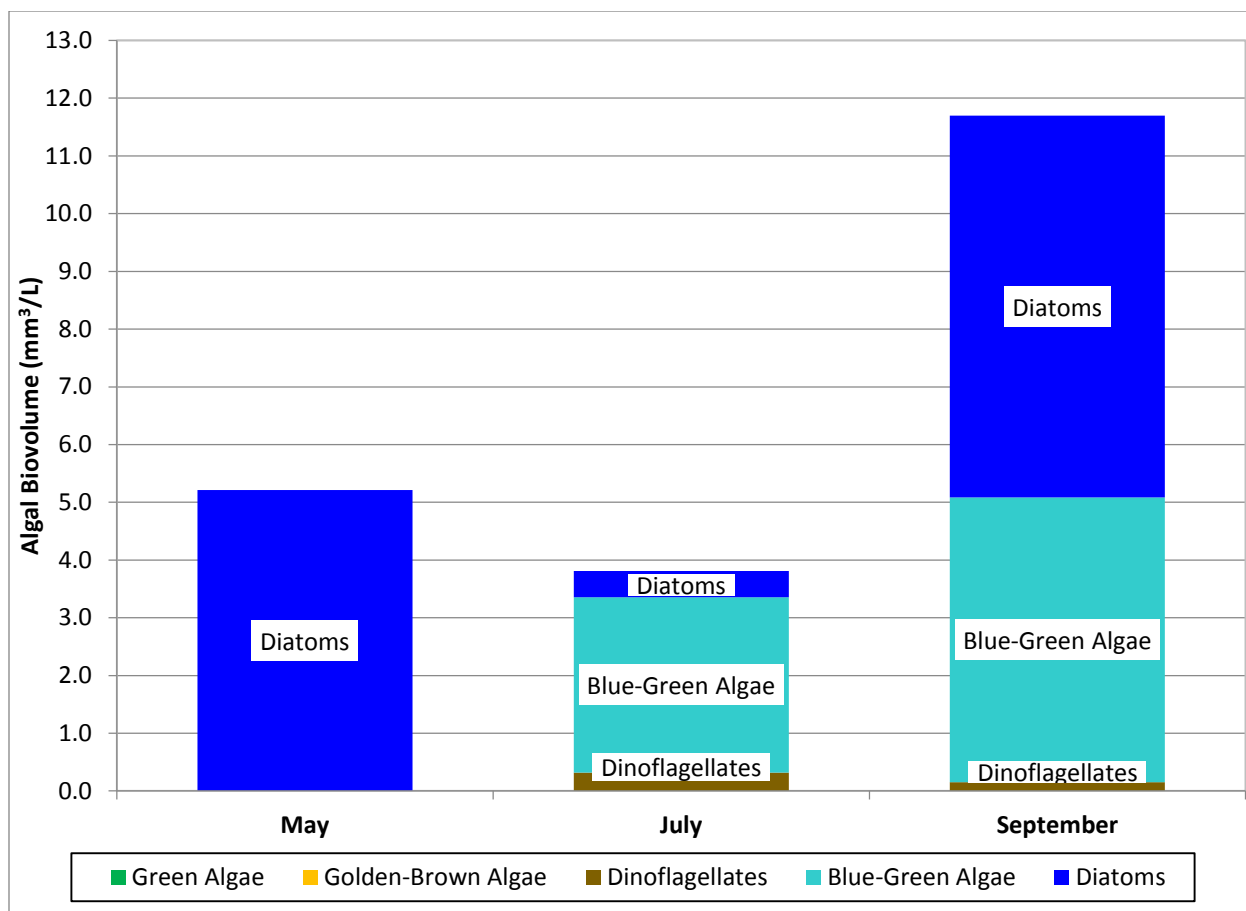
Figure 4.8. Graph showing total and relative phytoplankton biovolume at the near dam station of Pipestem Reservoir in 2015.

Phytoplankton samples were collected at the near dam station (PIPLKND1) in May, July, and September of 2015. Total and relative group biovolume are shown in Figure 5.8. The May sample was dominated by the diatom *Aulacoseira granulata*, which is often found in water bodies where eutrophic conditions exist. The July results show the blue green algae *Aphanizomenon flos-aquae* was dominant; however, the total biovolume shown in figure 5.8 does not reflect the observed algal bloom in the reservoir. This could potentially be the result of sampling error or an artifact of algal buoyancy. *Aphanizomenon flos-aquae* likely played a key role in the nitrogen cycle at Pipestem Reservoir in 2015 through nitrogen fixation and release into the water column. Diatom growth and observed biovolume in September could have been accelerated by this increased nitrogen availability.

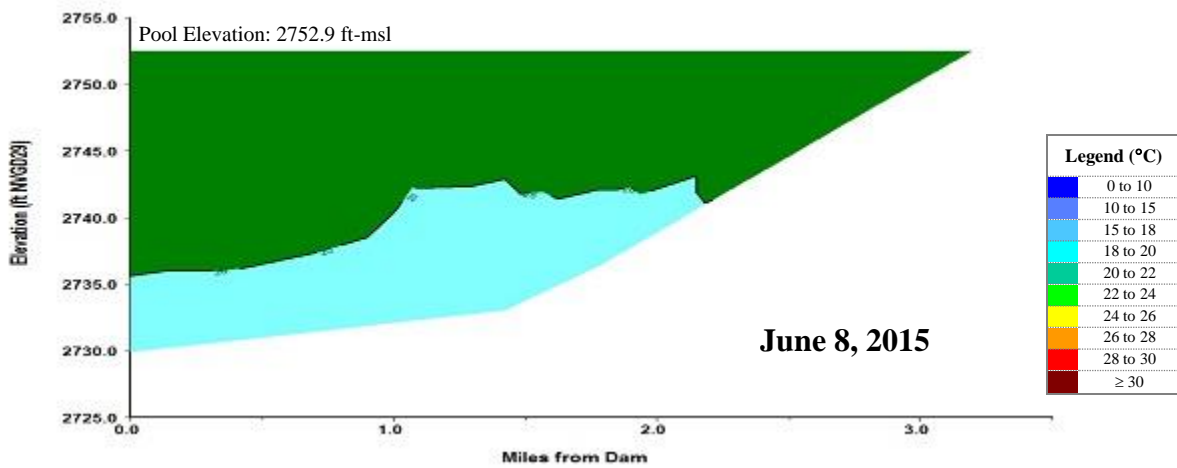
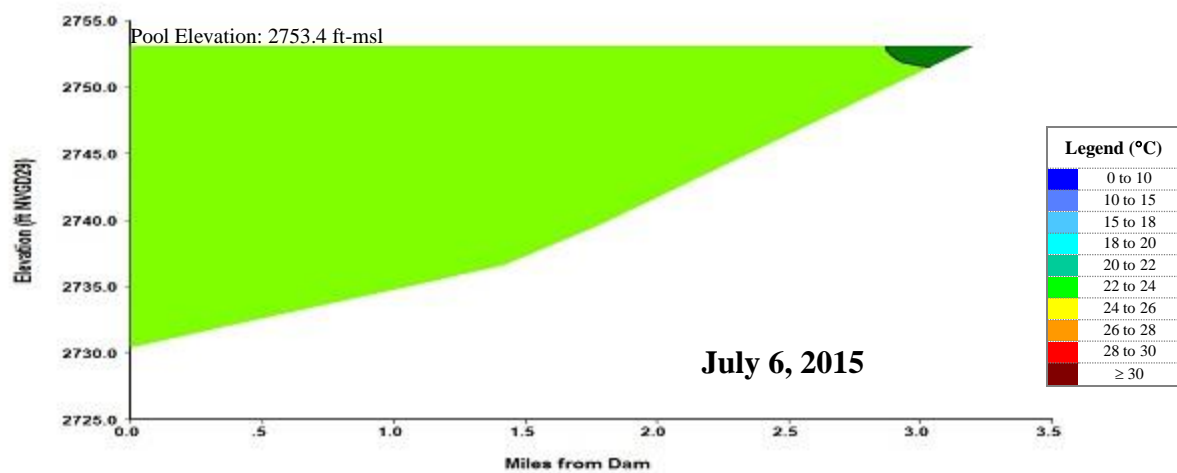
Plate 4-4. Longitudinal water temperature (°C) contour plots of Bowman Haley Reservoir based on depth-profile water temperatures measured at sites BOWLKND1, BOWLKMLN1, and BOWLKUPN1 in 2015.

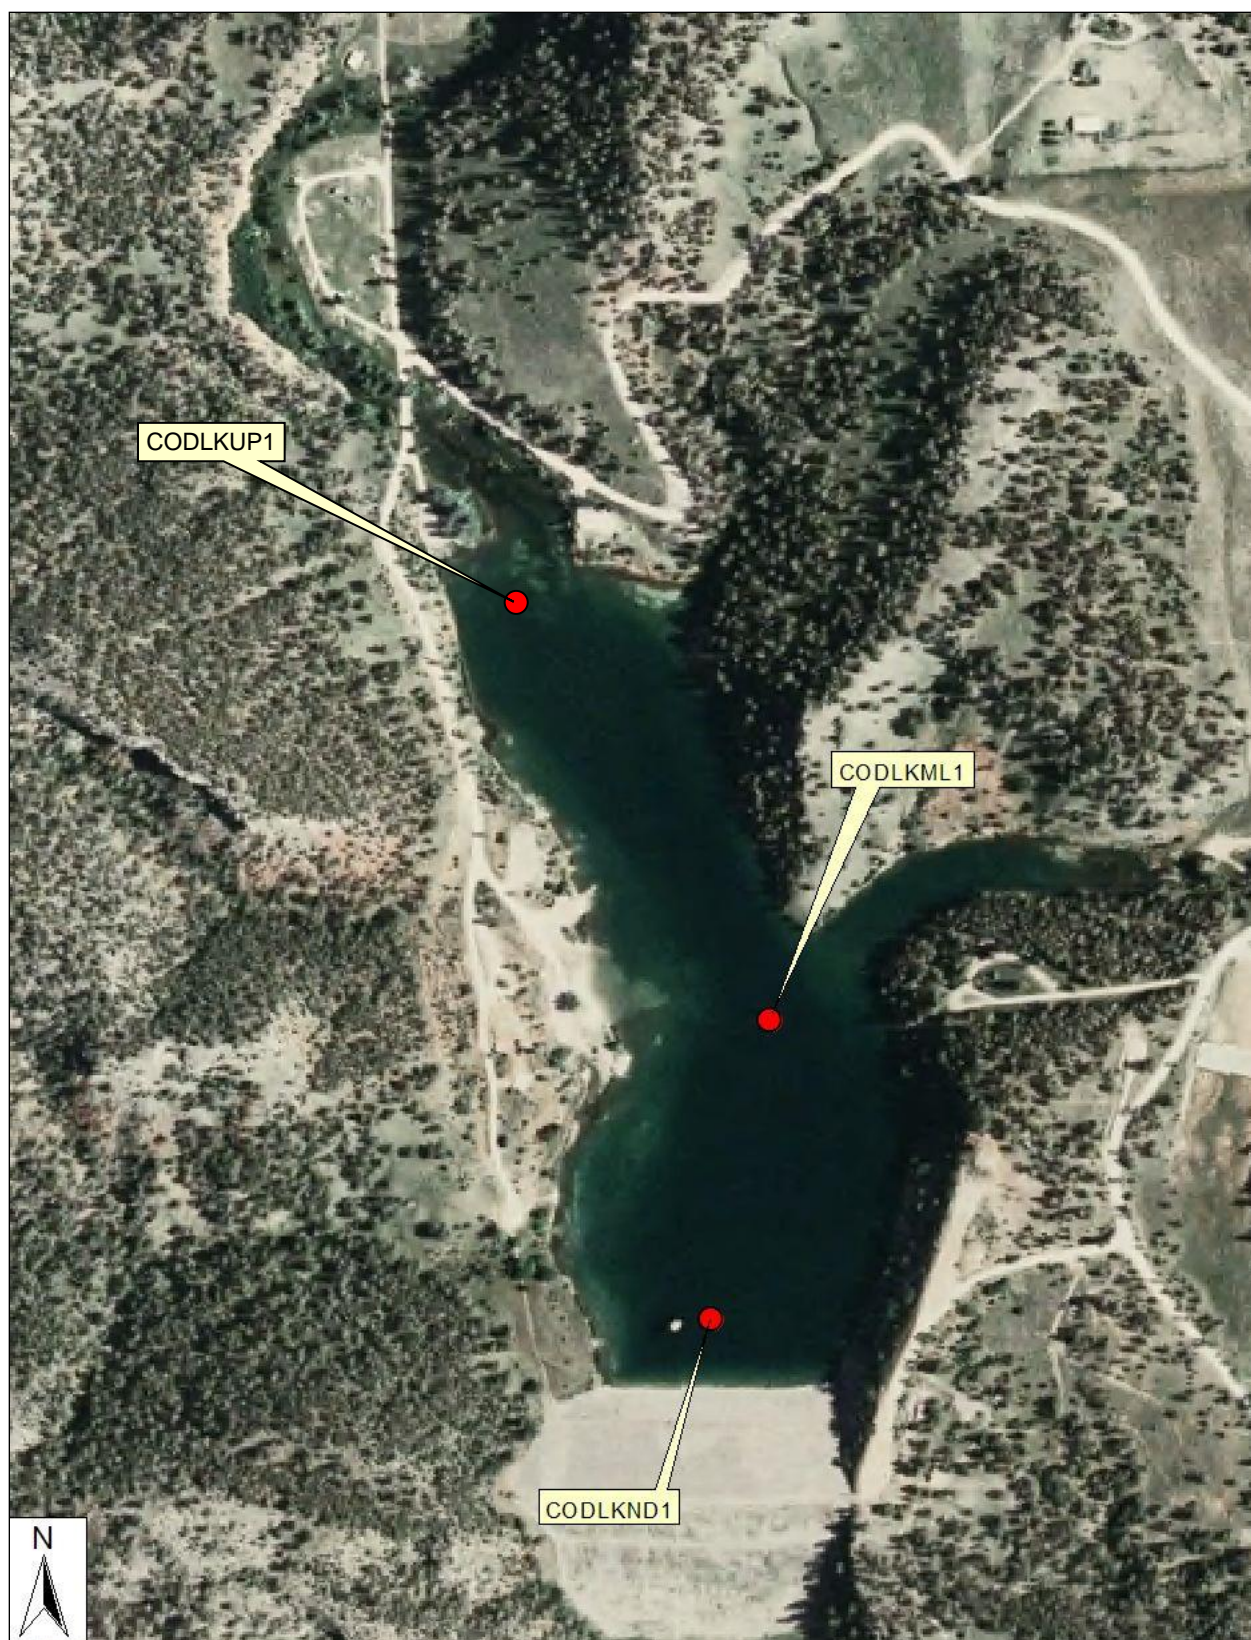
Figure 5.2. Location of sites where water quality monitoring was conducted at Cold Brook Reservoir during 2012 and 2015.

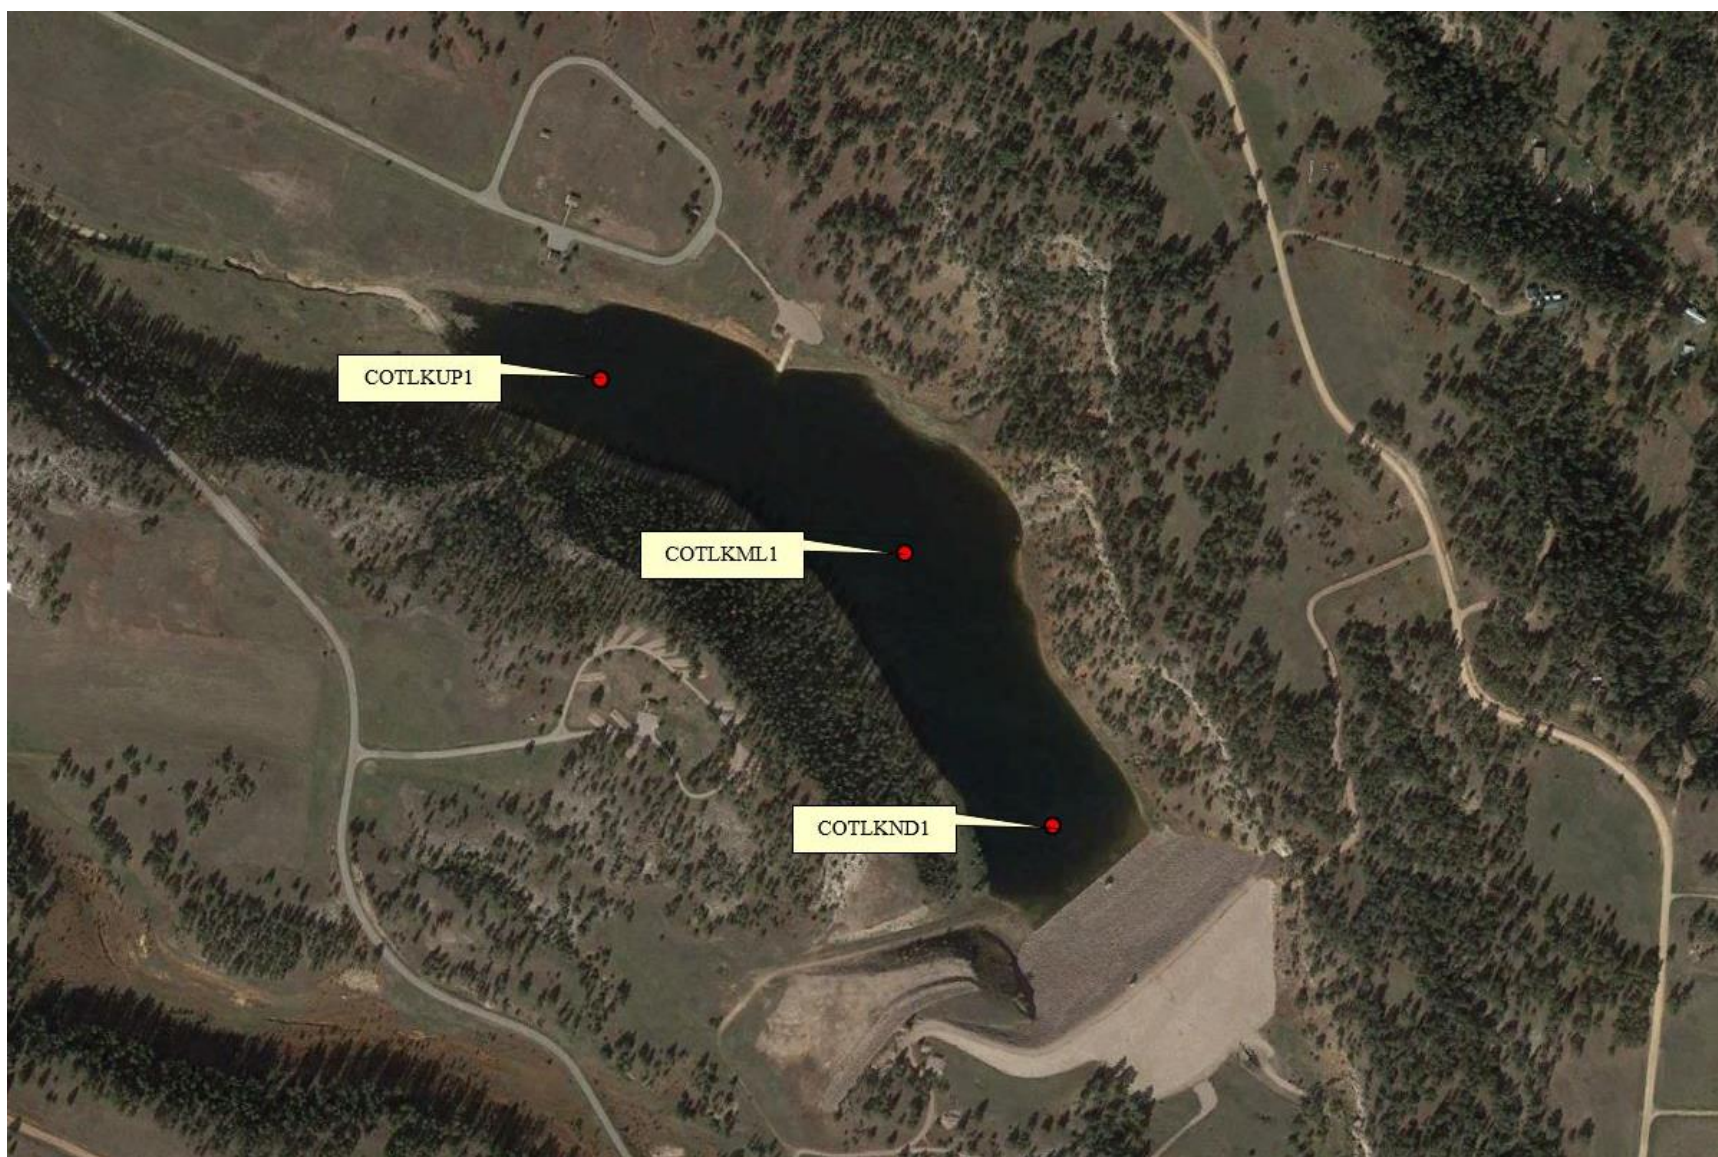
Figure 5.6. Location of sites where water quality monitoring was conducted at Cottonwood Springs Reservoir during 2012 and 2015.
