MISSOURI RIVER
INTERIOR LEAST TERN AND PIPING PLOVER
POPULATION STATUS AND PRODUCTIVITY SUMMARY
including
Permit Activity Report

1994

Prepared by the U. S. Army Corps of Engineers
Endangered Species Coordinators, Operations Division - Omaha District
215 North 17th Street, Omaha NE 68102

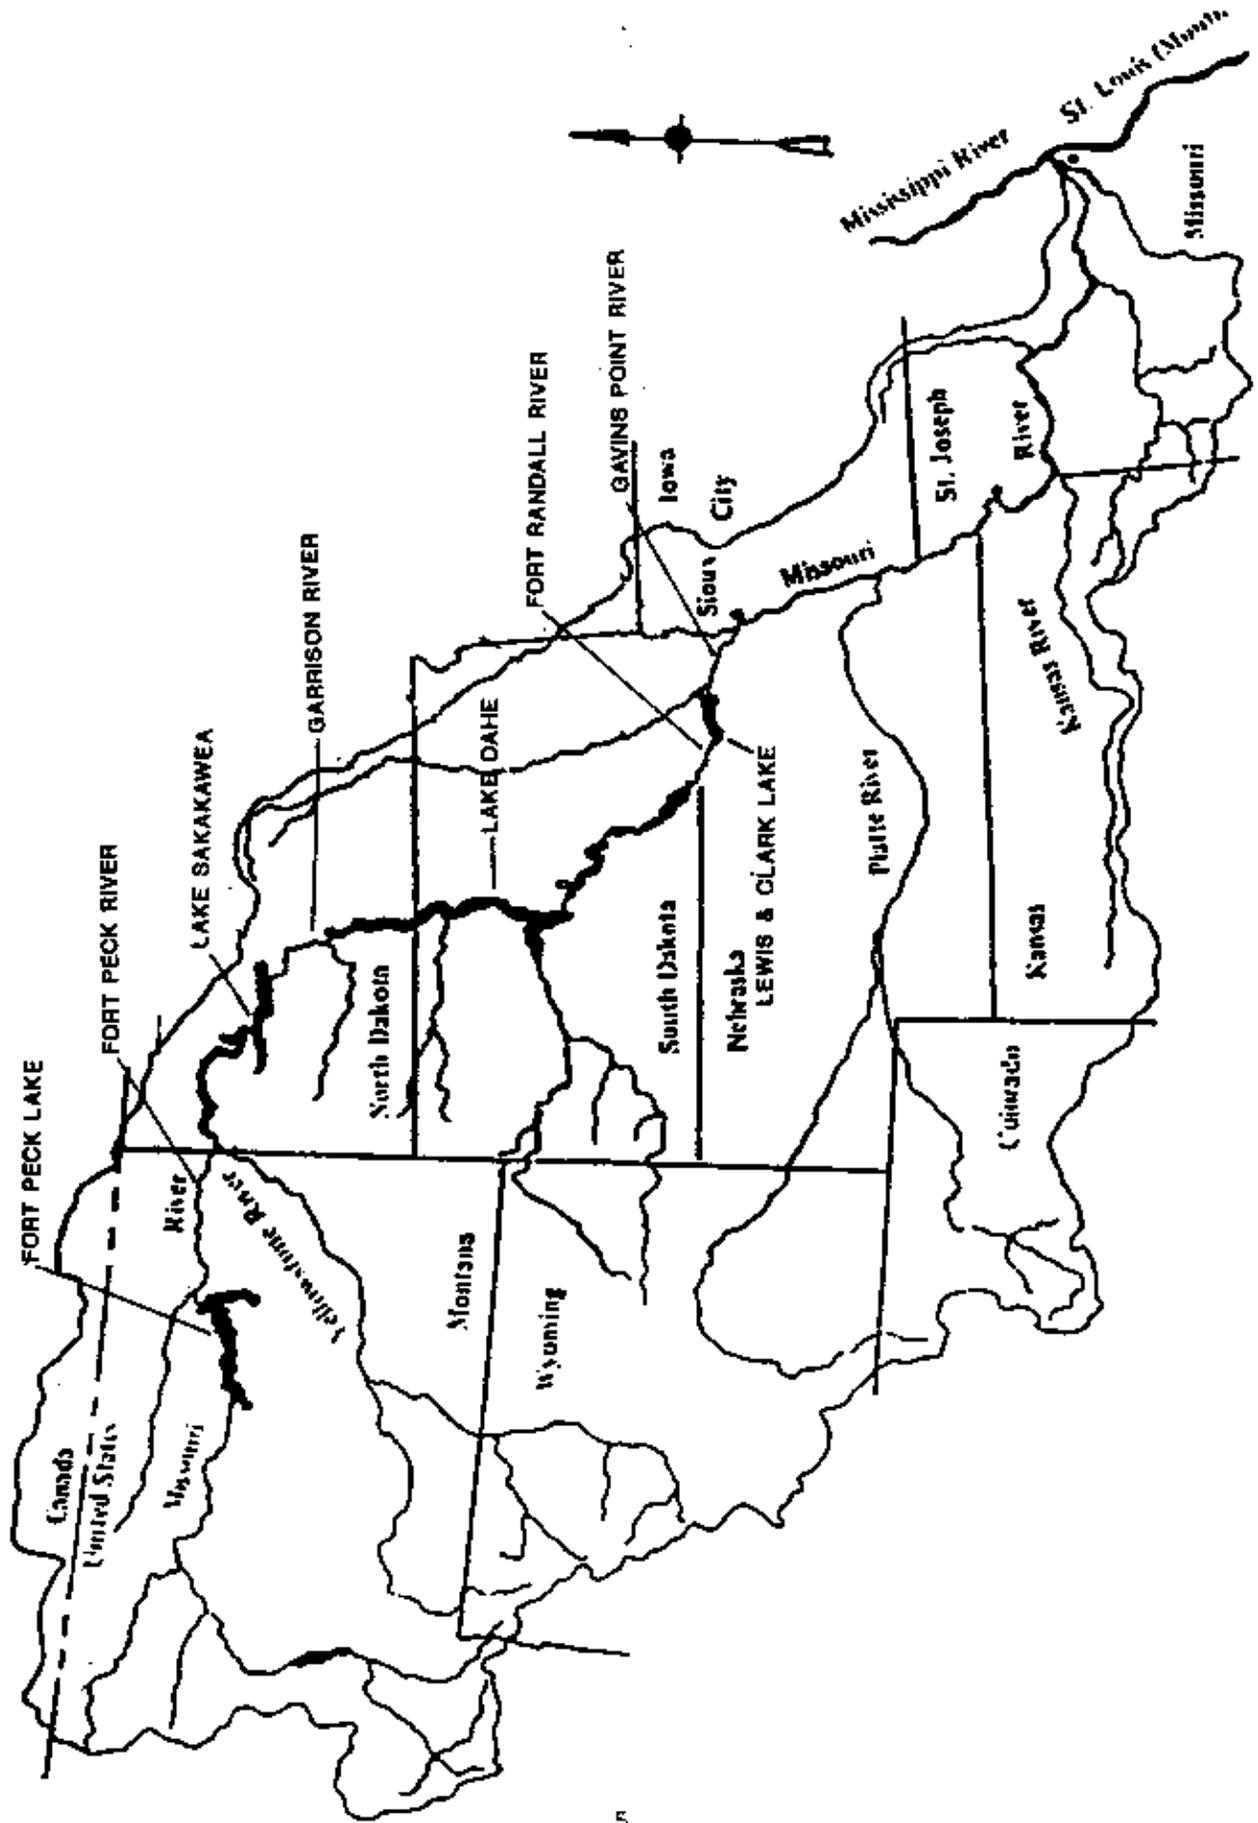
MISSOURI RIVER STUDY AREAS

The map on the following page depicts the study areas.

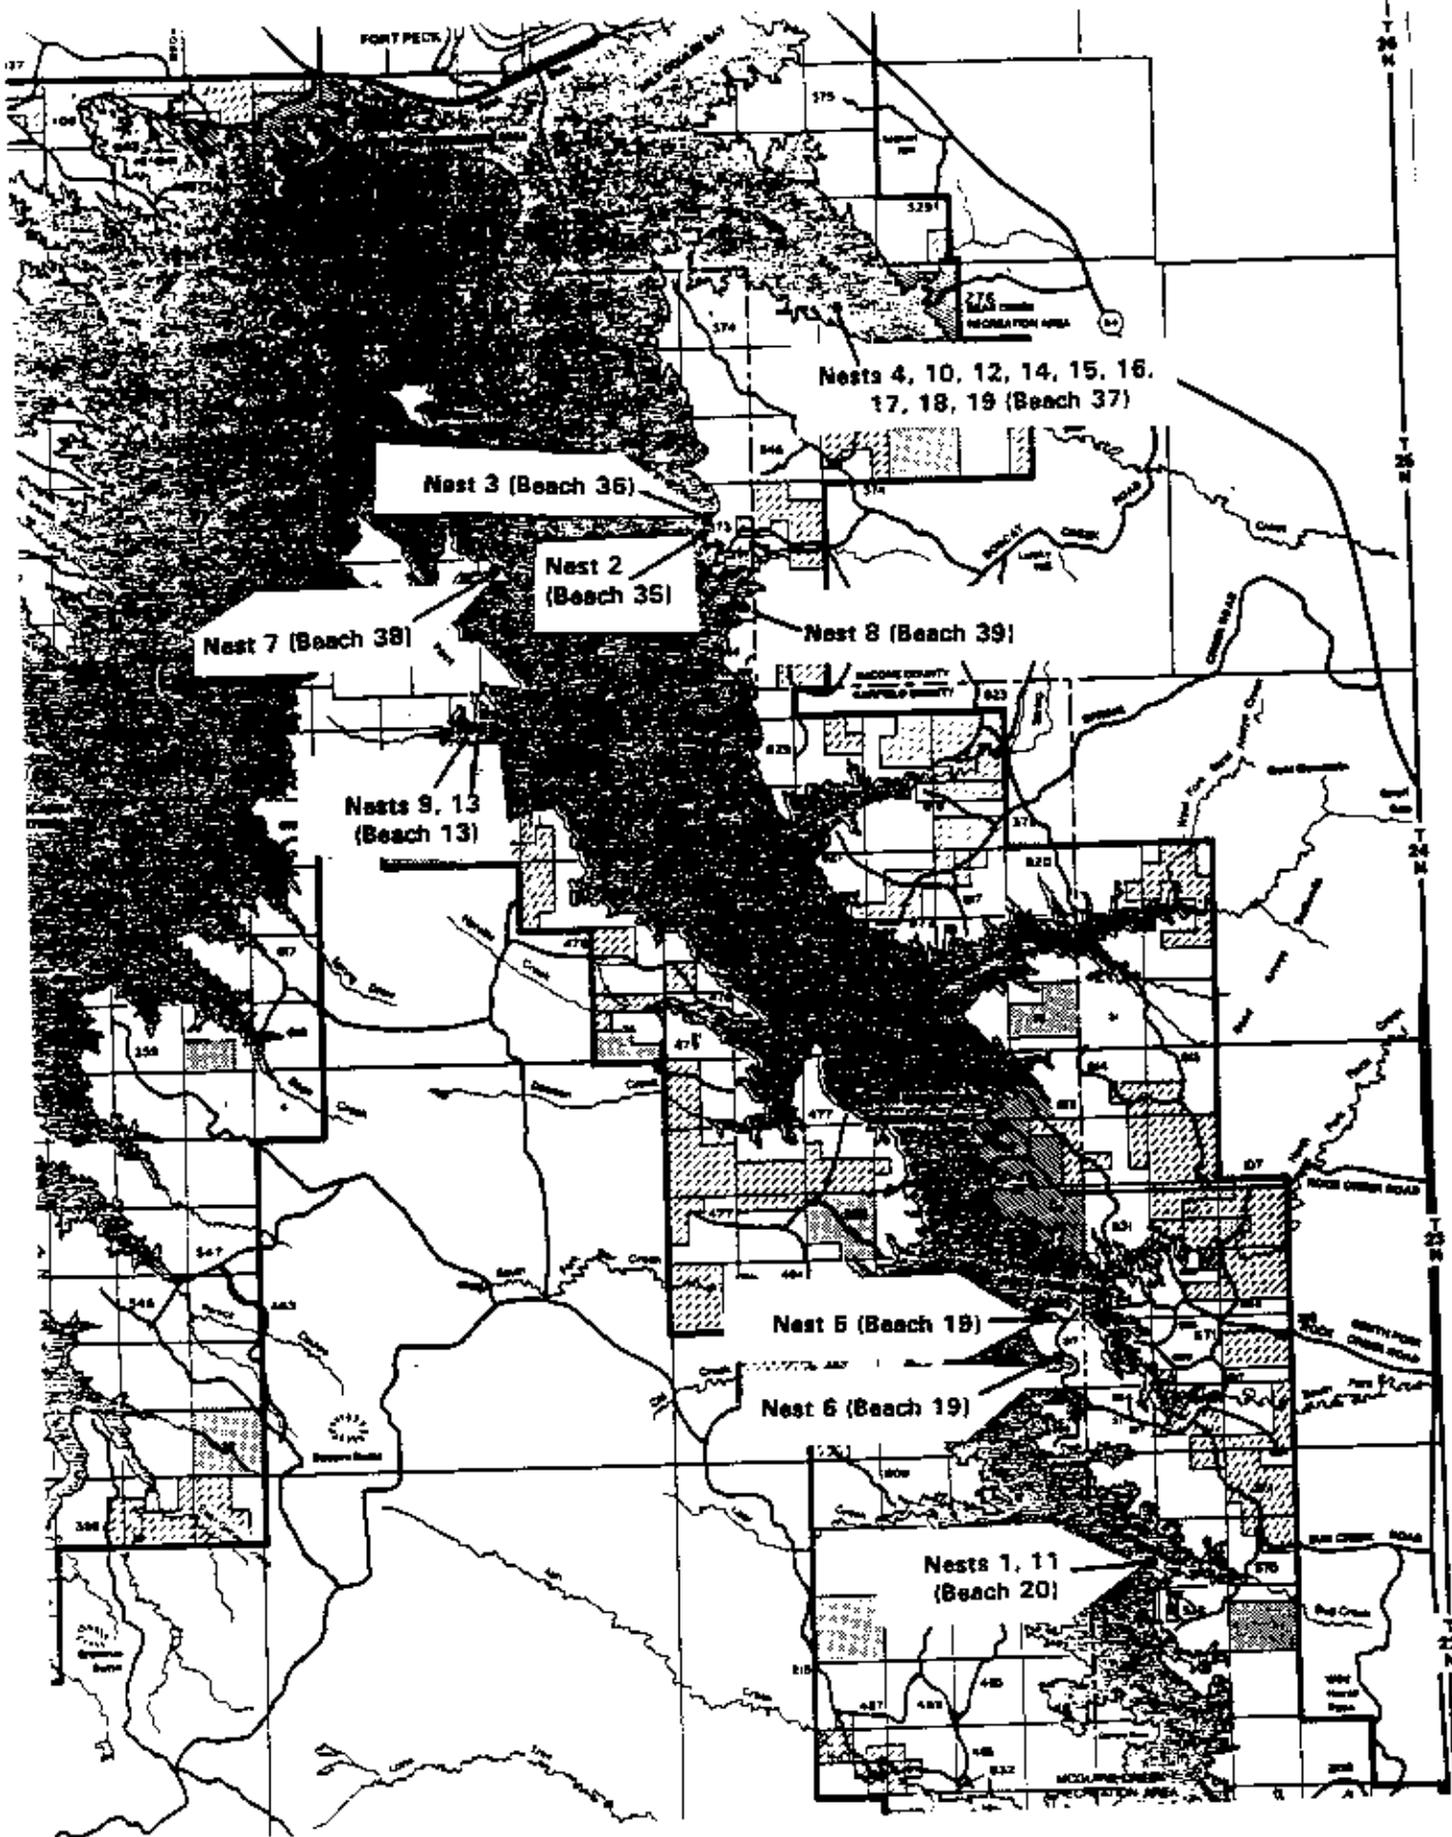
Figure 1. Nests and beaches used for nesting by least terns and piping plovers on Fort Peck Reservoir, Montana, 1994.

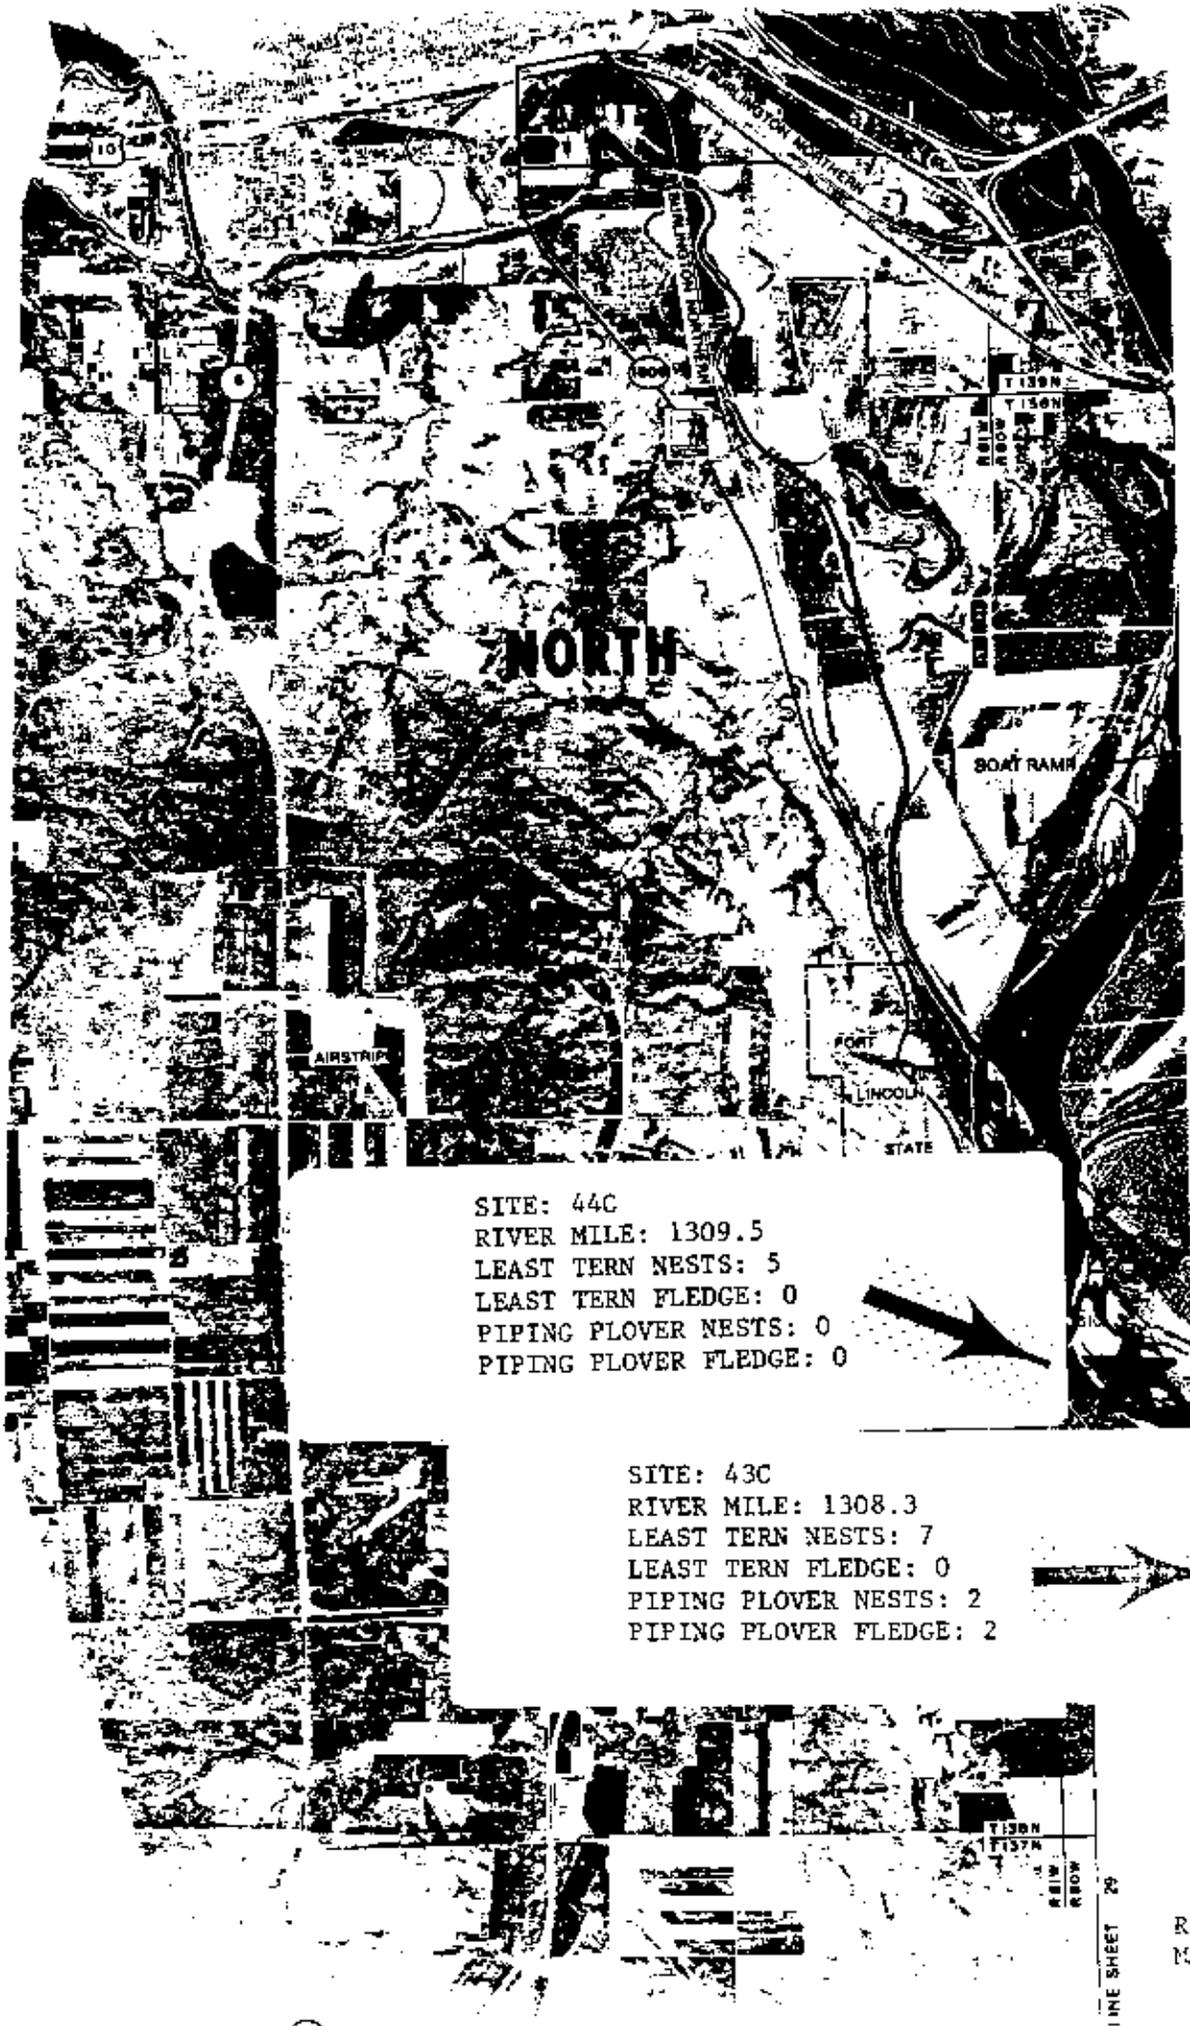
REACH 4
MAP E

←
SITE: 42F
RIVER MILE: 1320.0
LEAST TERN NESTS: 5
LEAST TERN FLEDGE: 13
PIPING PLOVER NESTS: 2
PIPING PLOVER FLEDGE: 4

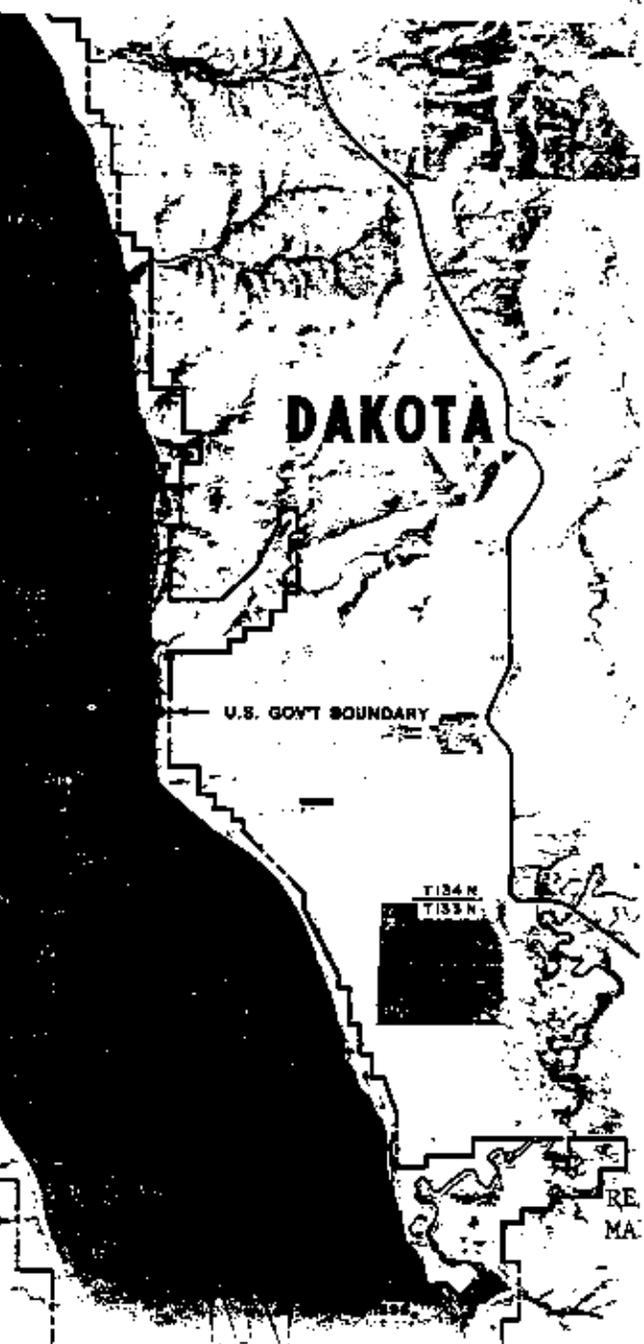
SITE: 51A
RIVER MILE: 1270.0
LEAST TERN NESTS: 54
LEAST TERN FLEDGE: 2
PIPING PLOVER NESTS: 23
PIPING PLOVER FLEDGE: 0

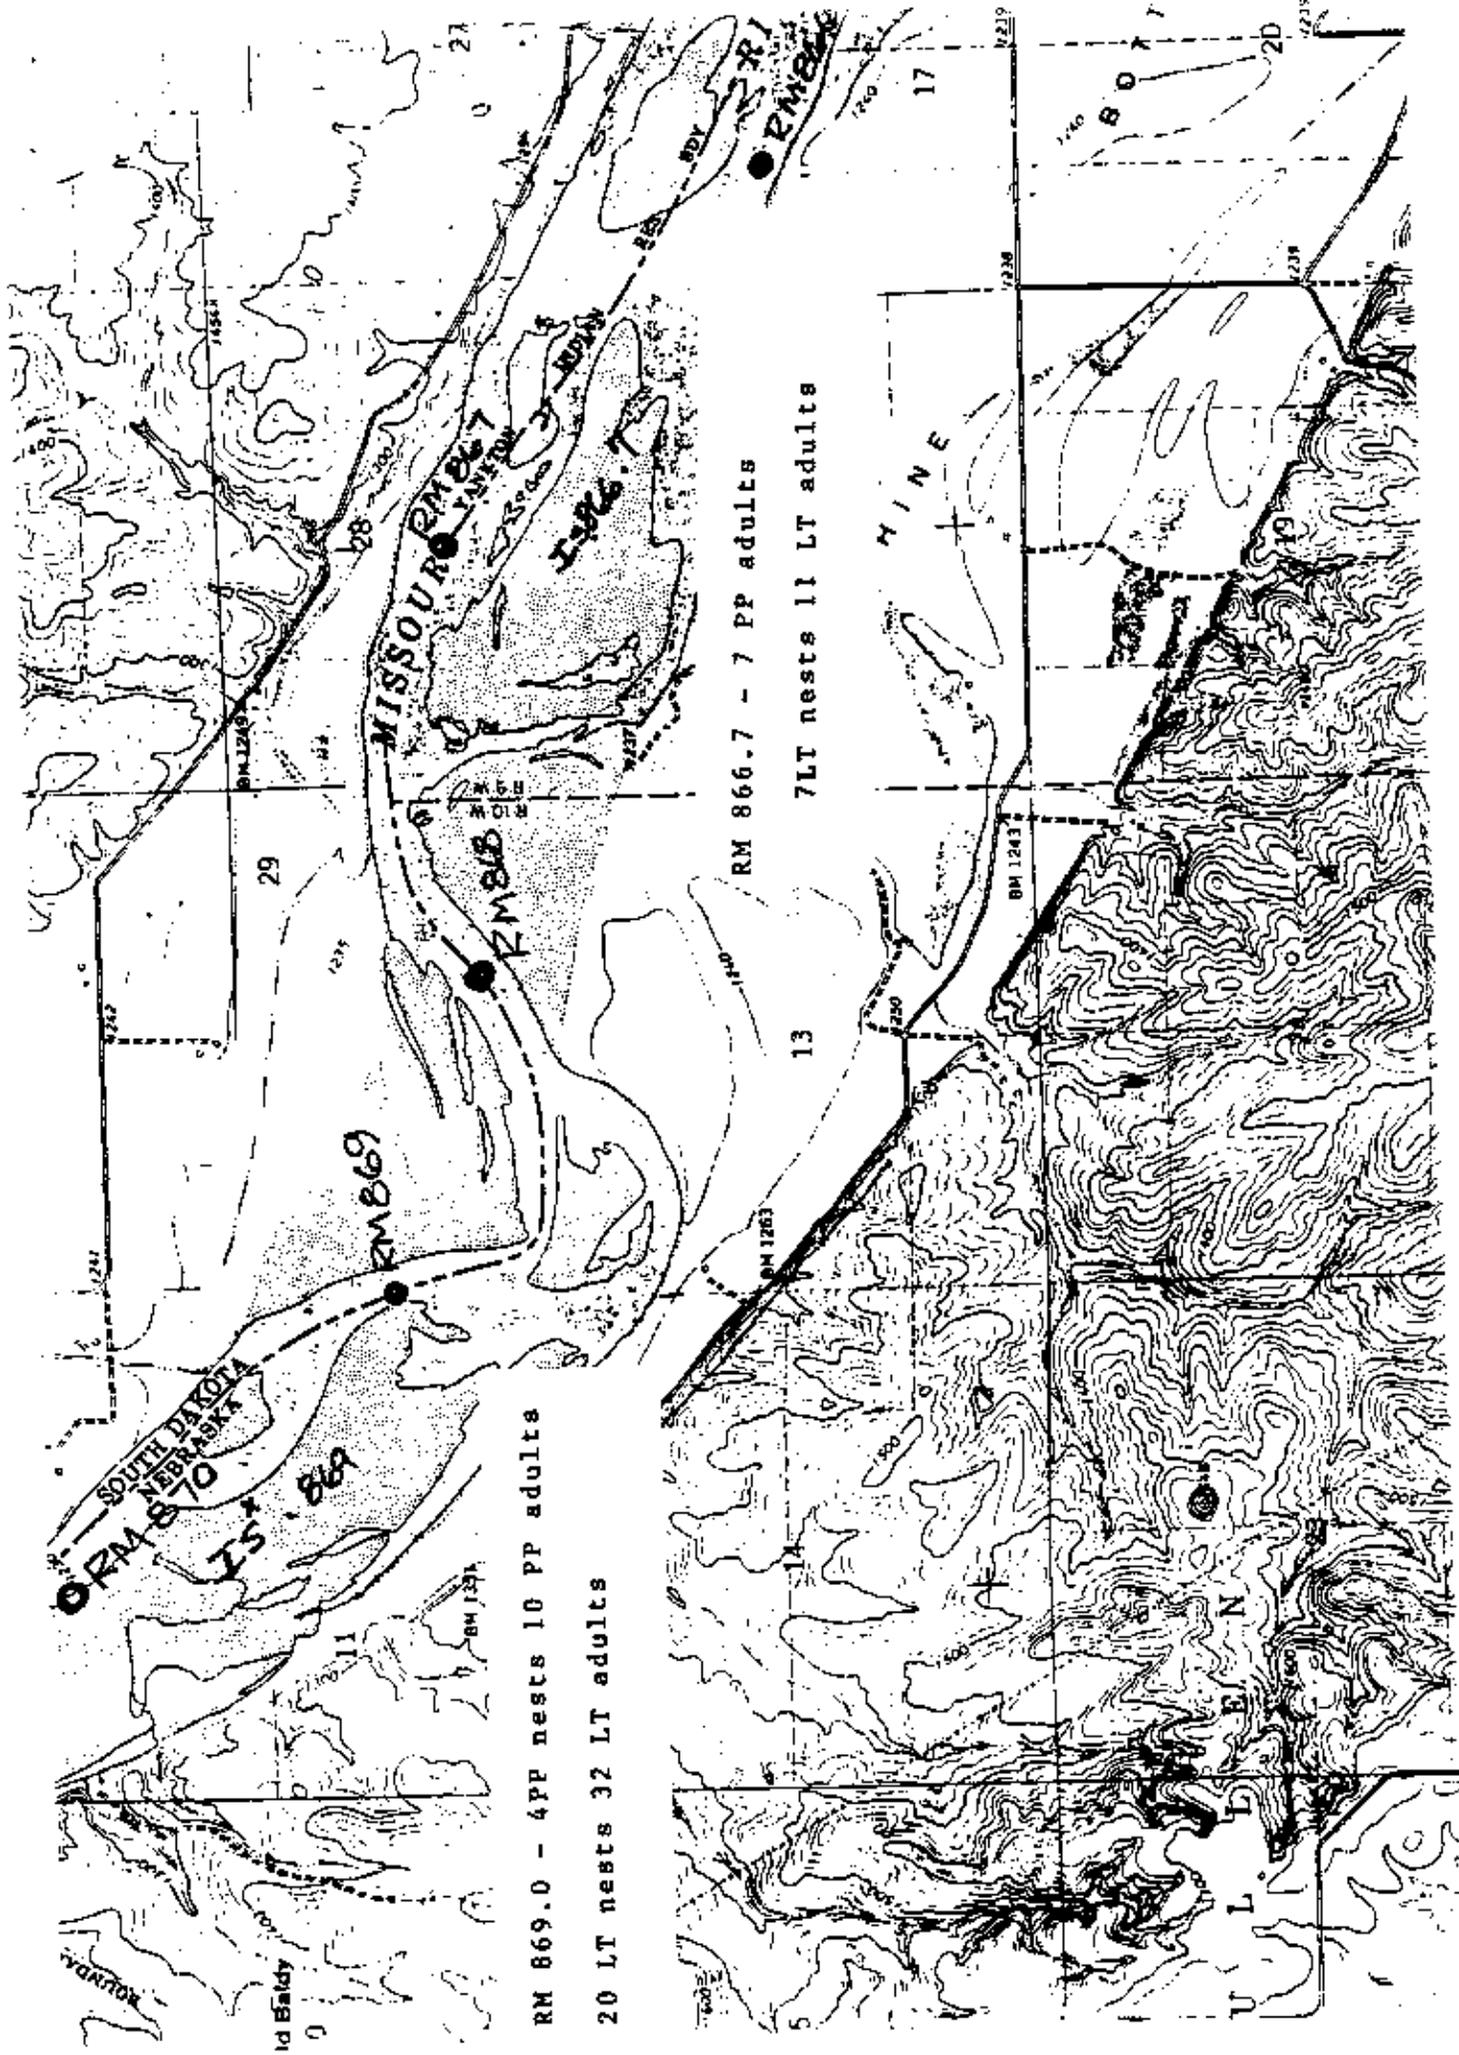
FORT RANDALL RIVER

RM 869.0 - 4PP nests 10 PP adults
 20 LT nests 32 LT adults

RM 866.7 - 7 PP adults
 7LT nests 11 LT adults

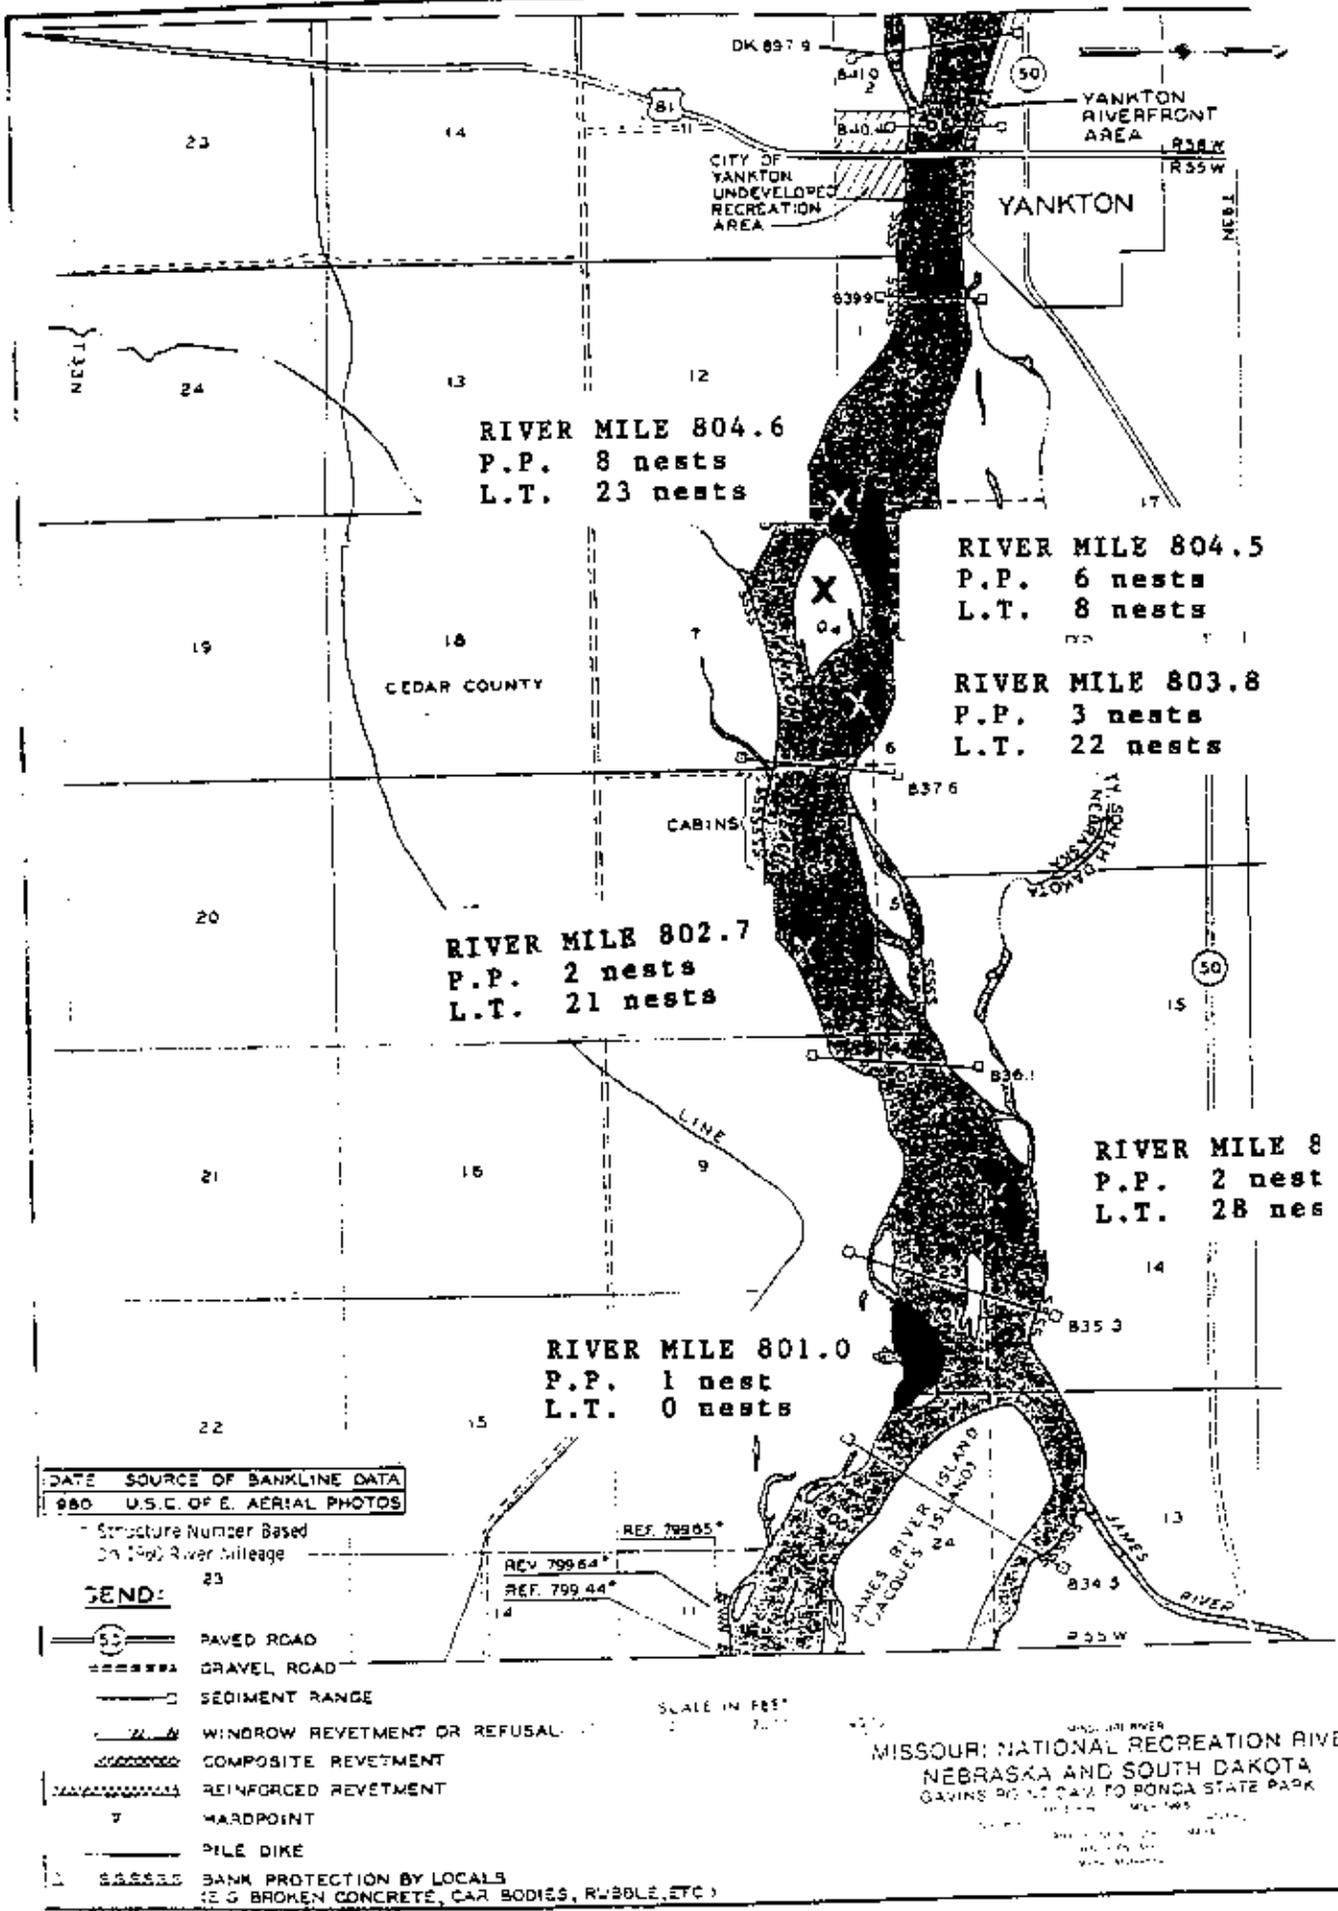
GAVINS POINT REACH

RIVER MILE 804.6
 P.P. 8 nests
 L.T. 23 nests

RIVER MILE 804.5
 P.P. 6 nests
 L.T. 8 nests
