PROSPECTUS

MEKINOCK BANK SITE
GRAND FORKS COUNTY, NORTH DAKOTA
S19 – 153N – 52W

April 20, 2018

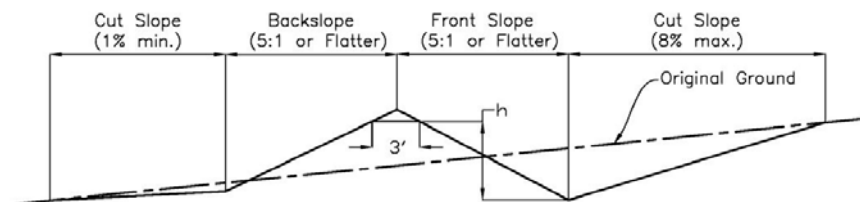
Figure 1. Typical terrace construction (per NRCS Practice STD 600)

Terraces will be open-ended and constructed along contours which will, along with filled/plugged ditches, extend travel time of sheet flow across the site, thereby recharging the water table and promoting expansion of Bank Site wetlands. Construction of low level terraces (~ 18"-24"), selective filling of ditches, and selective leveling of plow furrows will establish hydrologic regimes utilizing water sources available to the site per the KLJ water budget.
