**U.S. Army Corps of Engineers
Omaha District**

Water Quality Sampling Report

Results of the 2017 Water Quality Monitoring of the Van Hook Arm of Lake Sakakawea in Response to Avian Mortality

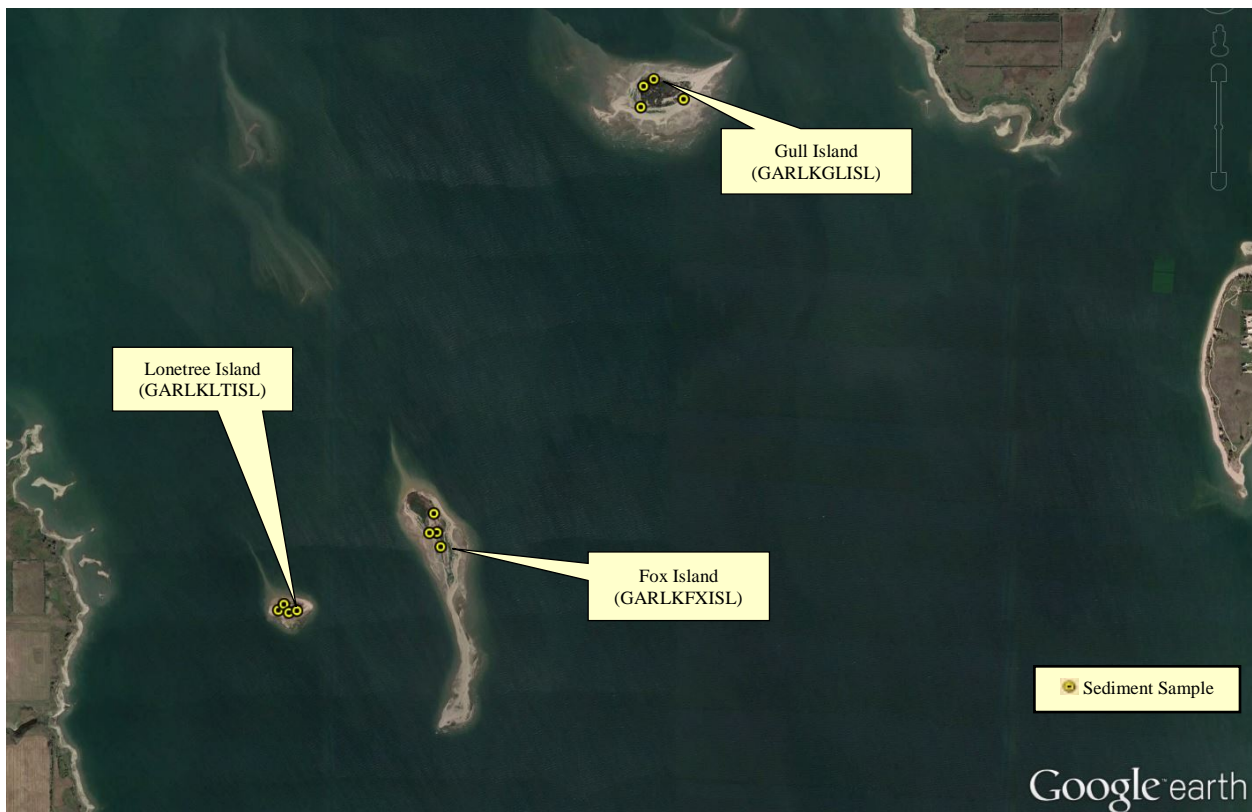
Figure 2. Location of Fox Island, Lonetree Island, and Gull Island and their respective sediment sample locations.

Sediment/soil samples were collected at four sites at each of the three identified islands (Fox, Lonetree, and Gull Islands) on 9-August-2017 (Figure 2). The four locations on each island where the sediment/soil samples were collected are shown in Figure 2 and described in Tables 2 and 3. The sediment samples at each site were collected with a 2 in. diameter stainless steel sediment core sampler. Core samples were collected to a depth of 1 foot at each location and then all four samples from each individual island were composited. A 500 mL volume of the composited sediment/soil material was then collected and transported to the laboratory for analysis. Total metals analysis was then performed on each of the three composited 500 mL sediment/soil samples.
