MISSOURI RIVER REGION - FY 1998  
INTERIOR LEAST TERN  
AND PIPING PLOVER

**BIOLOGICAL OPINION**  
**COMPLIANCE REPORT**  
AND PERMIT ACTIVITY REPORT

March, 1999

Omaha District

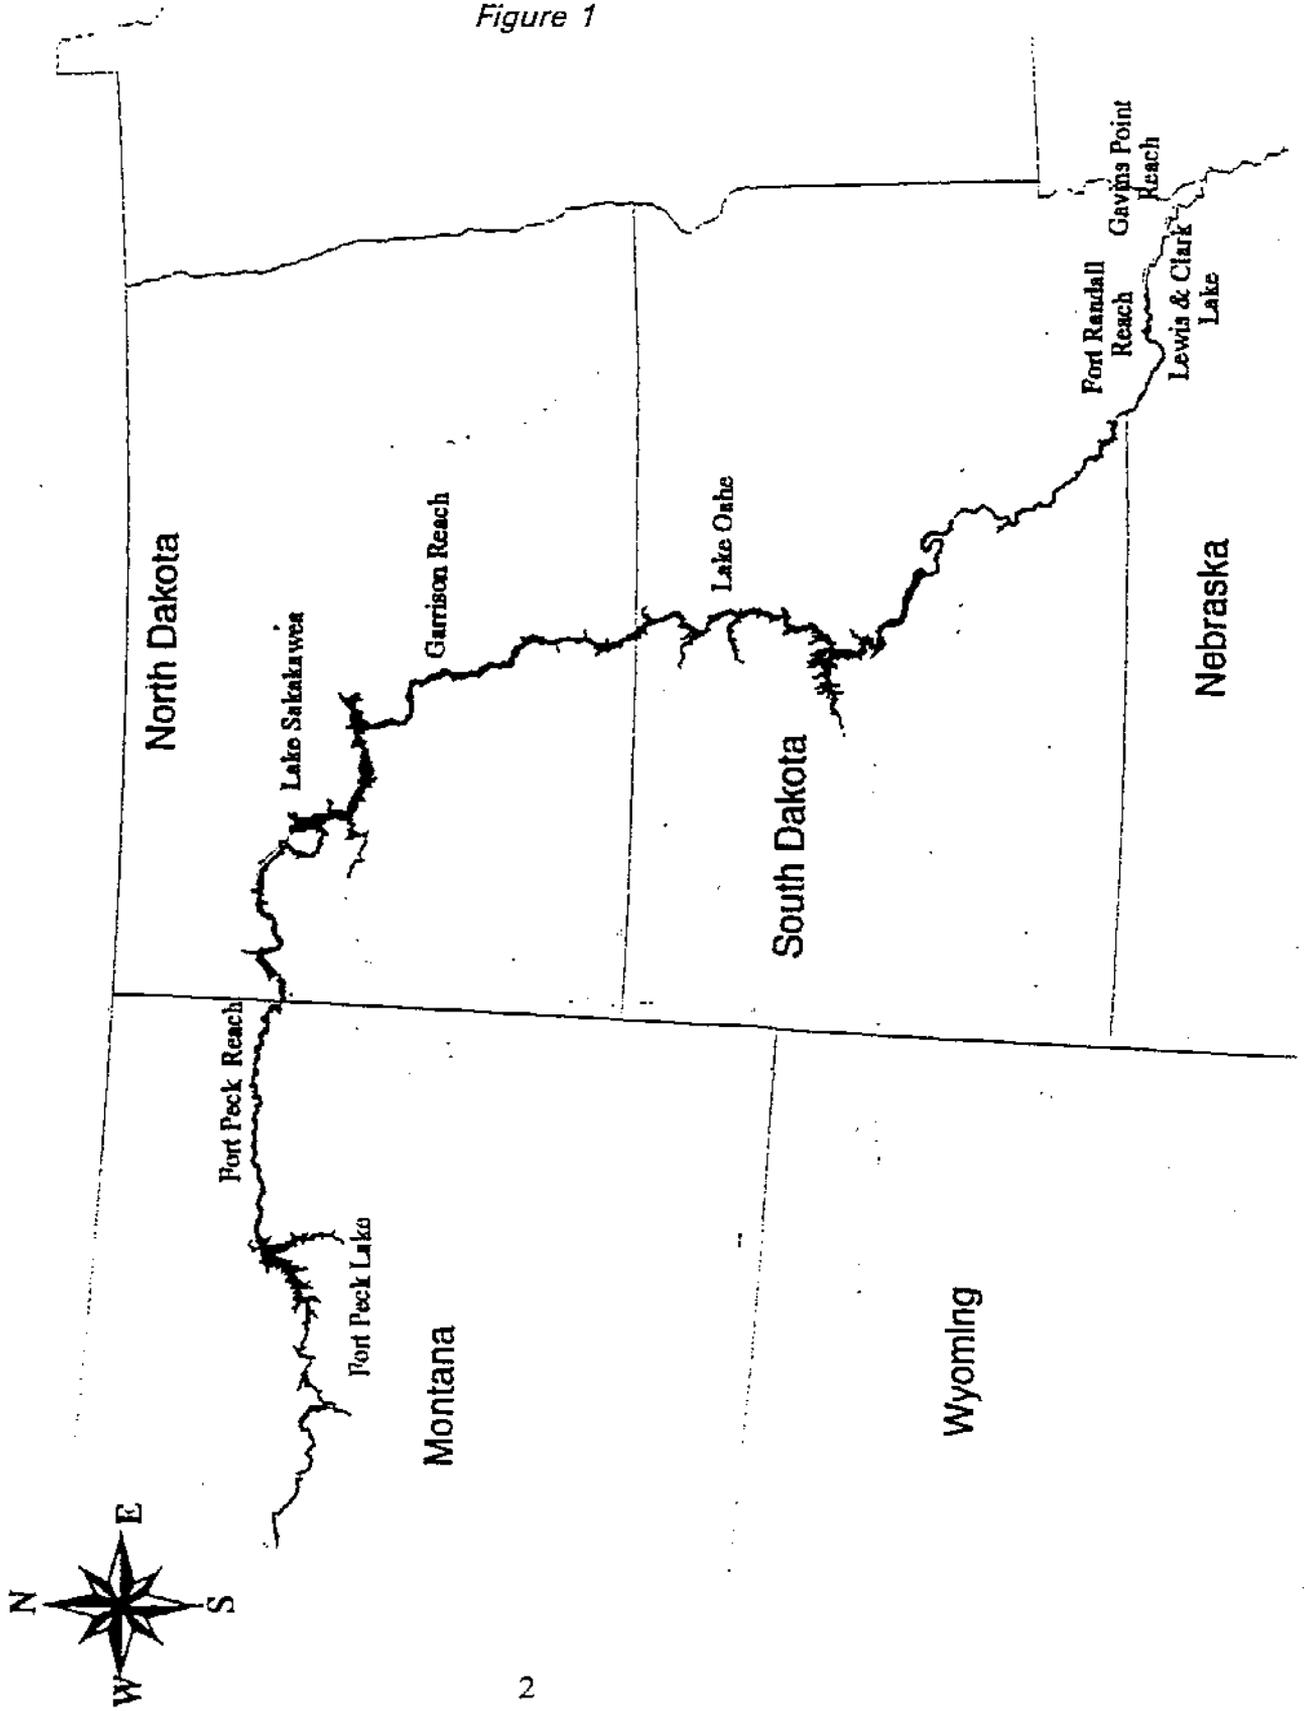
Figure 1

# MISSOURI RIVER STUDY AREAS

The Omaha District Corps of Engineers (District) has been involved in least tern and piping plover studies since the mid 1980's. Actions were increased following the issuance of a Biological Opinion (Opinion) by the U.S. Fish and Wildlife Service on November 14, 1990. Initial District implementation of that Biological Opinion began in 1992, following the development of a one-year work plan. Full District implementation of the Biological Opinion began in 1993, after the development of an implementation plan, "Omaha District's Fiscal Year 1993 - Fiscal Year 1995 Plan for Habitat Improvement for the Interior Least Tern and the Piping Plover," commonly known as the "Red Book." The Red Book was reviewed by the U.S. Fish and Wildlife Service and approved for implementation by the Missouri River Division of the Corps of Engineers (now the Missouri River Region, or "Region"). Corps' responsibilities under the Opinion lie within the Missouri River from Fort Peck Dam to Ponca, Nebraska, and the Missouri River Reservoirs (see Figure 1).

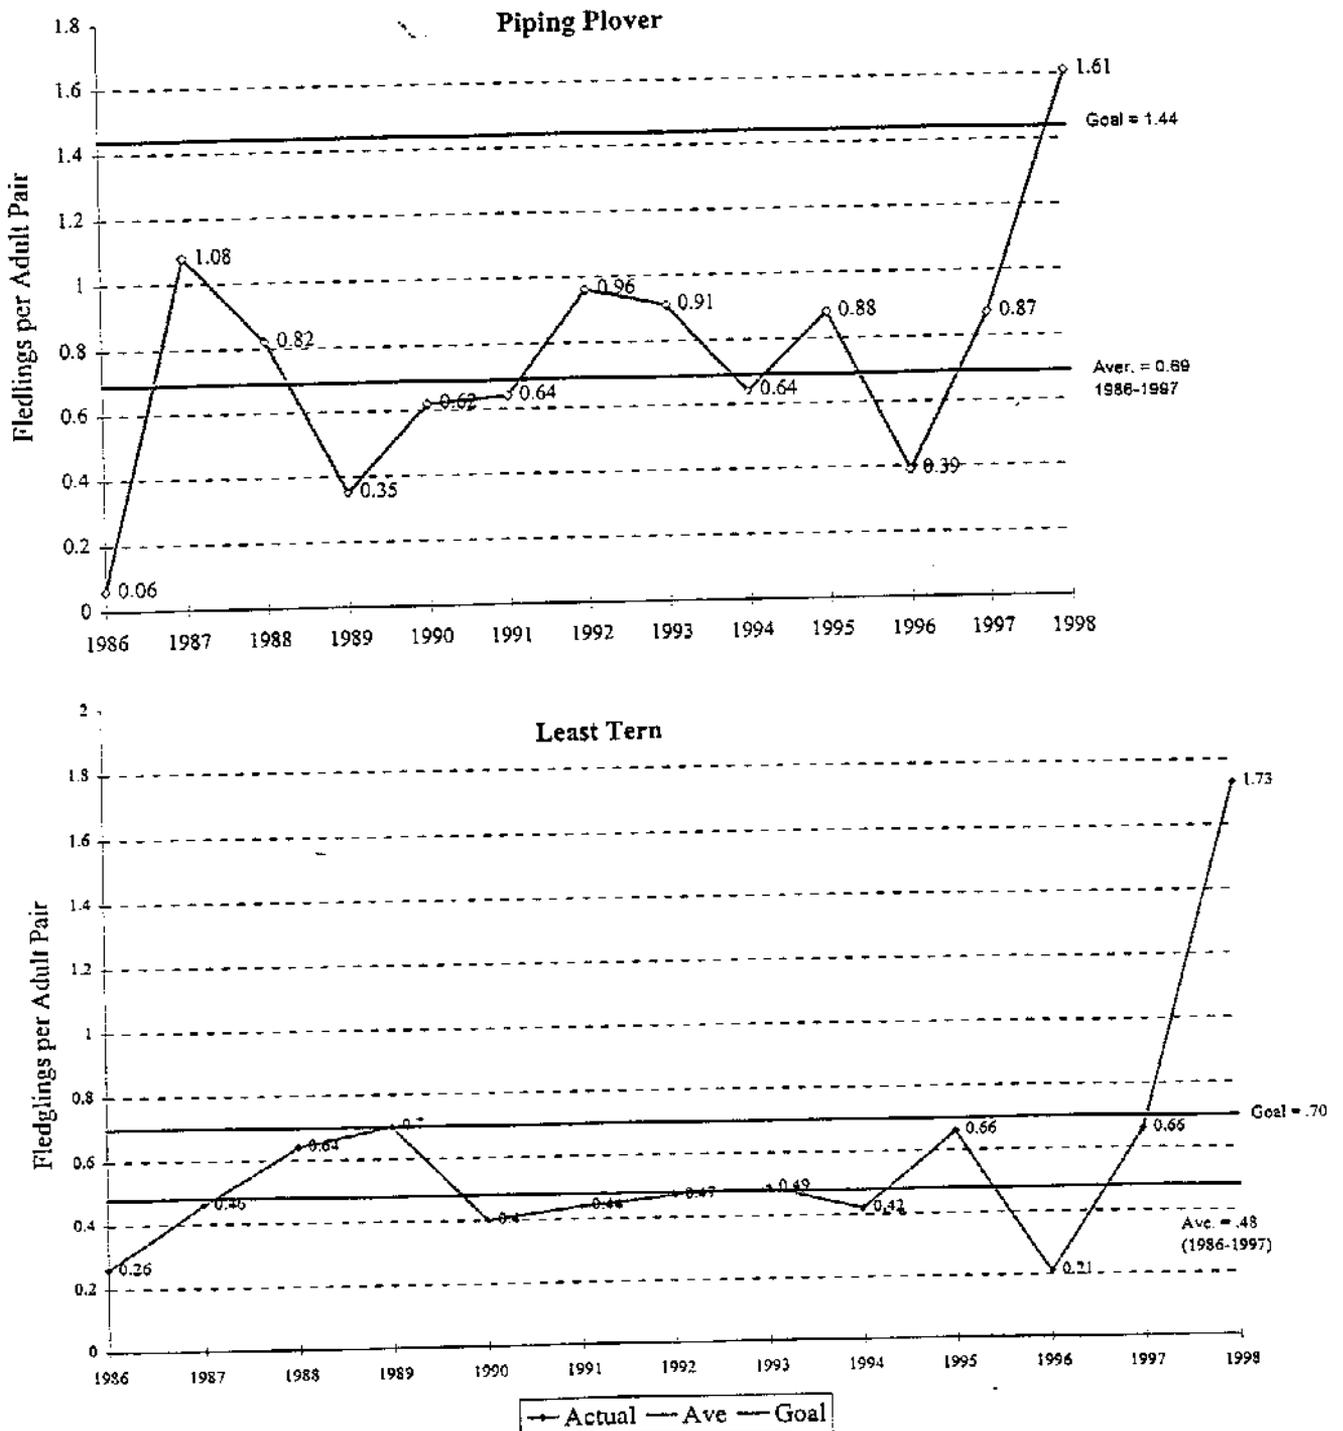
*Figure 5*  
Fledge Ratios on the Missouri River System, 1986 - 1998

System total fledge ratios on the Missouri River system were exceeded for the first time since the Corps began tracking these ratios. High flows in previous years have developed vast areas of vegetation-free high elevation sandbar habitat in the riverine portions of the Missouri River basin.

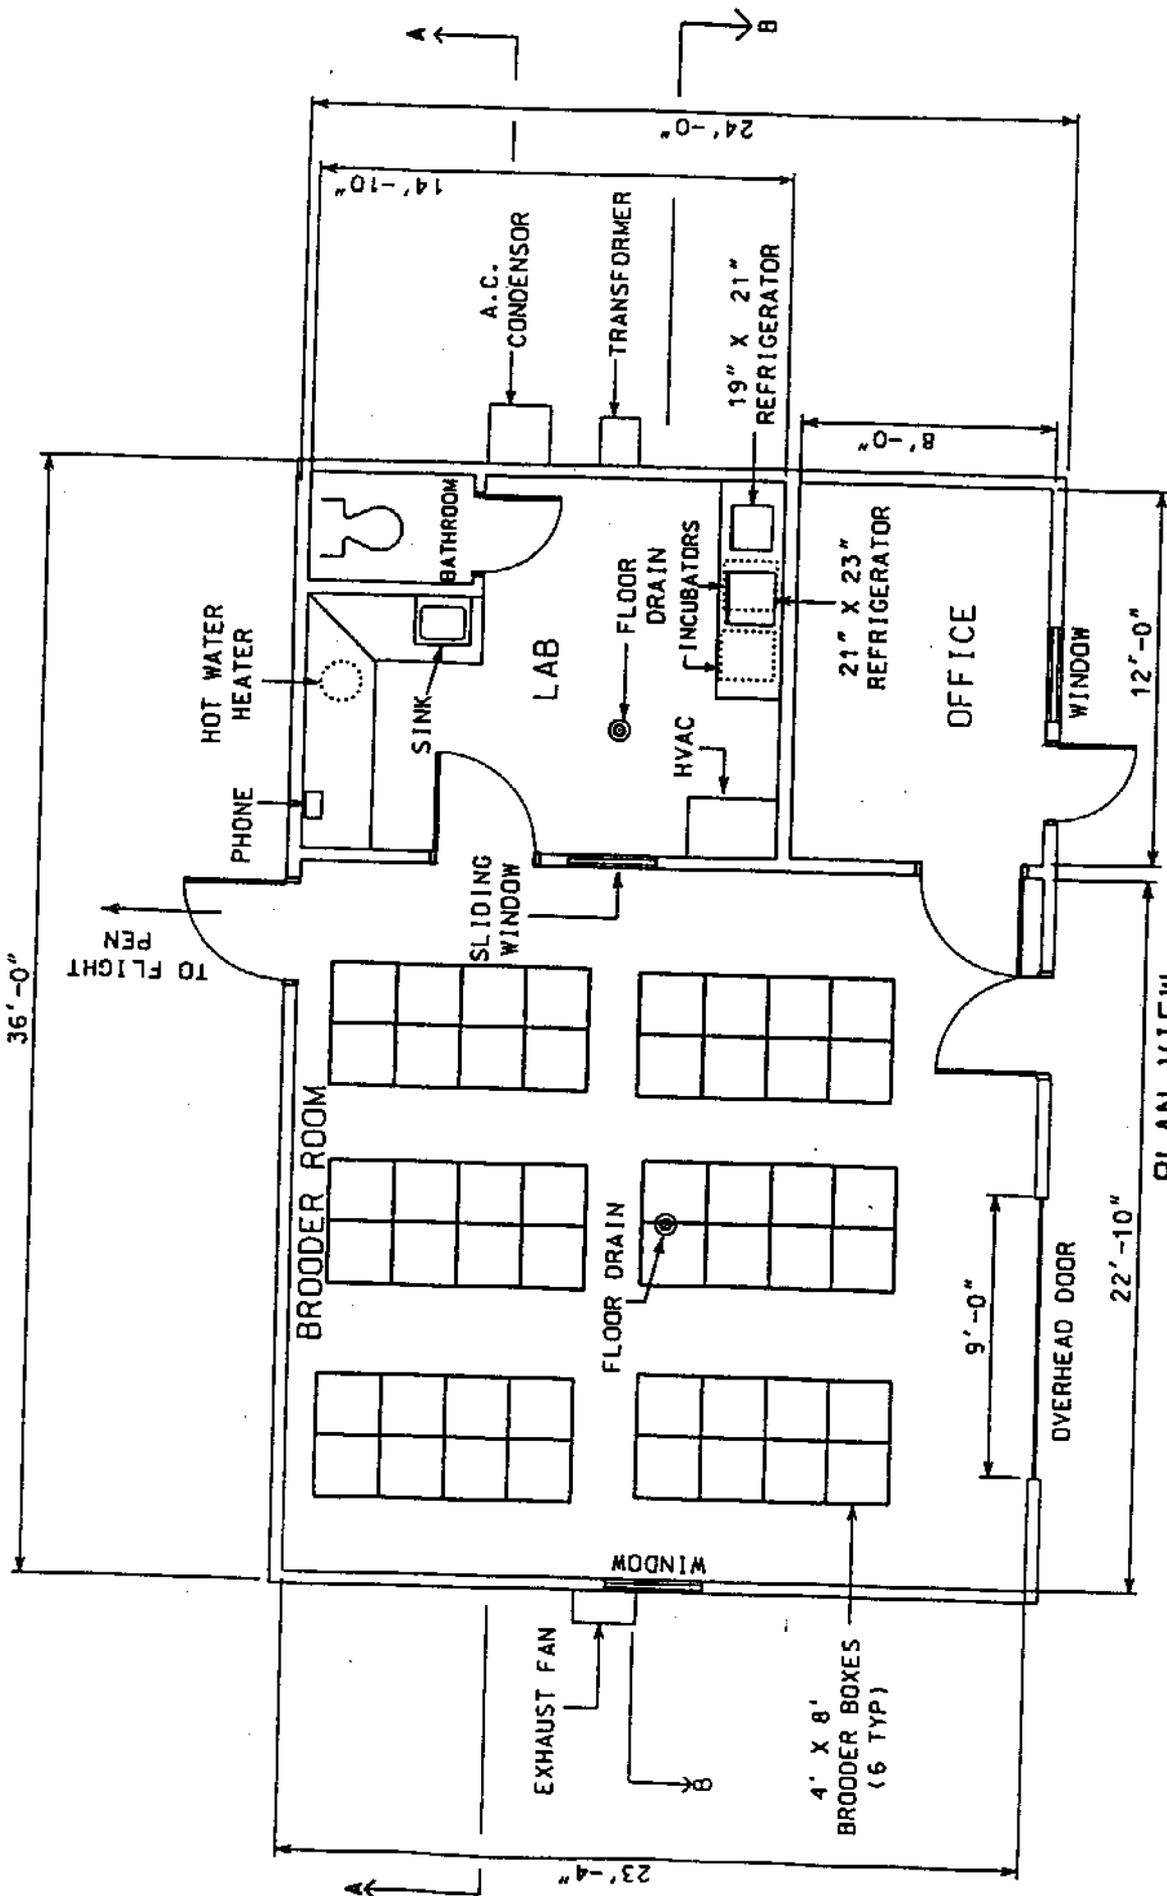
**PLAN VIEW**  
**CAPTIVE REARING BUILDING**

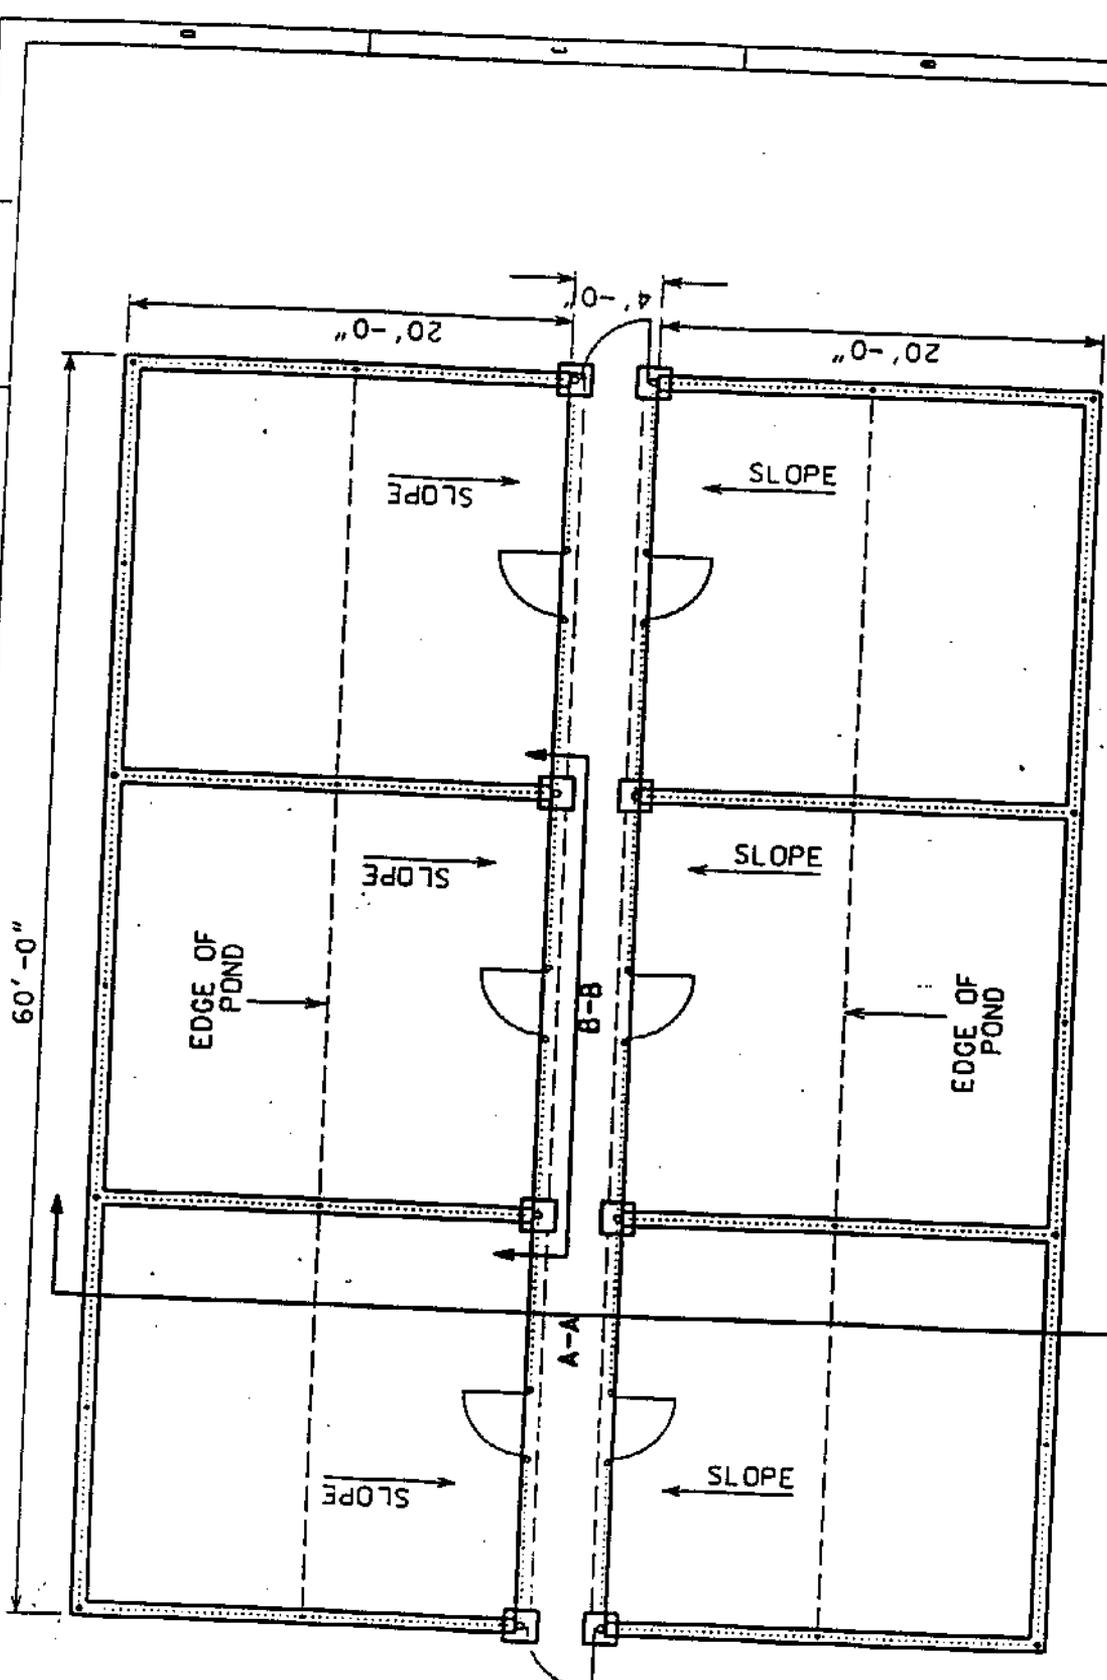
PLAN VIEW  
FLIGHT PEN

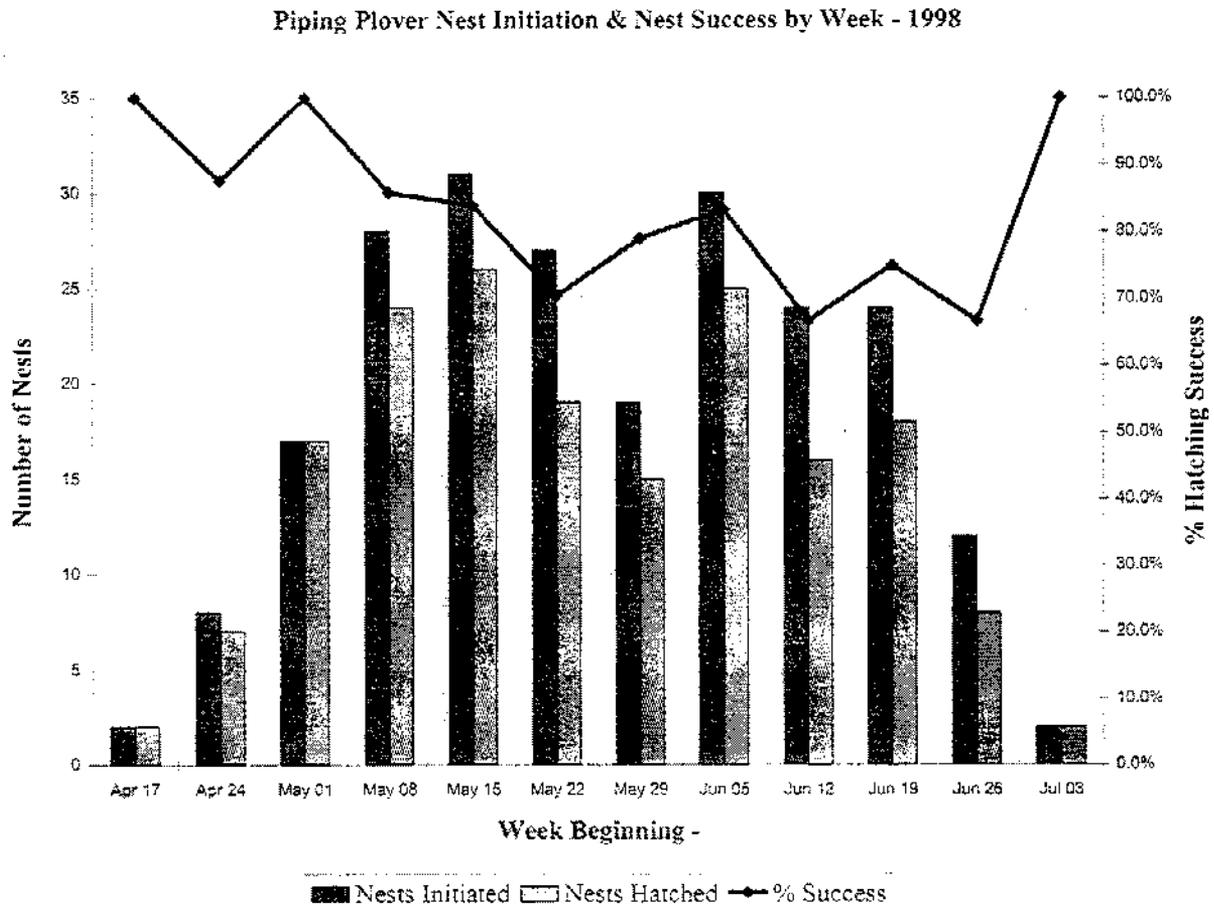
The chart below shows piping plover nest initiation and success by week for 1998. Compared to previous years two points are conspicuous. There was a pronounced shift to earlier nest initiations with a greater than normal number of nests being initiated in late April and early to mid May. The other item was a much higher nest hatching success compared to previous years. This will be more fully discussed in the productivity section.

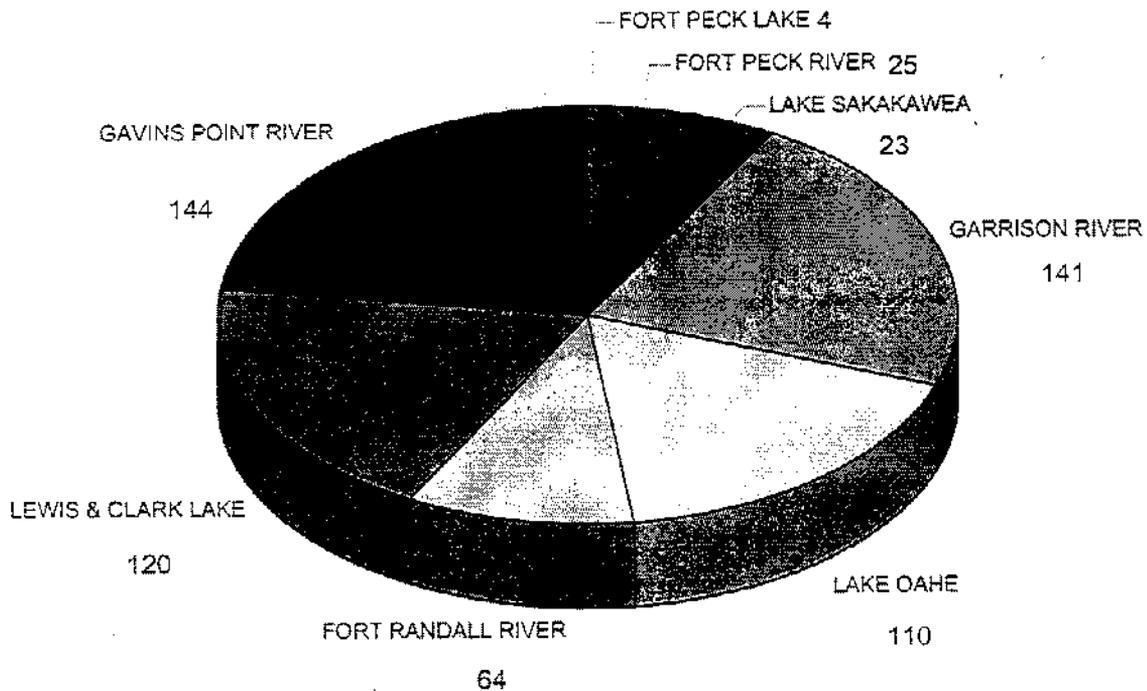
### LEAST TERN ADULT CENSUS BY REACH - 1998

The pie chart below shows the distribution of adult terns by reach on the System.

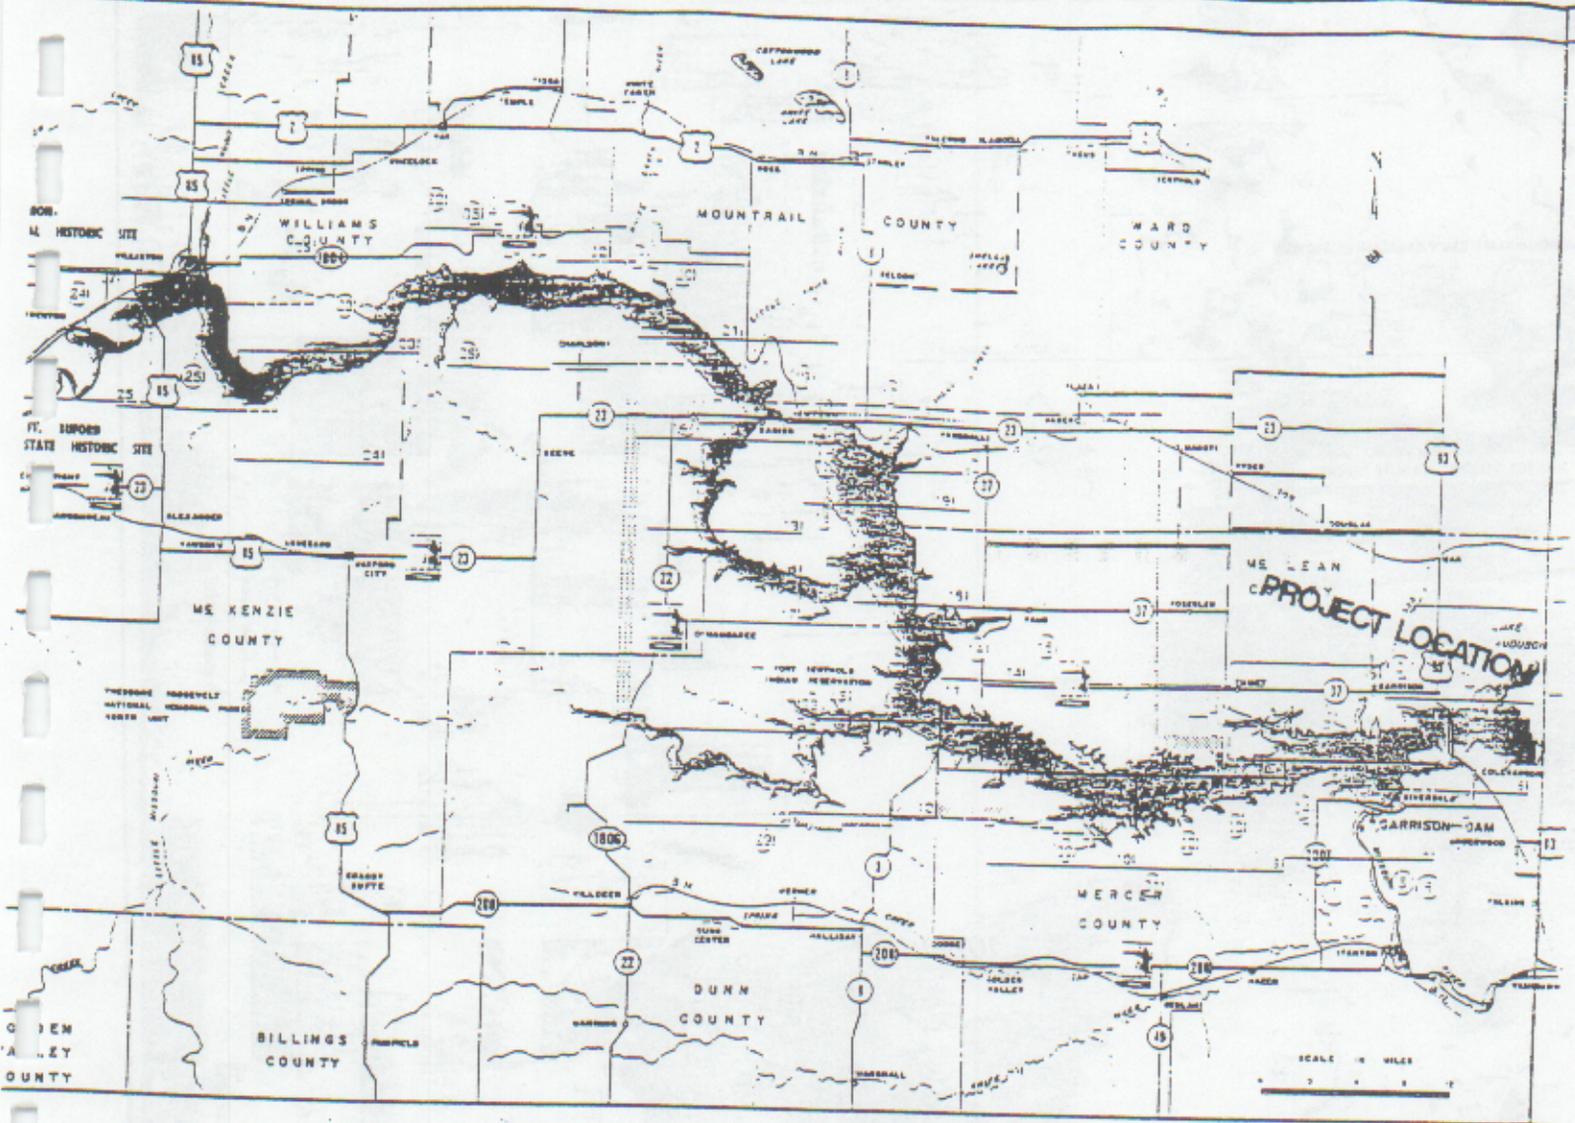
# PLOVER ISLAND CONSTRUCTION GARRISON PROJECT

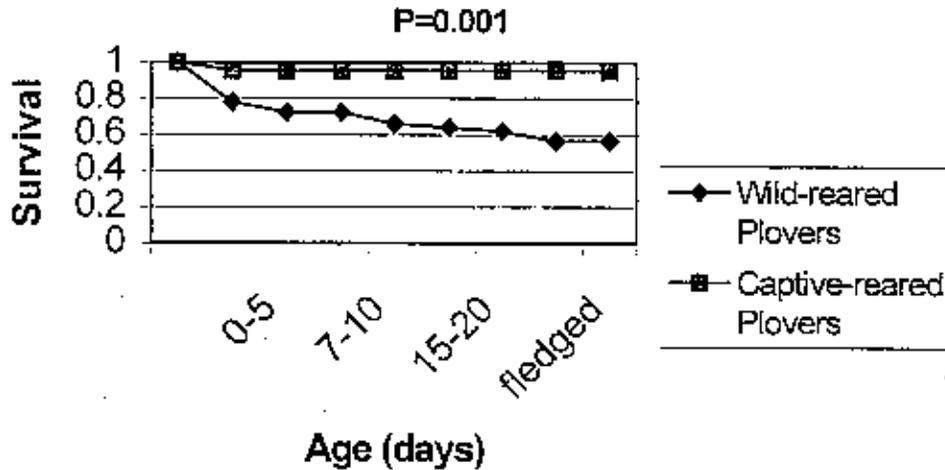
Figure 3. Pre-fledging survival of captive- and wild-reared piping plovers.

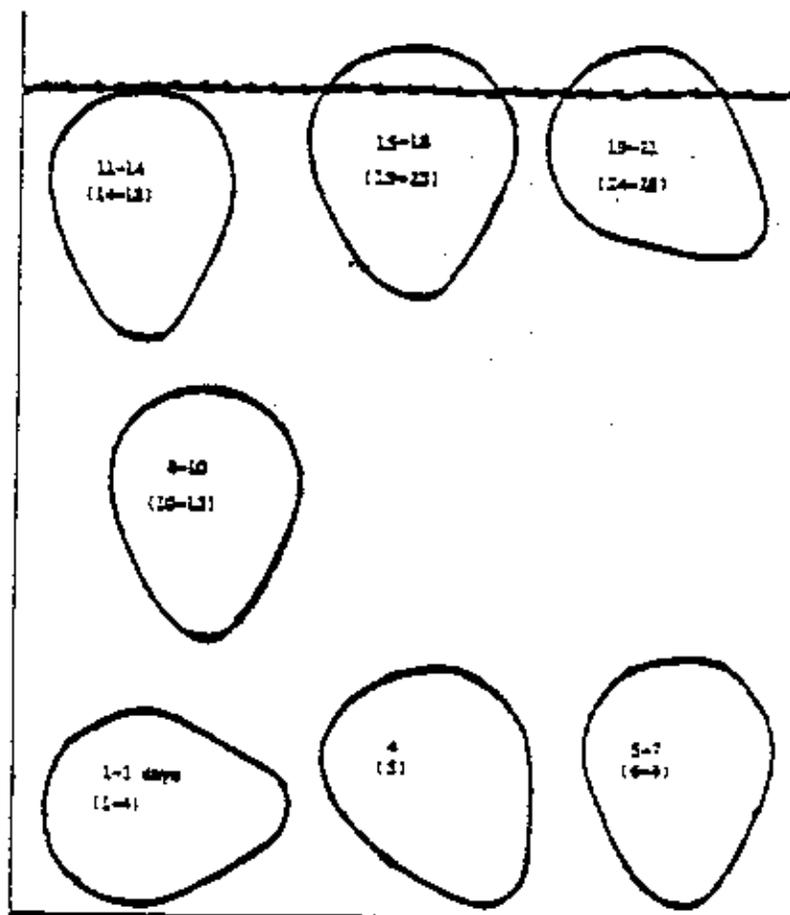
Figure 4. Egg floatation method for determining incubation stage of least tern and piping plover eggs (adapted from Hays and LeCroy 1971, modified by Schwalbach 1988). Egg position are show with the number of days into incubation indicated for least tern and piping plovers (in parentheses).

Nest initiation dates were back calculated upon finding a nest in the laying stage. If a completed clutch was found, incubation was determined using the egg floatation technique. Nest initiation was then calculated by adding the number of days incubated plus the number of eggs in a clutch multiplied by 1 if it is a least tern nest but multiplied by 2 and then subtract 1 if it is a piping plover nest. This number was then subtracted from the visit date to produce the nest initiation date. Least terns usually lay 1 egg a day for 3 days resulting in a normal clutch of 3 eggs. Incubation begins once the last egg is laid and typically lasts for 18-21 days (USFWS 1990). Piping plovers lay 1 egg every other day until a standard 4 egg clutch is completed. For re-nesting attempts, 3 eggs per clutch are typical. Incubation begins once the final egg is laid and typically lasts for 25 to 31 days (Haig and Oring 1987). Hatching dates were approximated by adding 20 days to the estimated least tern nest initiation date and by adding 32 days to the
